# Year 5 Habitat Monitoring Report

Habitat Project, Boeing Plant 2 Seattle/Tukwila, Washington Project # 0148440600 The Boeing Company

4/28/2020

Wood Environment & Infrastructure Solutions, Inc. 3500 188th Street SW, Suite 601 Lynnwood, Washington 98037 USA T: 425-921-4000

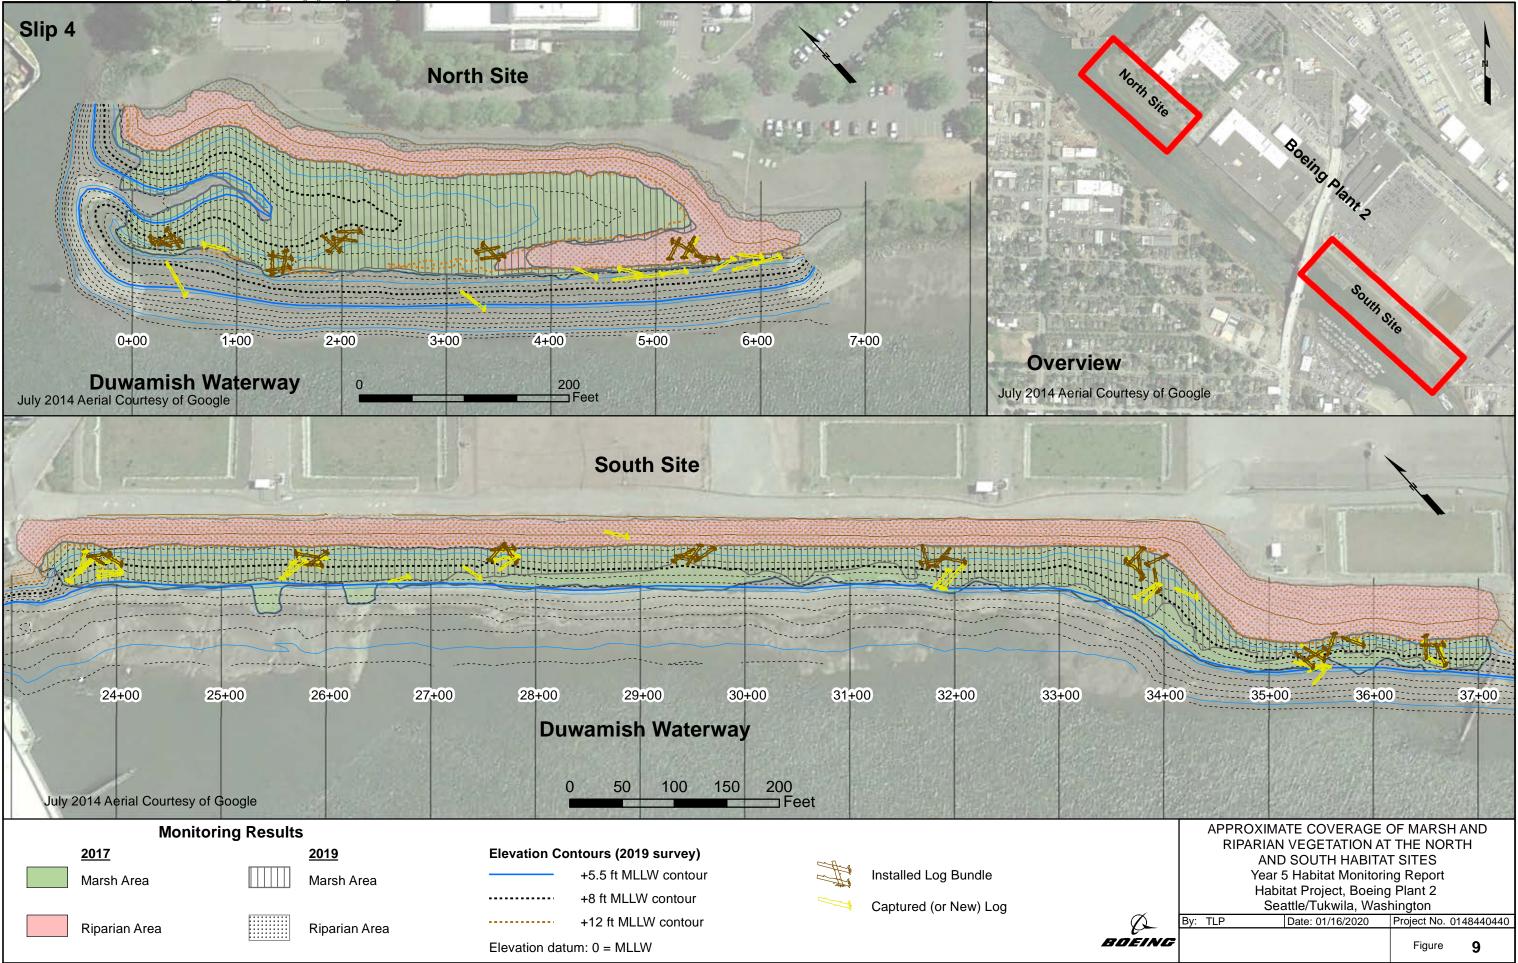
File Path: L:\BOEING\004 Shoreline Habitat\3000 Reports\Year\_5\_Habitat\_Monitoring\Figures\Figure x Coverage.mxd

Figure 9 shows the boundaries of areas where marsh plants were found in 2017 (Year 3) and in 2019 (Year 5). As shown in Figure 9, much of the change in areal coverage of marsh vegetation was observed at the South Site between +5.5 feet MLLW and +8 feet MLLW along the shoreline. Dwarf spikerush is the dominant species in this elevation band at both Sites. Dwarf spikerush was not originally planted but was an early colonizer and seems to prefer growing on the coir mats that were installed in this elevation range at the Sites. One factor that may explain the decrease in areal vegetation cover in the +5.5 to +8 foot MLLW range could be the continued decomposition and sedimentation of the coir mats. With less coir mat area available to grow on, dwarf spikerush cover in these areas has decreased. In addition, river scour in the +6 to +8 feet MLLW range has also likely contributed to loss of some vegetation in this range. This scour appears more focused or noticeable in the southern portions of the South Site where the bank grades are steeper.

The overall areal extent of the riparian areas was mapped qualitatively in Year 5 (Figure 9). Minimal observable change (6% increase) in the plan view area covered by the riparian vegetation was observed between 2017 (Year 3) (Amec Foster Wheeler, 2018) and 2019 (Year 5) (Table 4), demonstrating general overall stability of vegetation cover at the Sites (Figure 9). No observable change (0%) in the area covered by riparian vegetation was observed at the South Site compared to the 2017 survey results; the North Site exhibited a 16% increase in riparian vegetation cover from 2017 (Year 3) (Amec Foster Wheeler, 2018) to 2019 (Year 5).
