FINAL *BOUCHARD B-120* OIL SPILL SHORELINE INJURY
ASSESSMENT: INJURY QUANTIFICATION

BUZZARDS BAY, MASSACHUSETTS AND RHODE ISLAND

June 2008

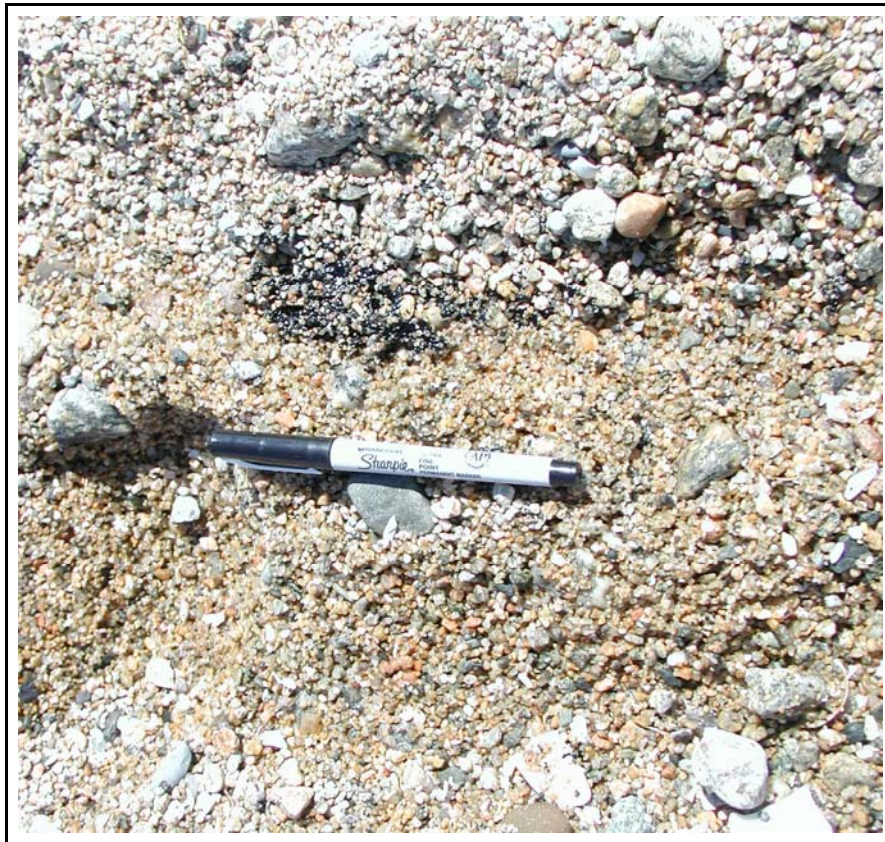
FIGURE 9. Very lightly oiled coarse substrate on the east side of Barney's Joy in April 2003.

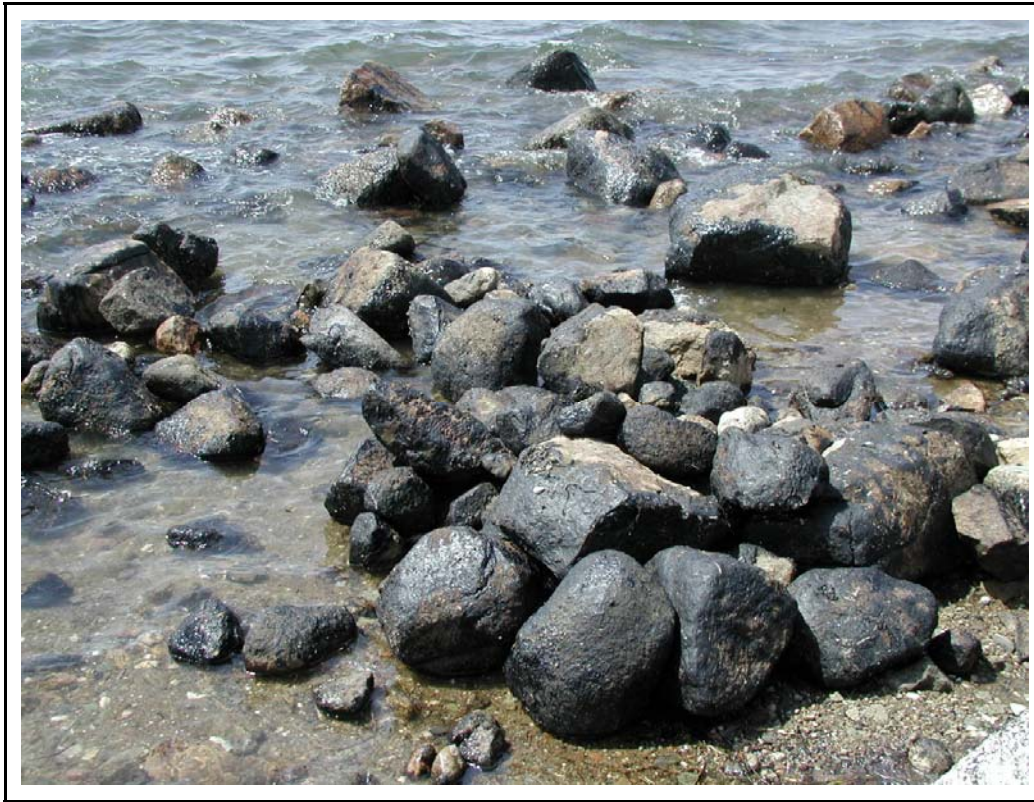
FIGURE 12. Moderately oiled coarse substrate on Brant Island. Photo taken in May 2003.

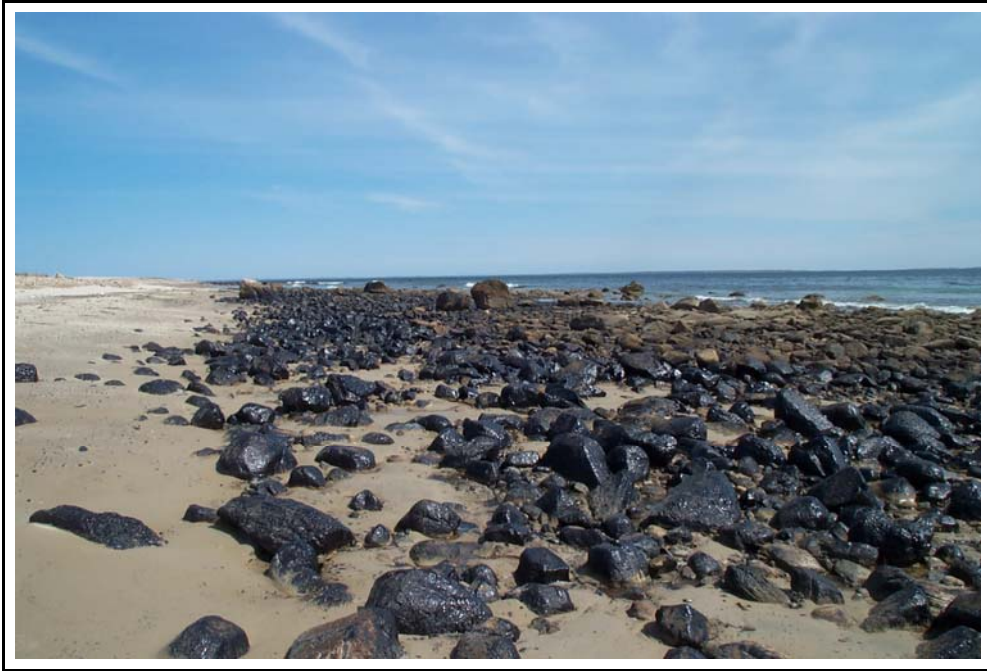
FIGURE 14. Heavily oiled coarse substrate at Barney's Joy in April 2003.

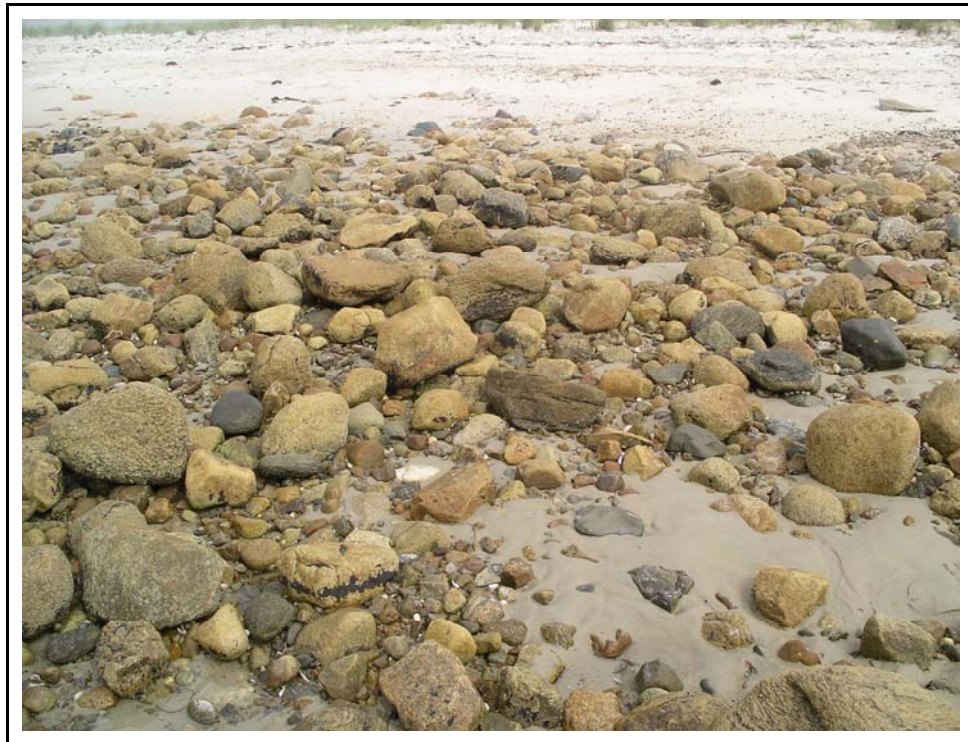
FIGURE 15. Heavily oiled coarse substrate at Barney's Joy in August 2004.

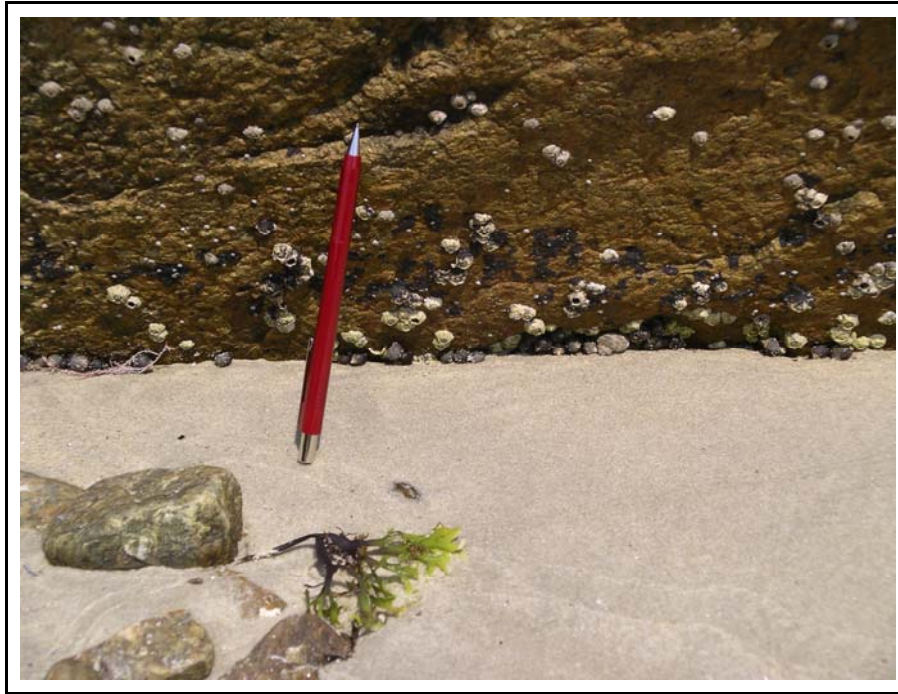
FIGURE 16. Barnacles on heavily oiled coarse substrate at Barney's Joy (west of the point) in August 2004. Note the size and number of barnacles compared to those in Figure 17.

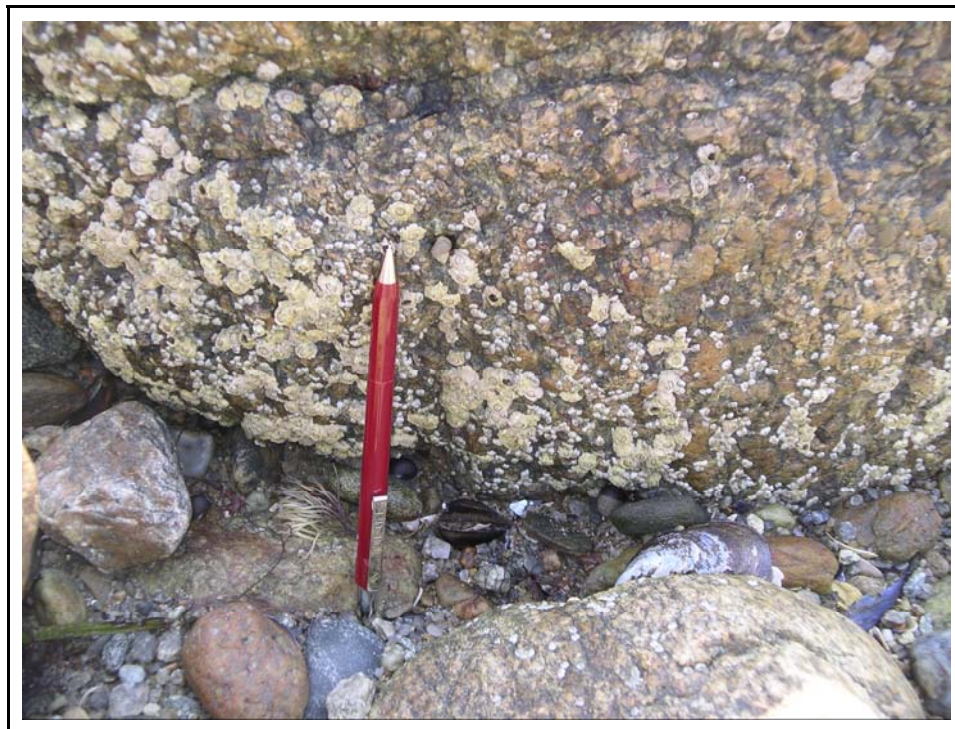
FIGURE 17. Barnacles on very lightly oiled coarse substrate at Barney's Joy (north of the point) in August 2004. This shoreline had older barnacle age classes and higher numbers.

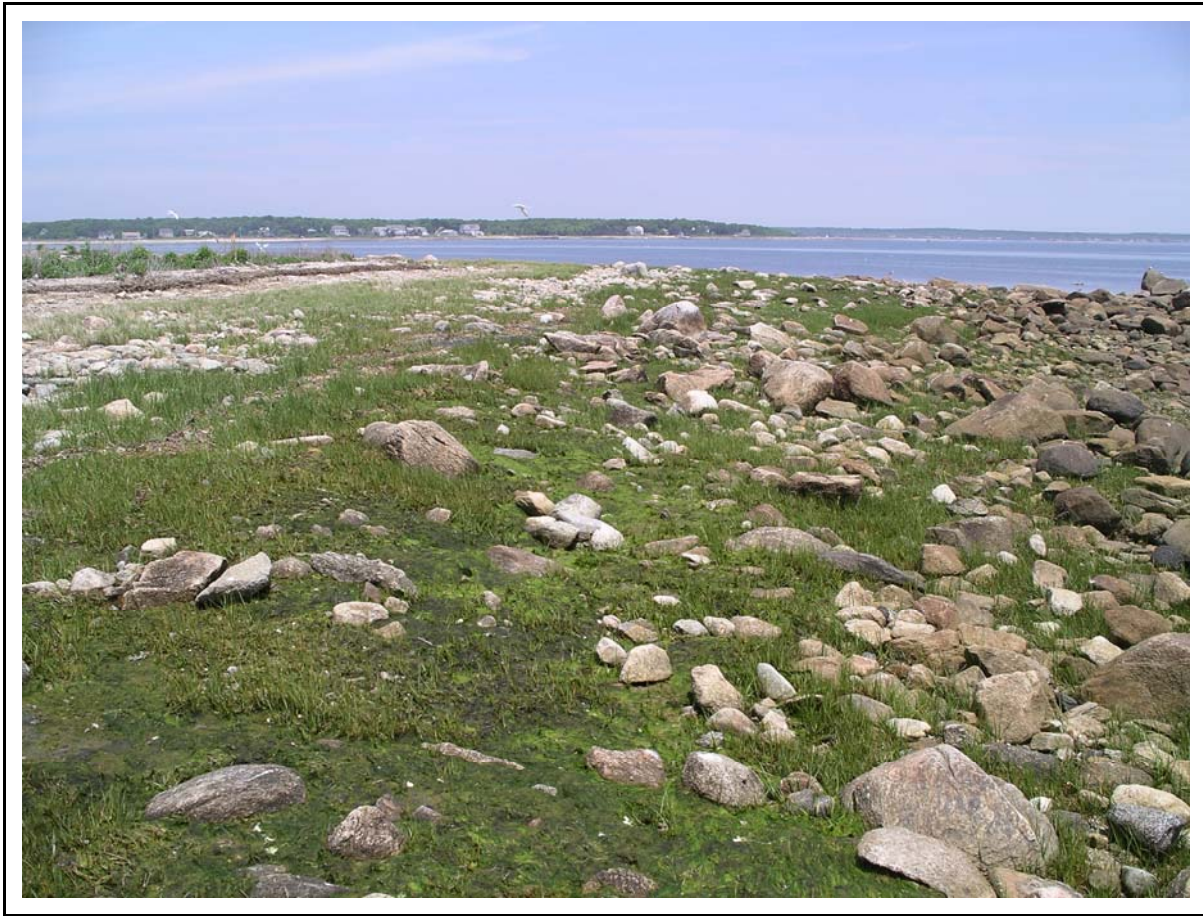
FIGURE 19. Heavily oiled coarse substrate on Ram Island in June 2004.

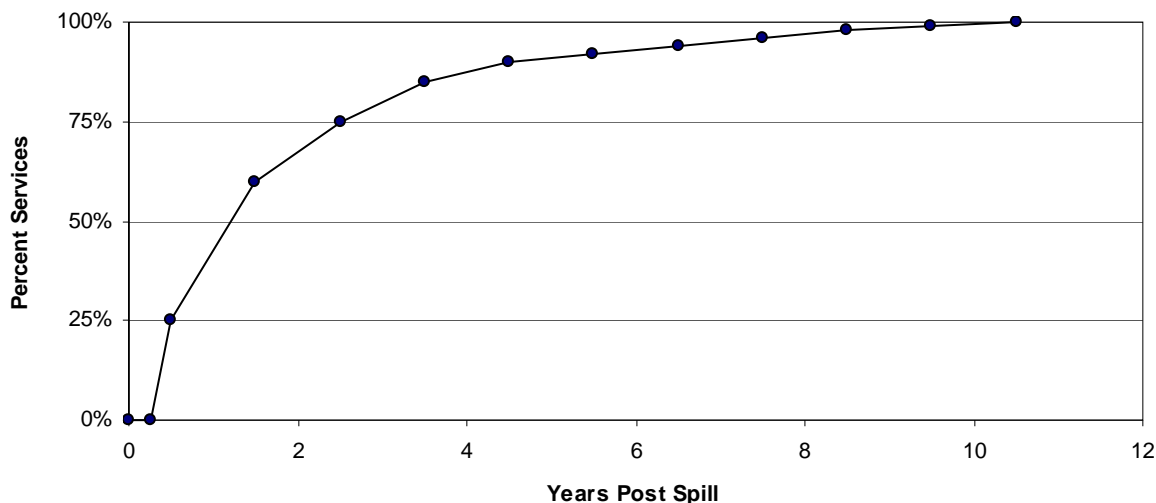
FIGURE 20. Heavily oiled coarse substrate recovery curve.

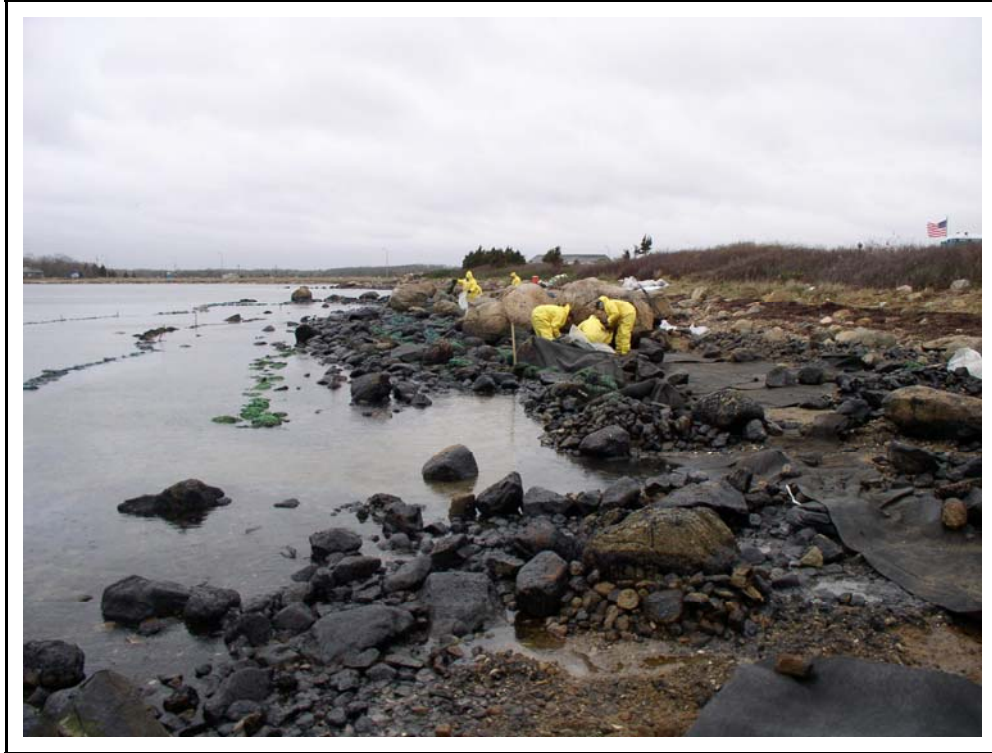
FIGURE 21. Sediment replacement site on Long Island in May 2003 prior to replacement. Note trees in background relating to Figures 21 and 22 for orientation.

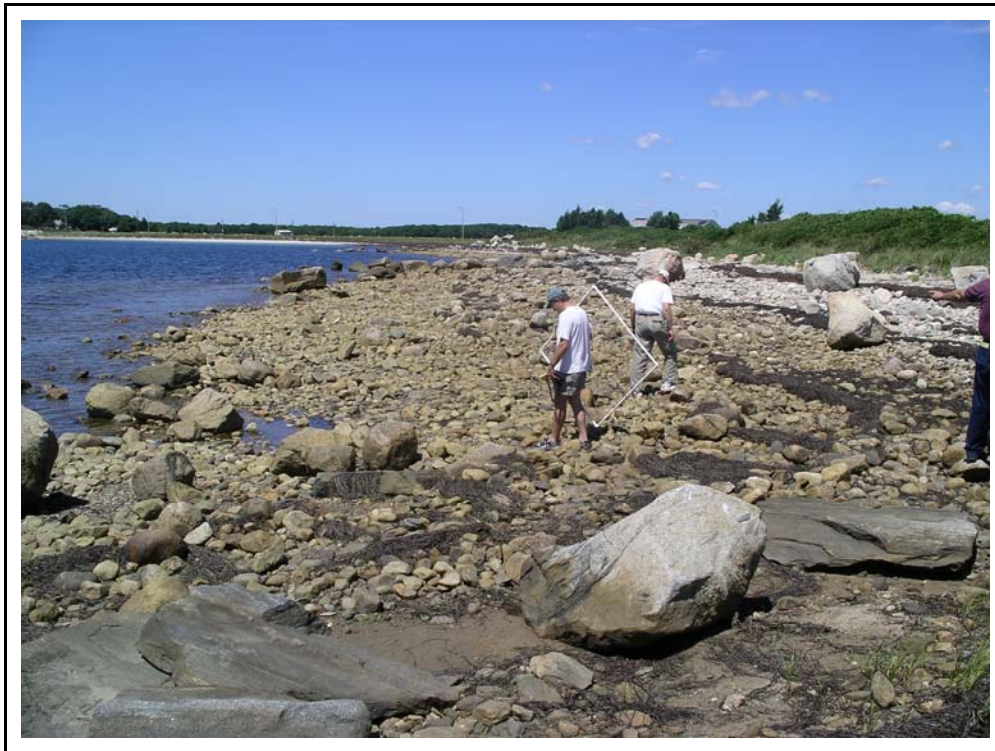
FIGURE 22. Sediment replacement site on Long Island. Photo taken in August 2004.

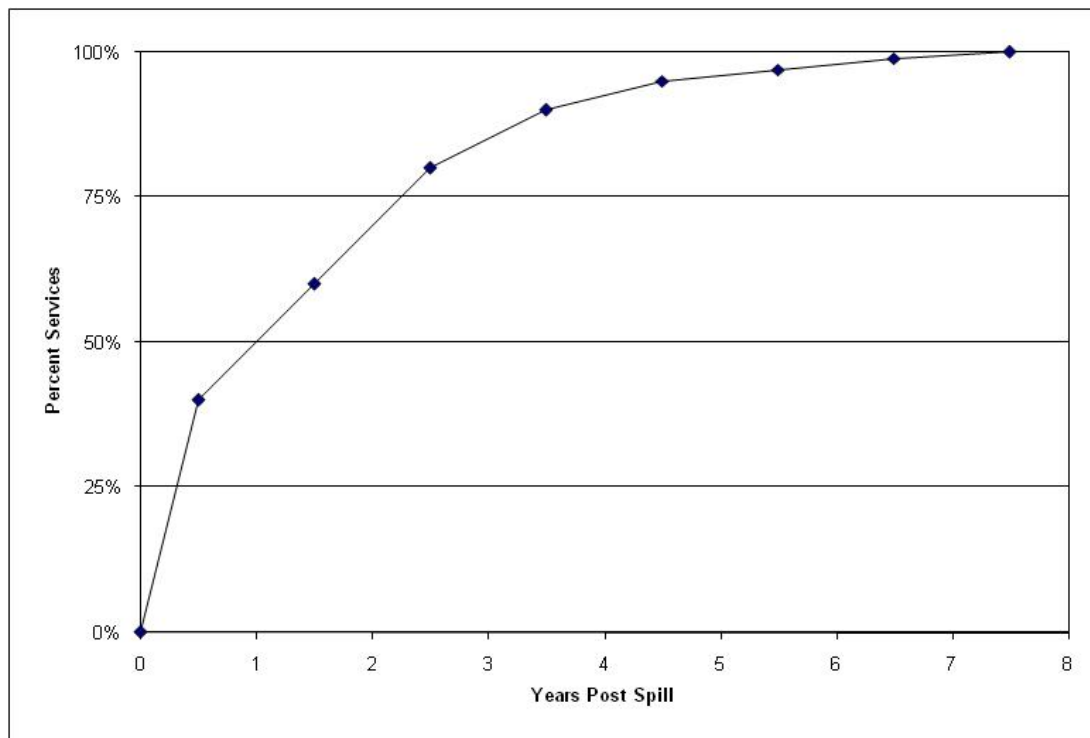
FIGURE 24. Recovery curve for Crescent Beach and Brant Island sediment replacement sites.

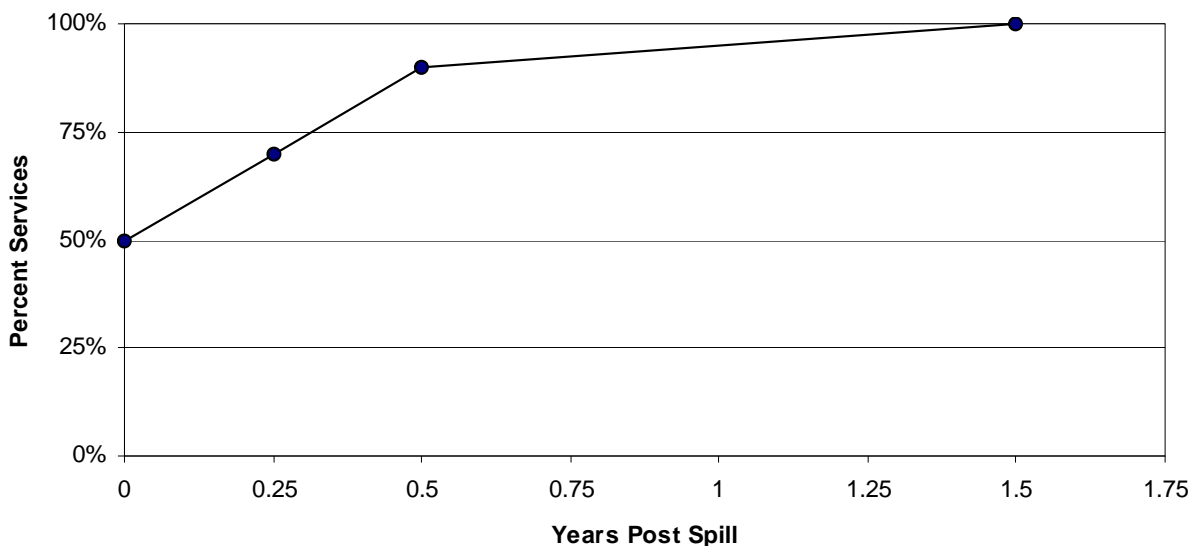
FIGURE 26. Lightly oiled sand beach recovery curve.

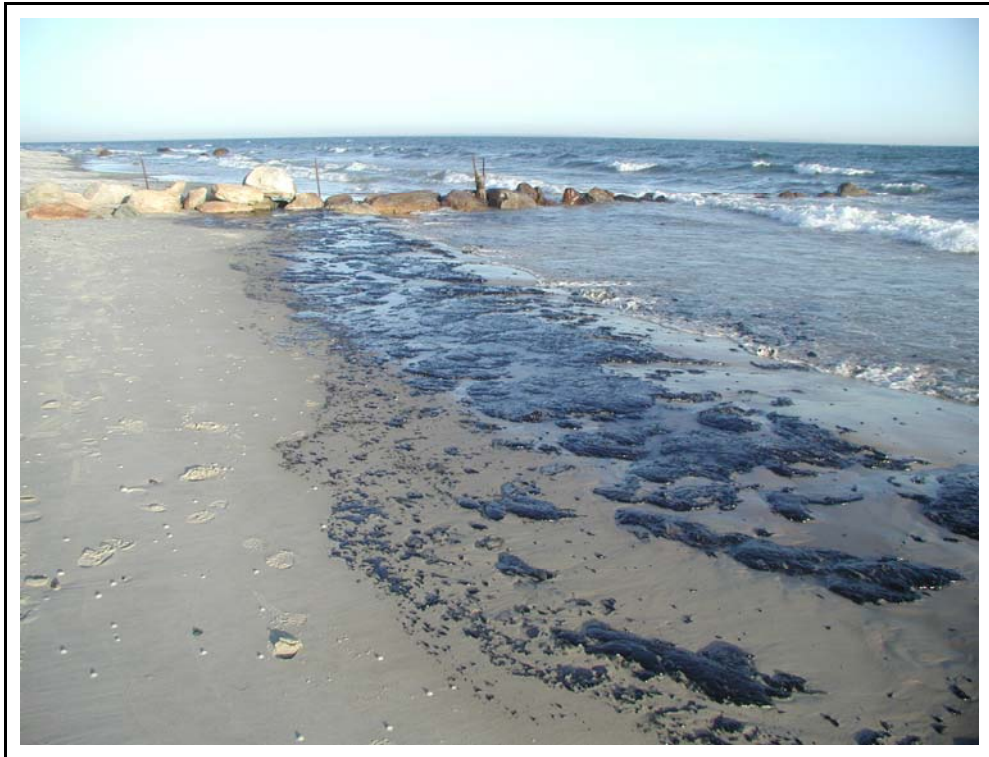
FIGURE 28. Heavily oiled sand beach at Barney's Joy. Photo taken in April 2003.

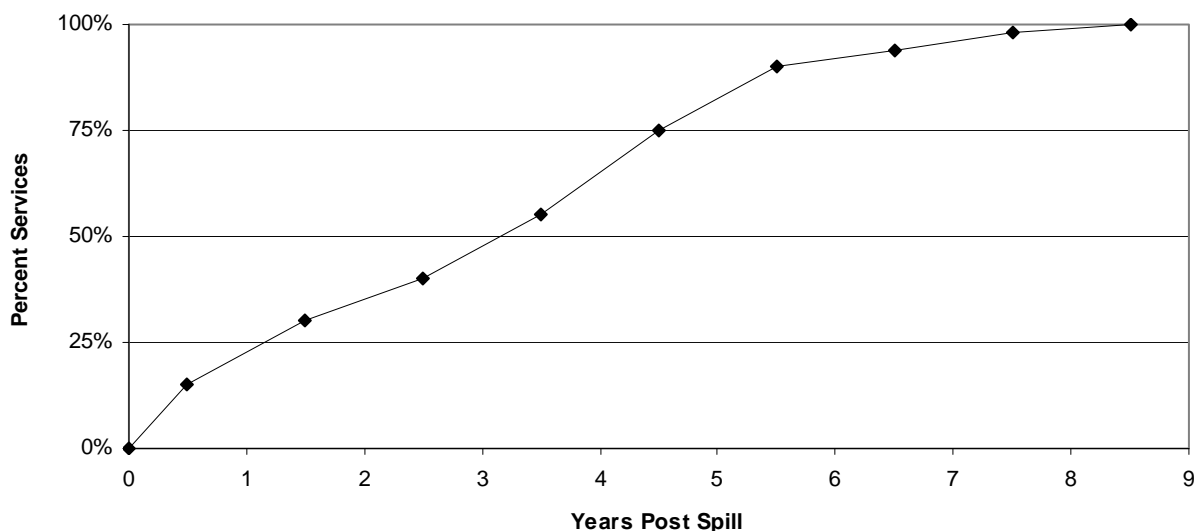
FIGURE 33. Heavily oiled marsh recovery curve.

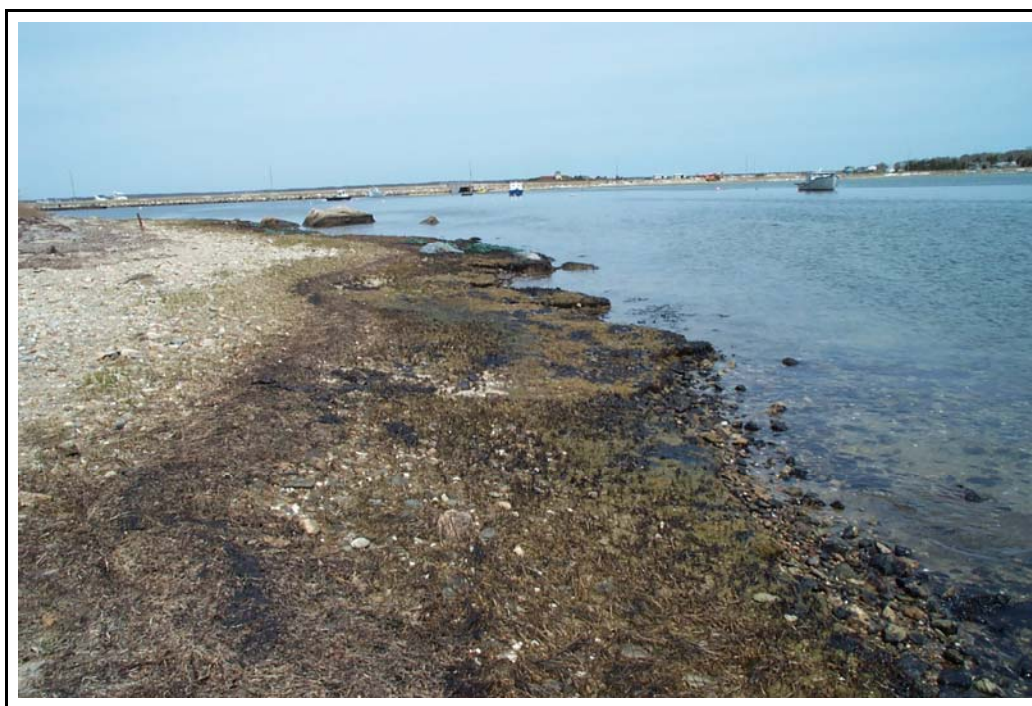
FIGURE 34. Moderately oiled marsh on the eastern side of Long Island. Photo taken in April 2003.

The Trustees estimated an 80% service loss (20% services present) after one growing season had occurred (0.5 yrs post-spill). Some of the bare areas in this marsh had been replanted with *S. alterniflora* in July 2003. Few plants appeared to be healthy by September 2003 (Fig. 35). The SAT re-surveyed Long Island about 1.5 years after the spill and found similar bare spots with minimal re-colonization of marsh plants (Figure 36). A long band of bare soil was an obvious indication of where oil had stranded along the marsh. A fairly thick algal mat covered the bare soil and may have prohibited seed germination or vegetative spreading due to excessively high sulfide levels. In some areas, *S. alterniflora* appeared shorter in height than expected. Eroding scarps along the moderately oiled shoreline of Long Island were noted where marsh vegetation had not re-colonized. The substantial reduction in primary productivity with the loss of the marsh plants and the loss of habitats for epifauna, and thus birds foraging, caused the Trustees to estimate a 70% loss of services after the second growing season (1.5 yrs post-spill).

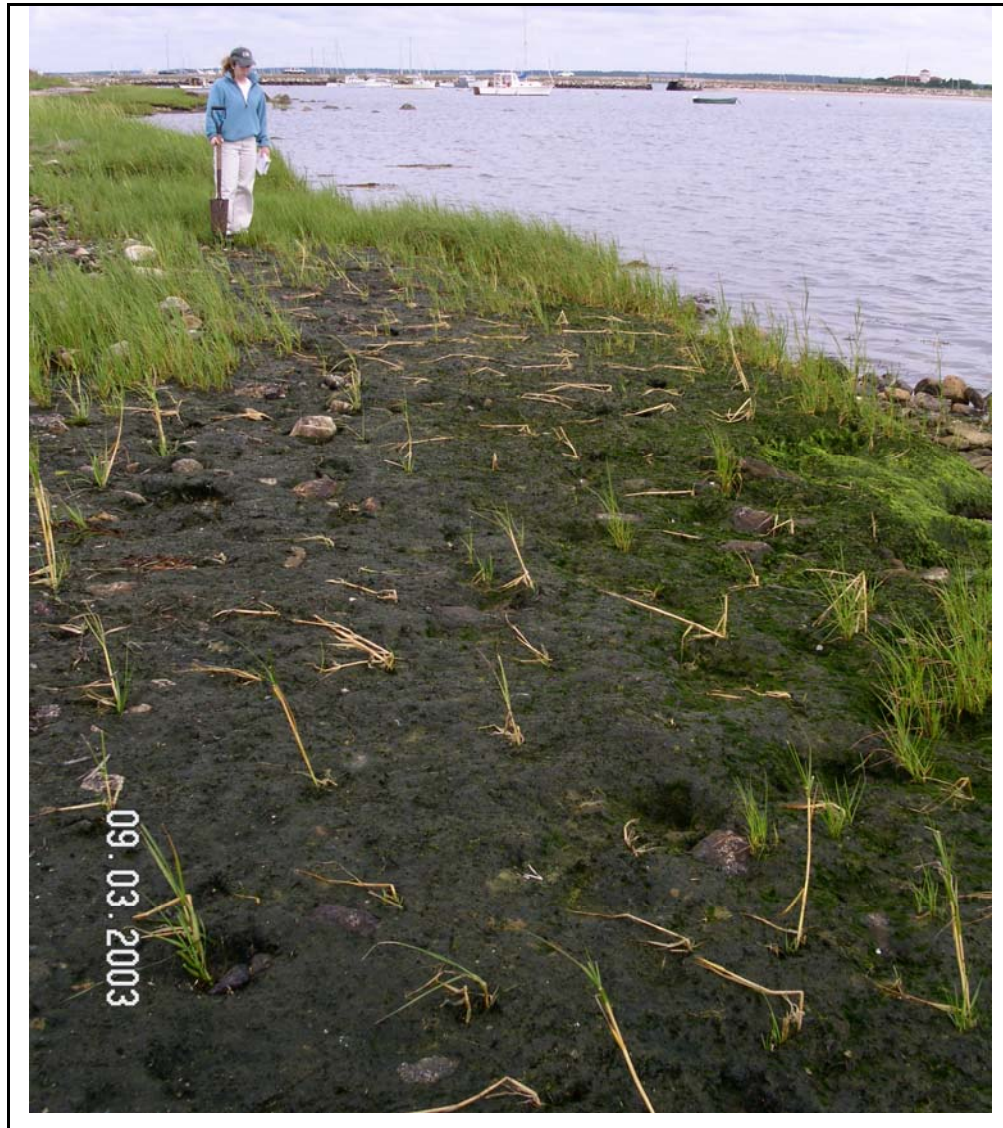
FIGURE 35. Moderately oiled marsh on Long Island. Note dead *S. alterniflora* plantings. Photo taken September 2003.

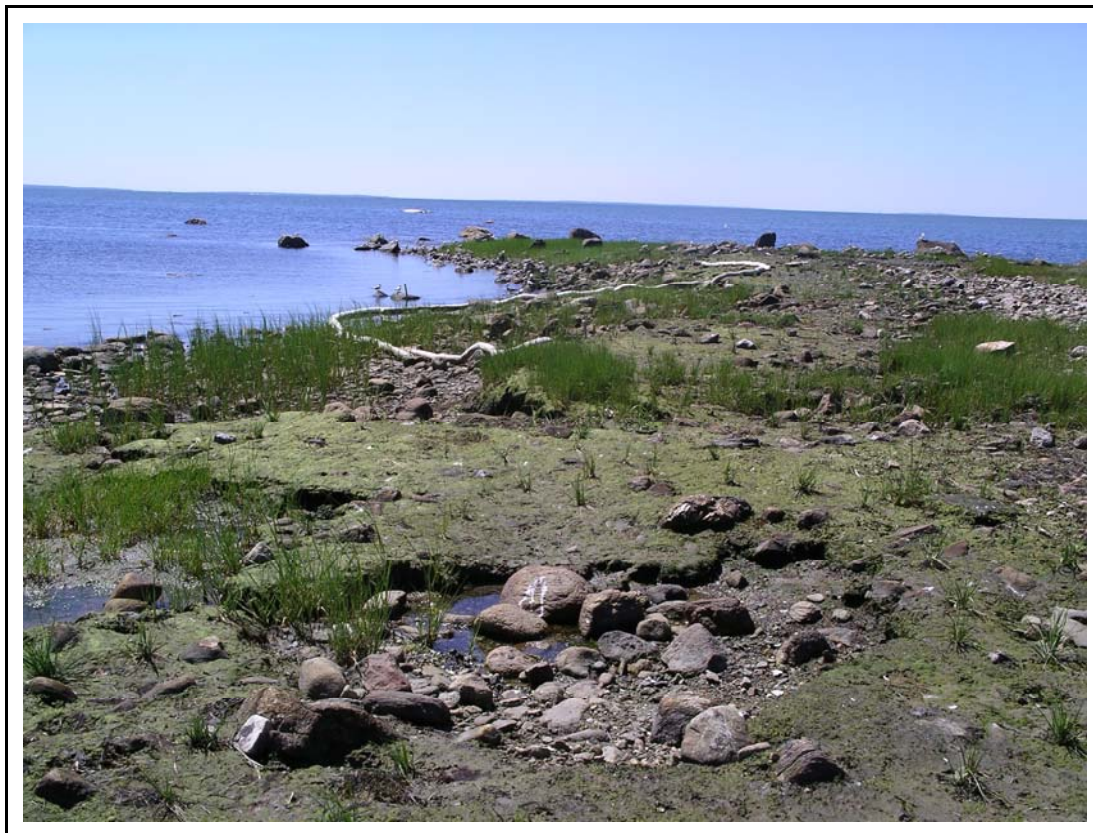
FIGURE 36. Moderately oiled marsh on Long Island. Note bare patches and eroded peat flat. Photo taken August 2004.

The Trustees estimated the loss of services was at 50% of baseline by the end of the third growing season (2.5 yrs post-spill) based on observations in June 2005. The bare spots were still present on Long Island (Figure 37) causing a reduction in primary productivity and available habitat for epifauna and birds. At the end of the fourth growing season (3.5 yrs post-spill), the loss of services was estimated at 30% of baseline (70% services present). The bare patches would slowly start to fill in and the algal mat would no longer remain on the substrate. However, a loss of fish and birds using the habitat may still be evident with a reduction in vegetation and associated prey items.

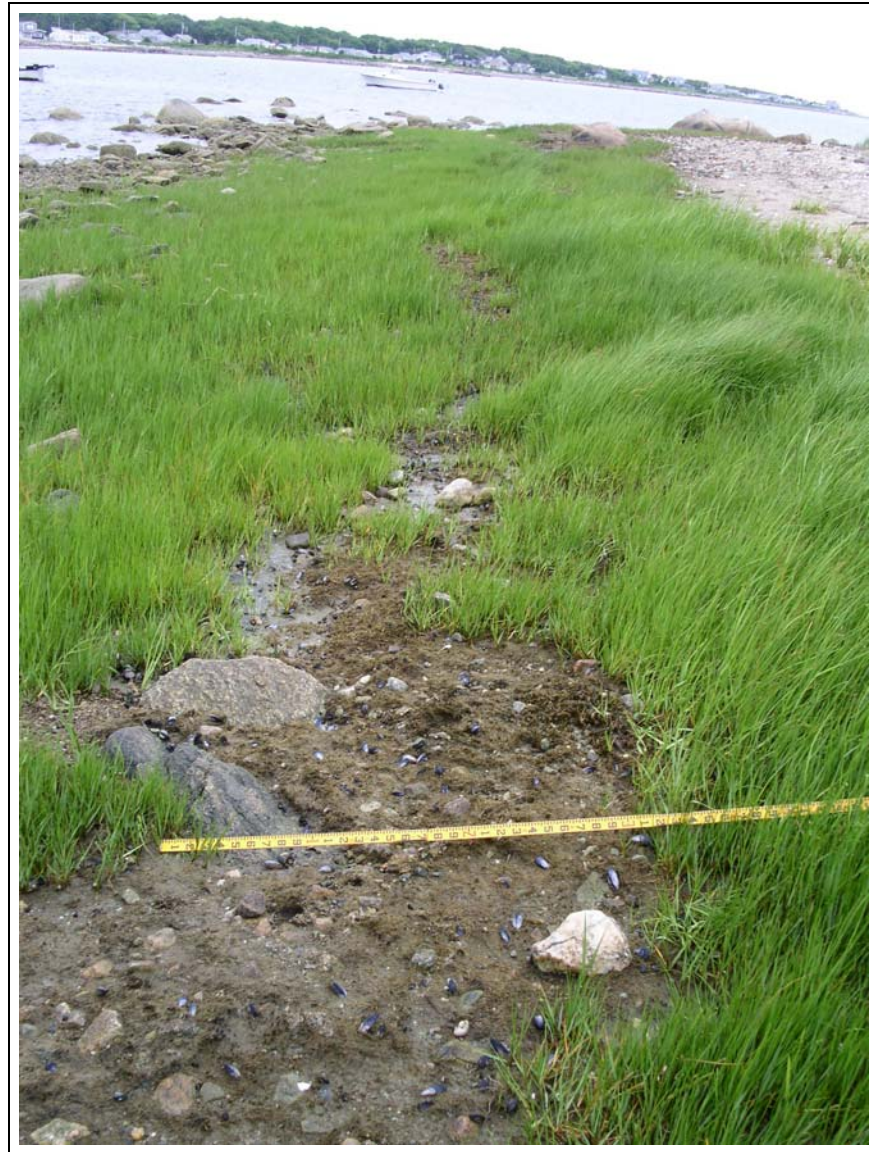
FIGURE 37. Moderately oiled marsh on Long Island. Bare patches are still present. Photo taken June 2005.

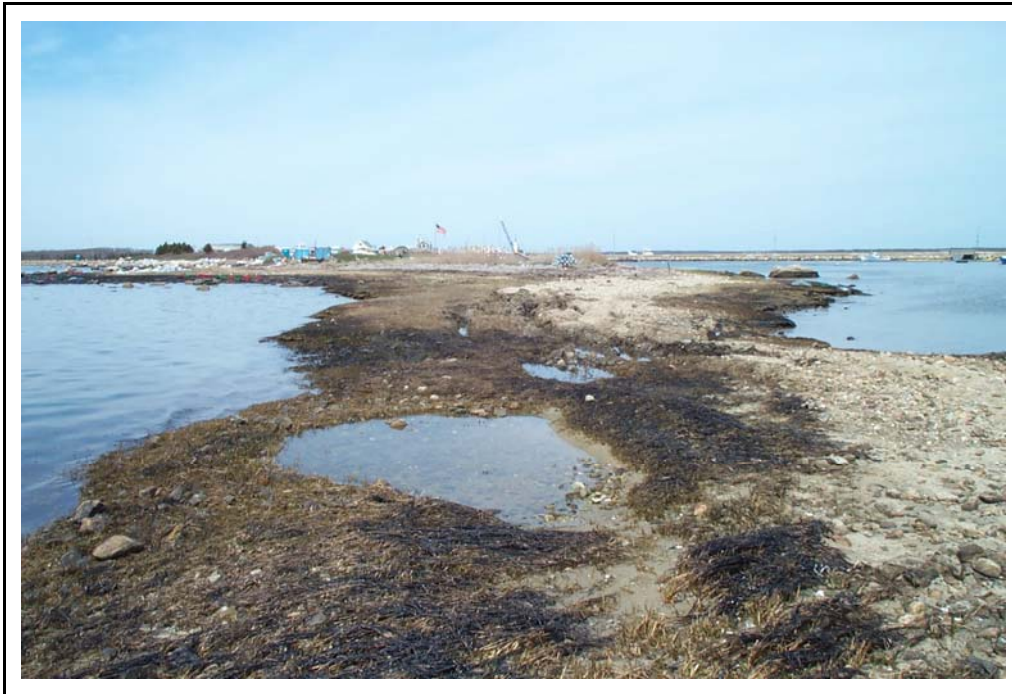
FIGURE 38. Heavily oiled marsh on Long Island. Photo taken in April 2003.

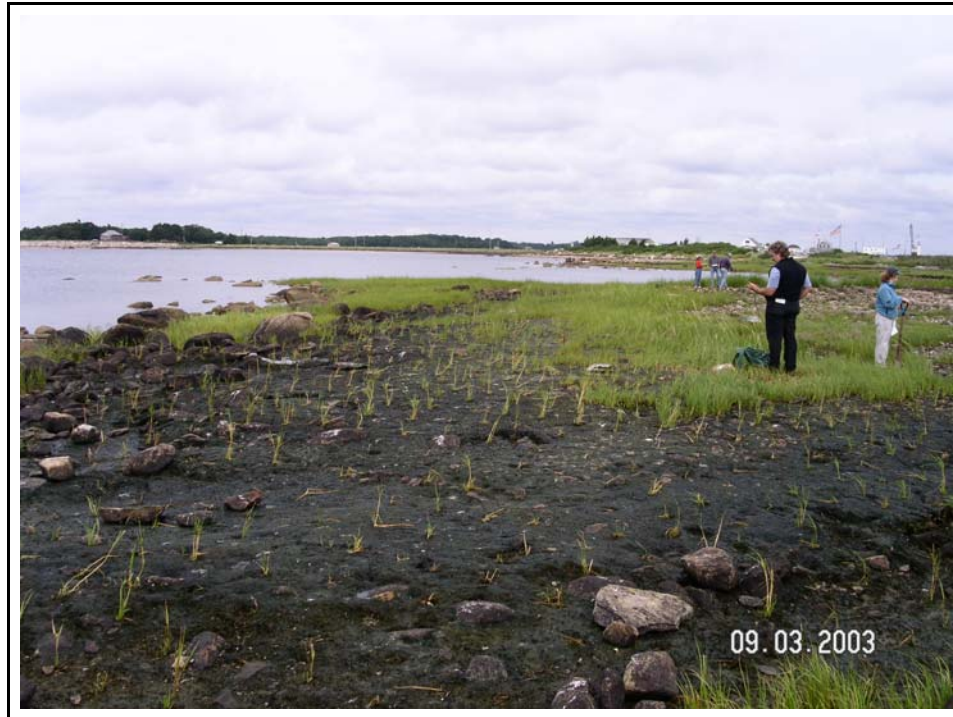
FIGURE 39. Heavily oiled marsh on western side of Long Island; photo taken in September 2003. Note the sprigs of planted *Spartina alterniflora*.

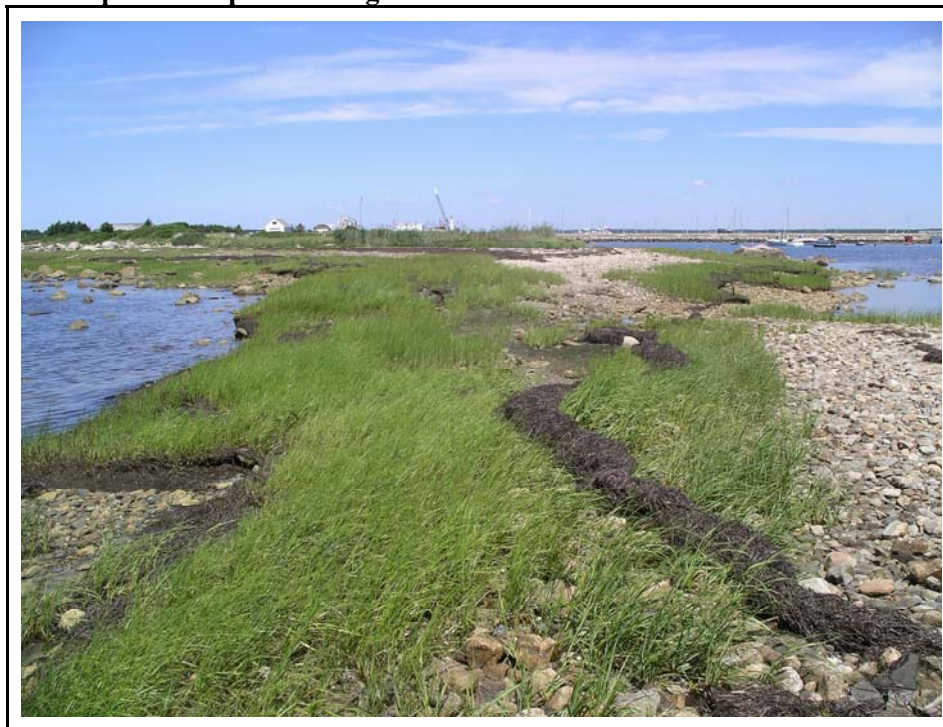
FIGURE 40. Heavily oiled marsh on west side of Long Island; photo taken in August 2004; compare with photo in Figure 38.

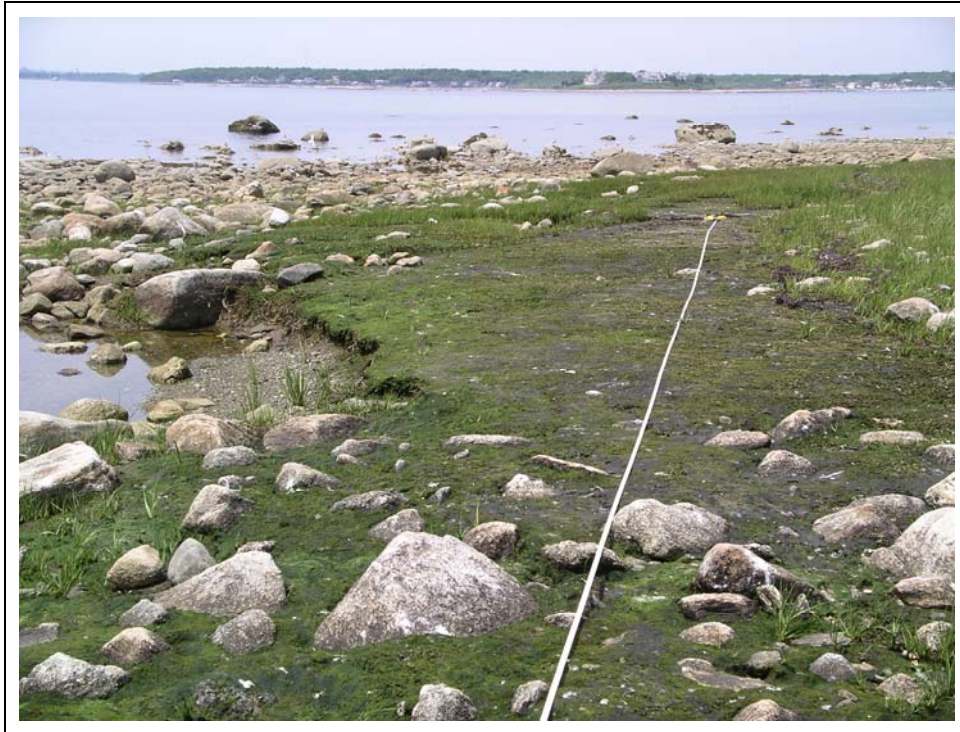
FIGURE 41A. Heavily oiled marsh on Ram Island; photo taken in June 2004, prior to *Spartina alterniflora* planting.

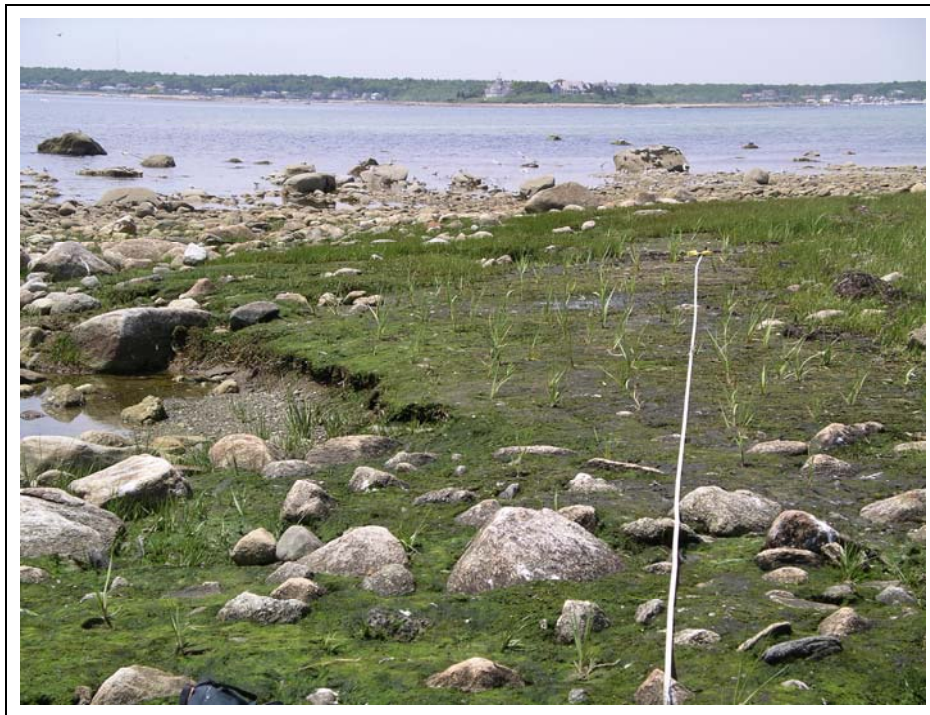
FIGURE 41B. Heavily oiled marsh on Ram Island: photo taken in June 2004, after *S. alterniflora* planting. Compare to Fig. 41A and 41C.

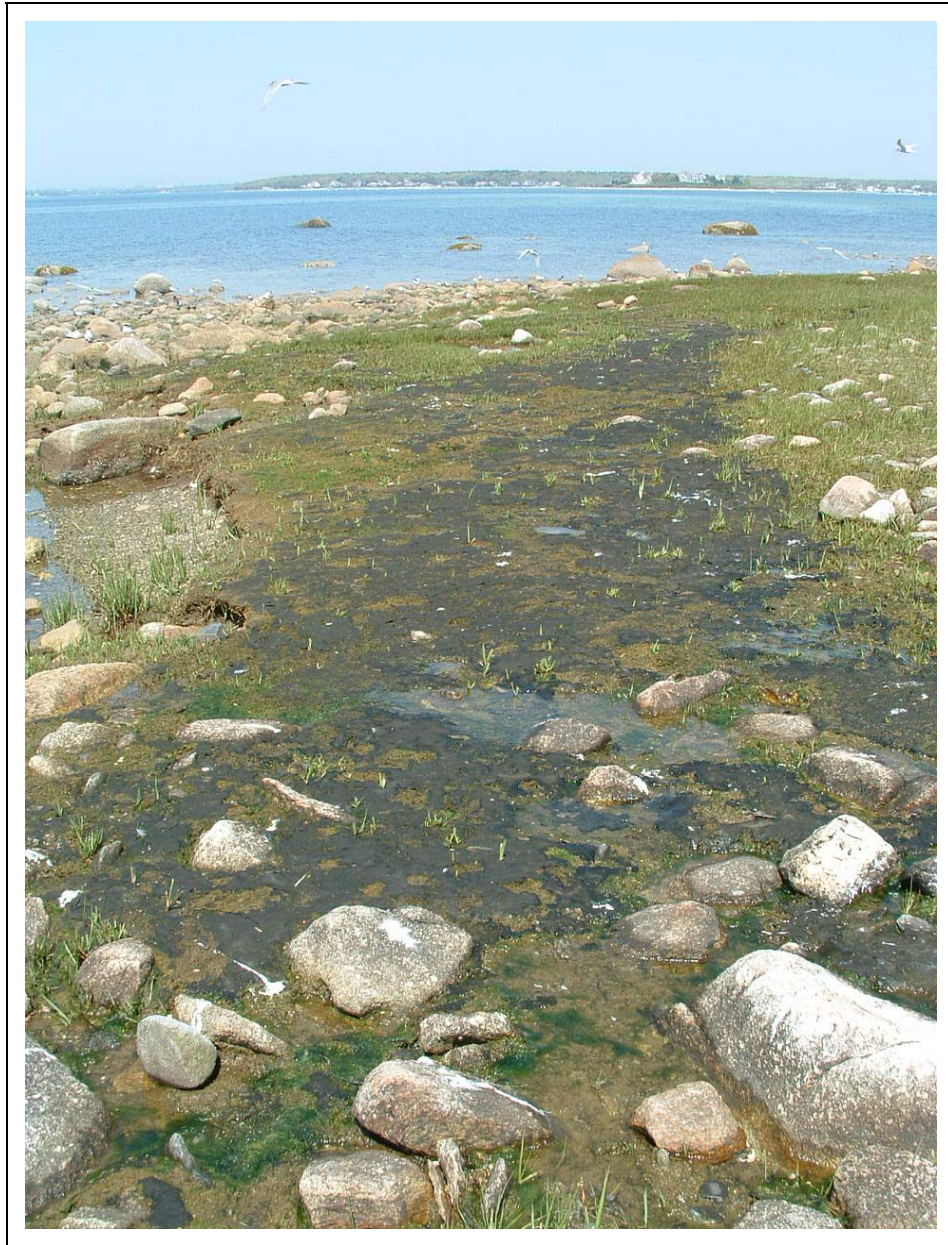
FIGURE 41C. Heavily oiled marsh on Ram Island; photo taken in June 2005.

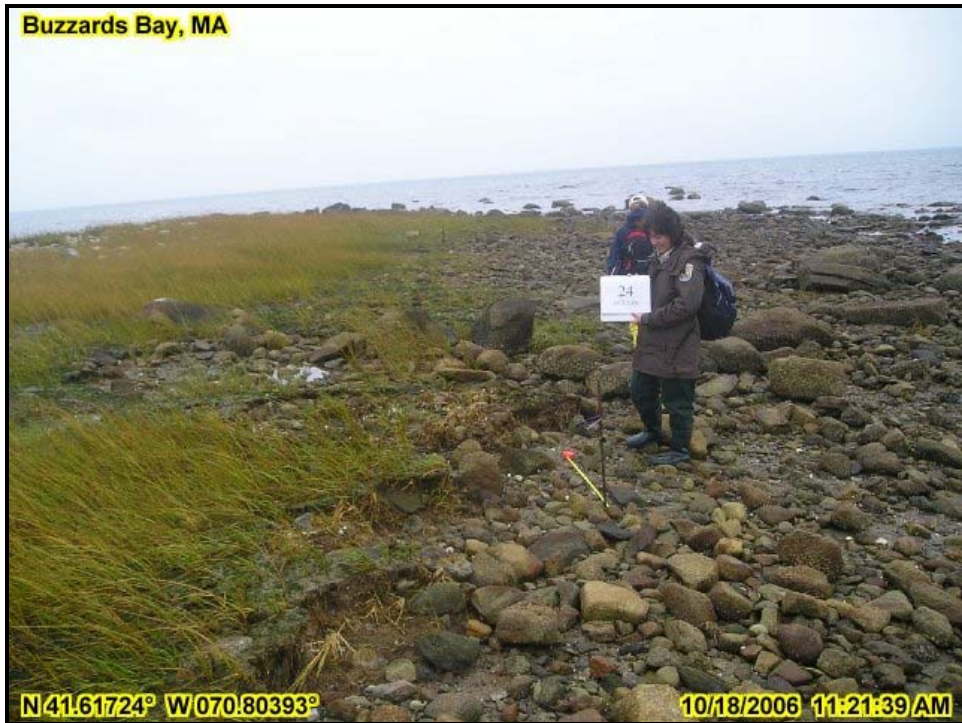
FIGURE H-2. Eroding Marsh Peat Scarp and Monitoring Stake and Photostation #24

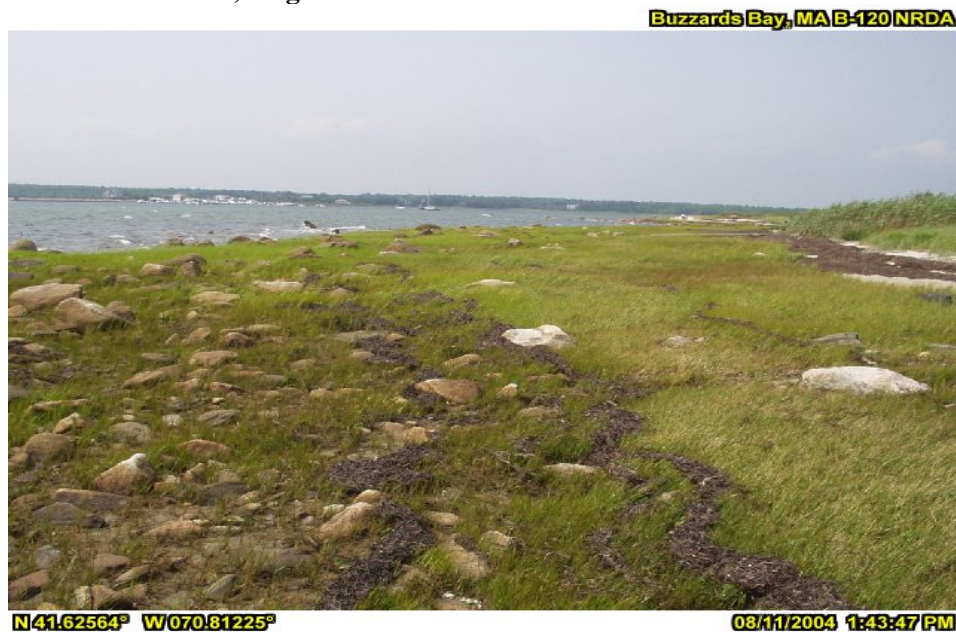
Figure 7. Brandt Island Cove, August 2004

Photographs taken during field visits in 2004 show substantial vegetation growth on Brant Island Cove (Figure 7) which includes 80% of the heavily oiled marsh and the marsh looks healthy.
