Year Three Monitoring Report

NOISETTE CREEK SALT MARSH RESTORATION

Prepared for: Natural Resource Damage Trustees

Prepared By: Tidewater, A JMT Division

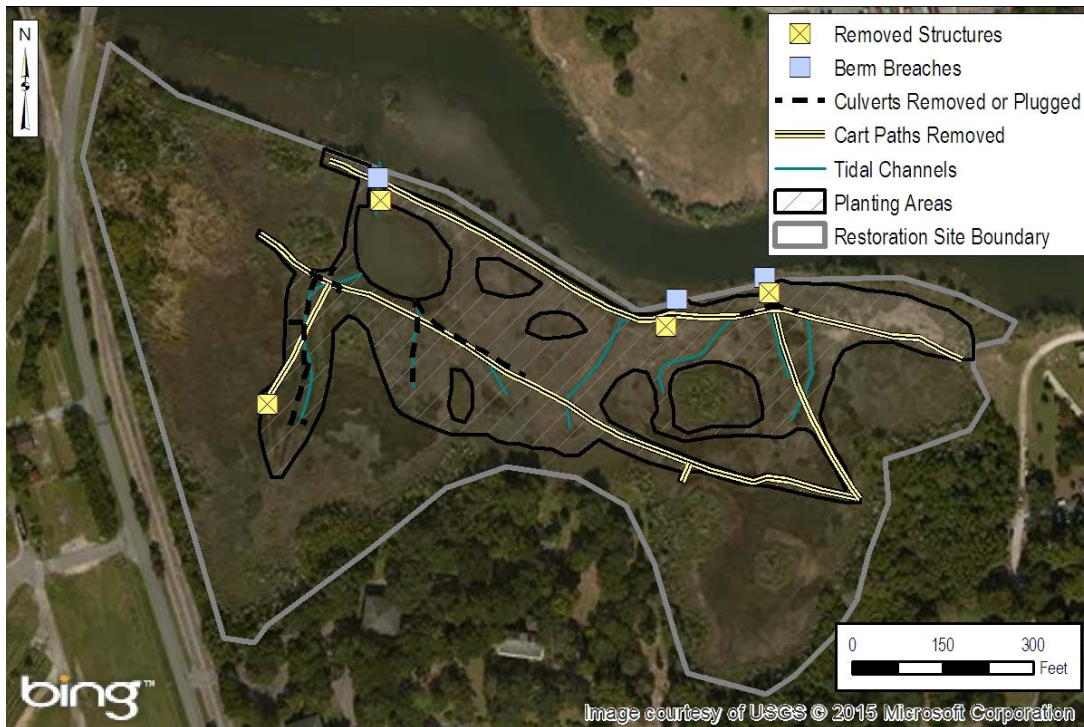
Figure 2. Restoration Plan

The Proposed Salt Marsh Restoration Plan (herein, Restoration Plan), dated May 16, 2007, for the former golf course was developed by Lewis Environmental Services, Inc. The final restoration plan and construction drawings were developed by URS with assistance from Tidewater Environmental Services Inc. (Tidewater) and Lewis Environmental Services, Inc. The restoration plan is depicted on Figures 2 and 3.

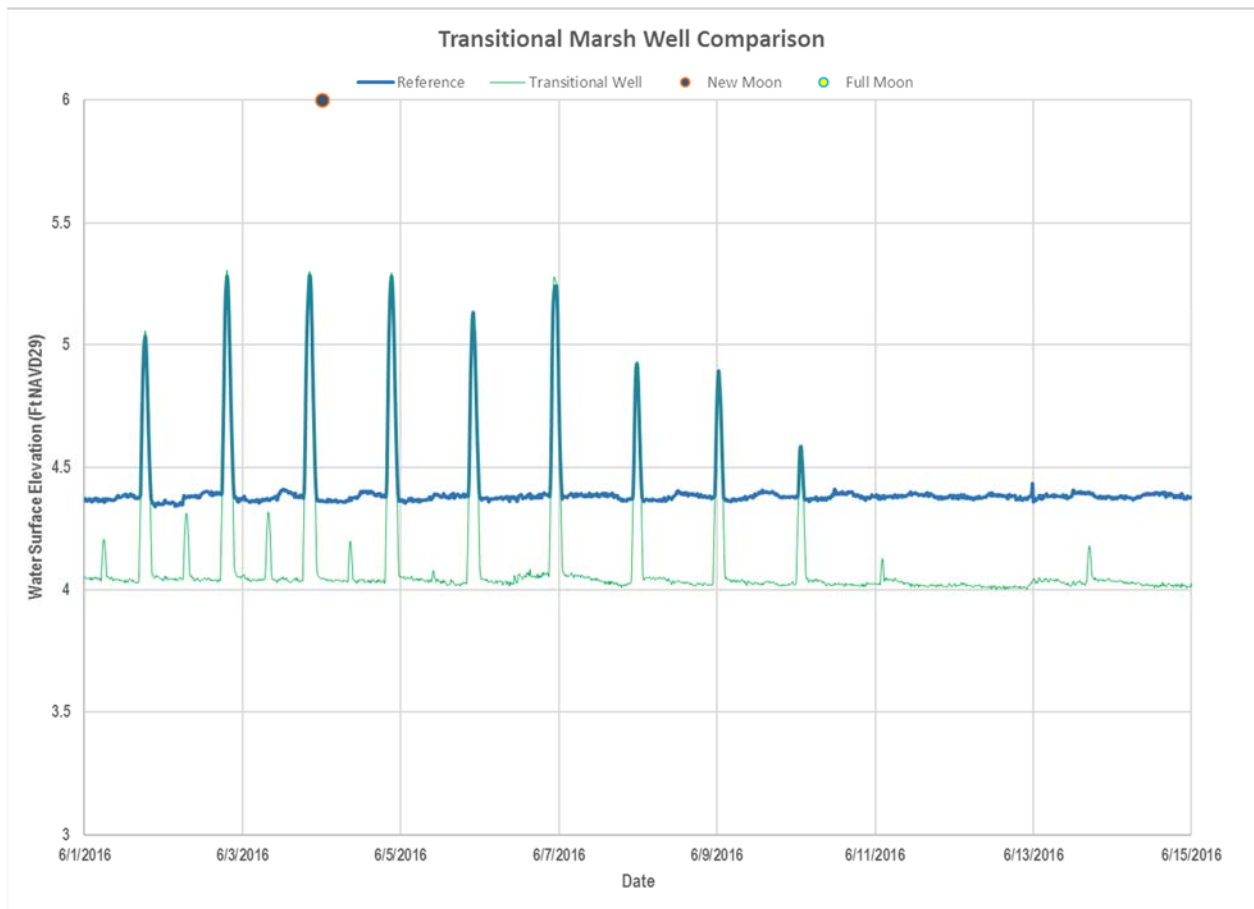
Chart 3: Transitional Well Tidal Data from Restoration and Reference Sites

Note that tidal inundation is not recorded at the transitional well until the tide reaches the equivalent elevation of the transitional well at the bridge and pond. Additionally, the peak tides recorded at the Transitional Well is consistent with the levels recorded at Bridge and Pond Wells. Similarly, as shown in Chart 3, the tidal levels recorded at the transitional wells at the restoration and reference sites are consistent. MHW and MHHW are higher at the transitional wells at the restoration and reference sites than what is recorded at the bridge and the pond because these areas are only inundated on larger (or spring) tides. Based upon this information, it appears that the tidal flows between Noiset Creek and the marsh have been restored to normal conditions.

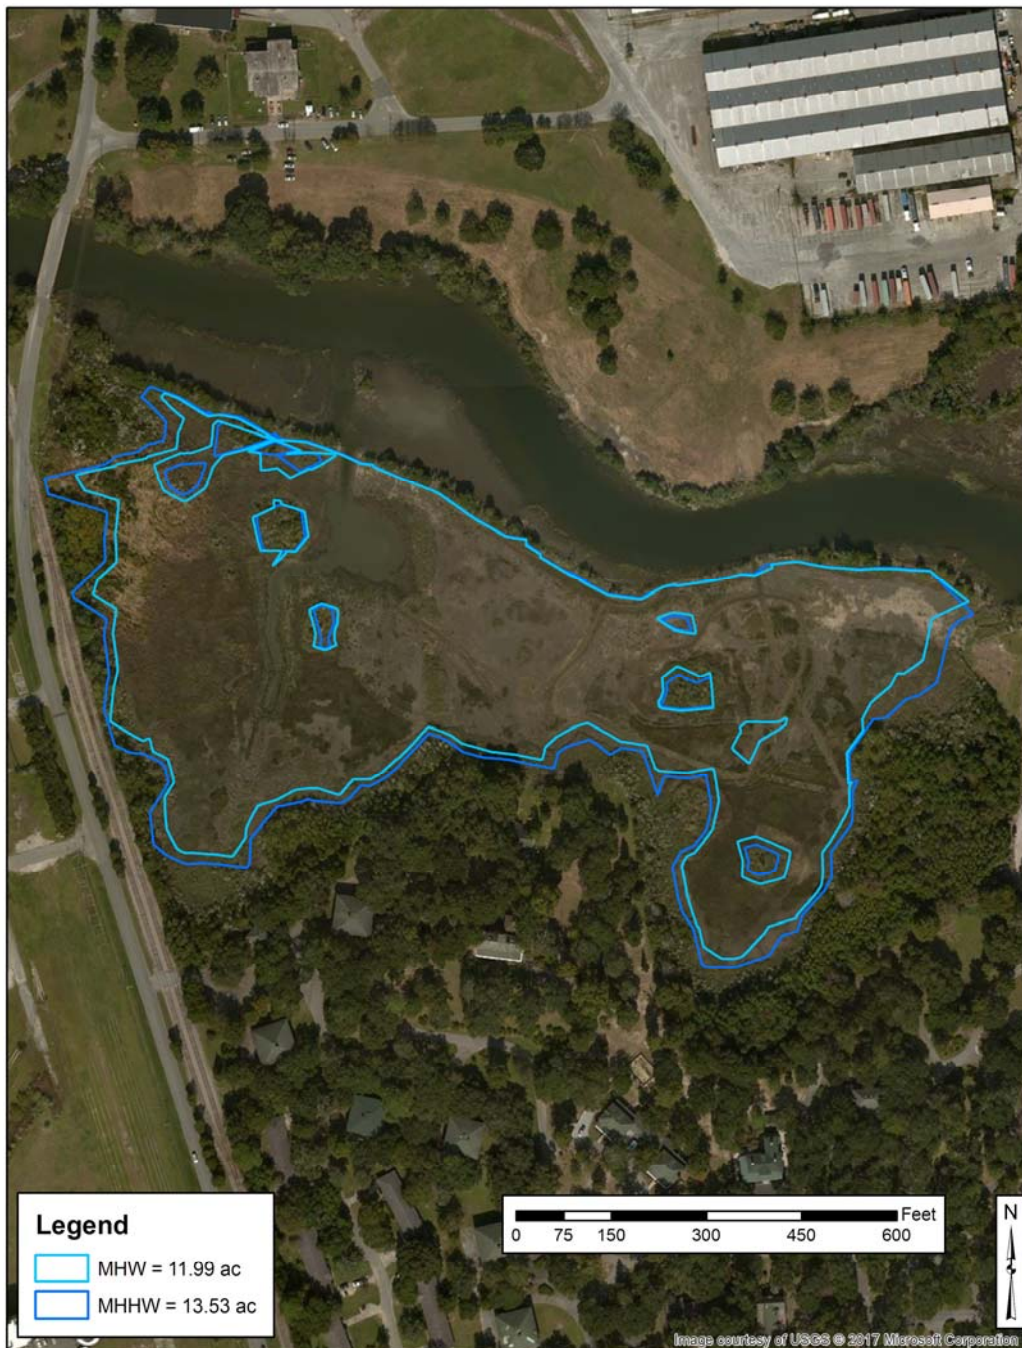
Figure 8: Restored Acreage of Salt Marsh

Figure 8 shows the number of acres that are inundated on a regular basis based upon site topography and the mean high water (MHW) and mean higher high water (MHHW) elevations from the Year Three Monitoring Report. Based upon visual observations of the site, it appears that MHW and MHHW accurately reflects site conditions, and the acreage of restored saltmarsh is verified by data collected from the wells during Year Three. Based upon these observations, the project appears to have completed the goal of restoring a natural tidal regime to the site.
