Final Damage Assessment and Restoration Plan/
Environmental Assessment
for the July 25-26, 2010
Enbridge Line 6B Oil Discharges near Marshall, MI

October 2015

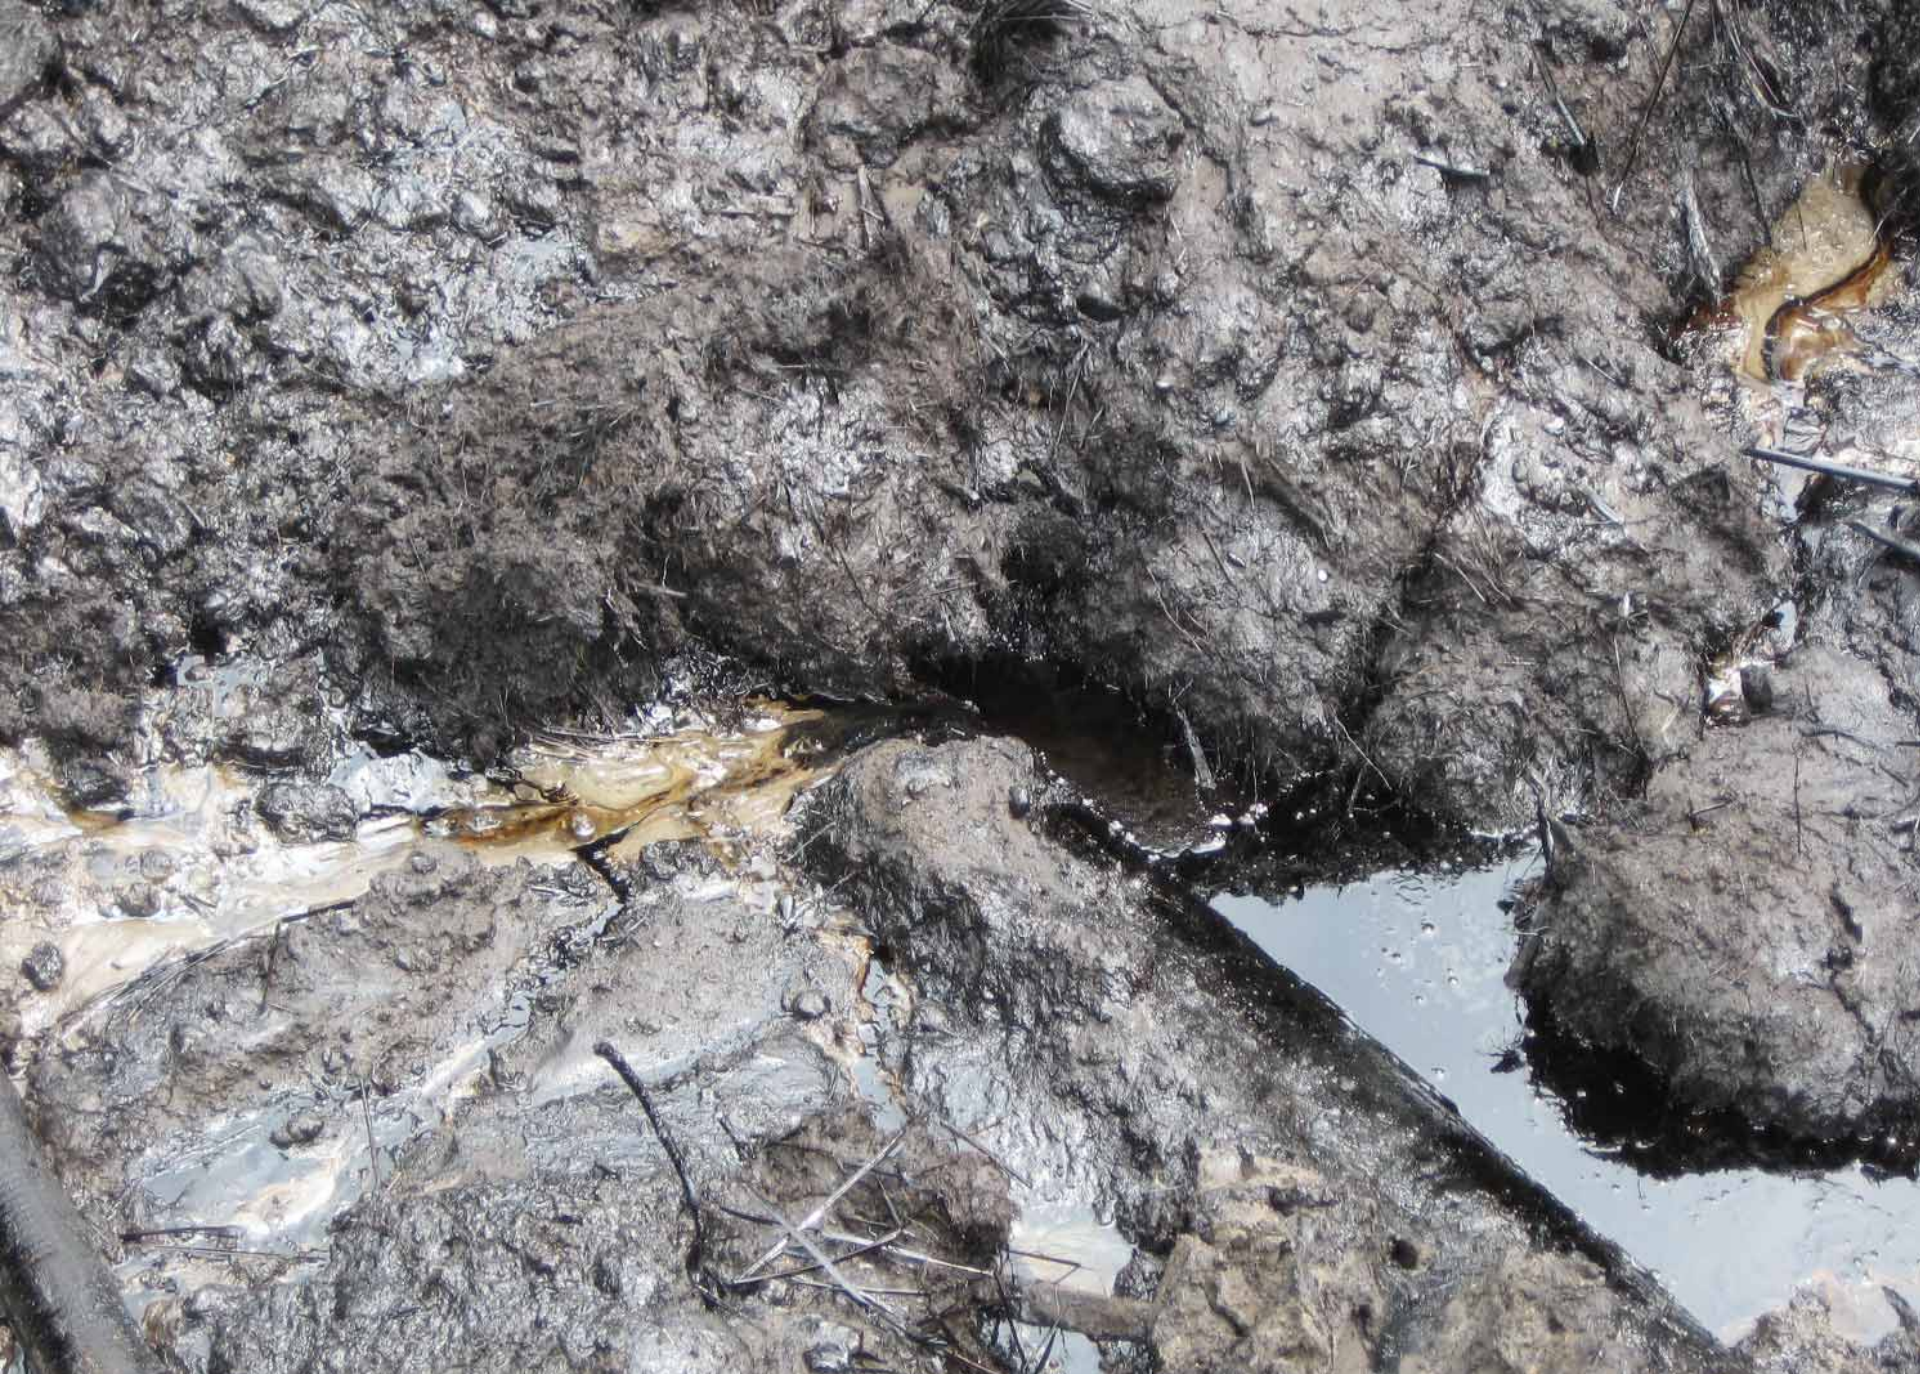
Oil coming out of culvert on Talmadge Creek on first day of spill, July 26, 2010.

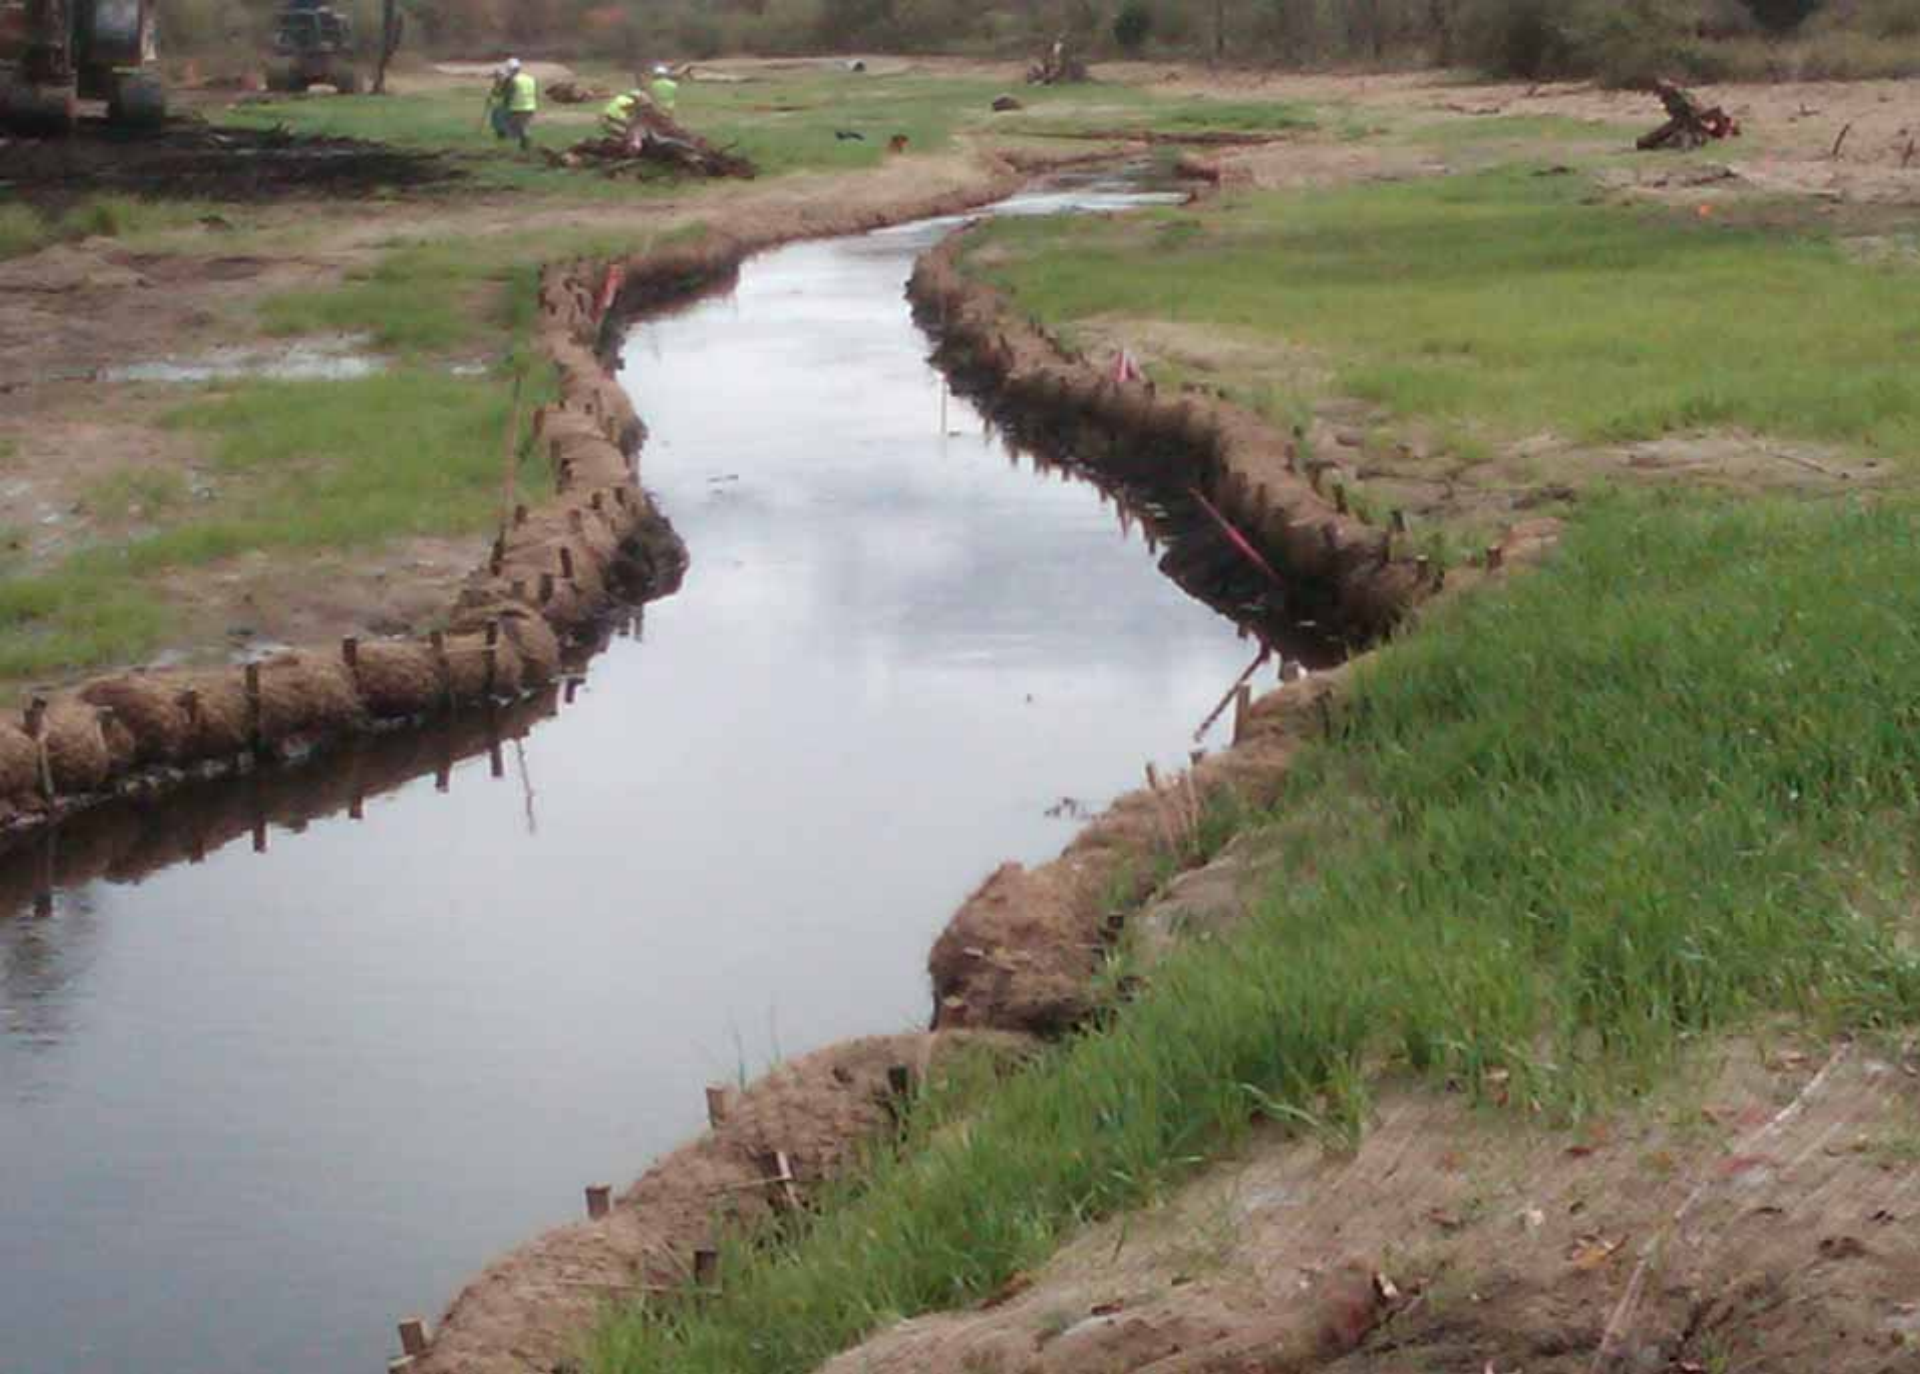
Talmadge Creek following restoration, which included soil backfilling, coconut matting, vegetation seeding, and silt fencing.

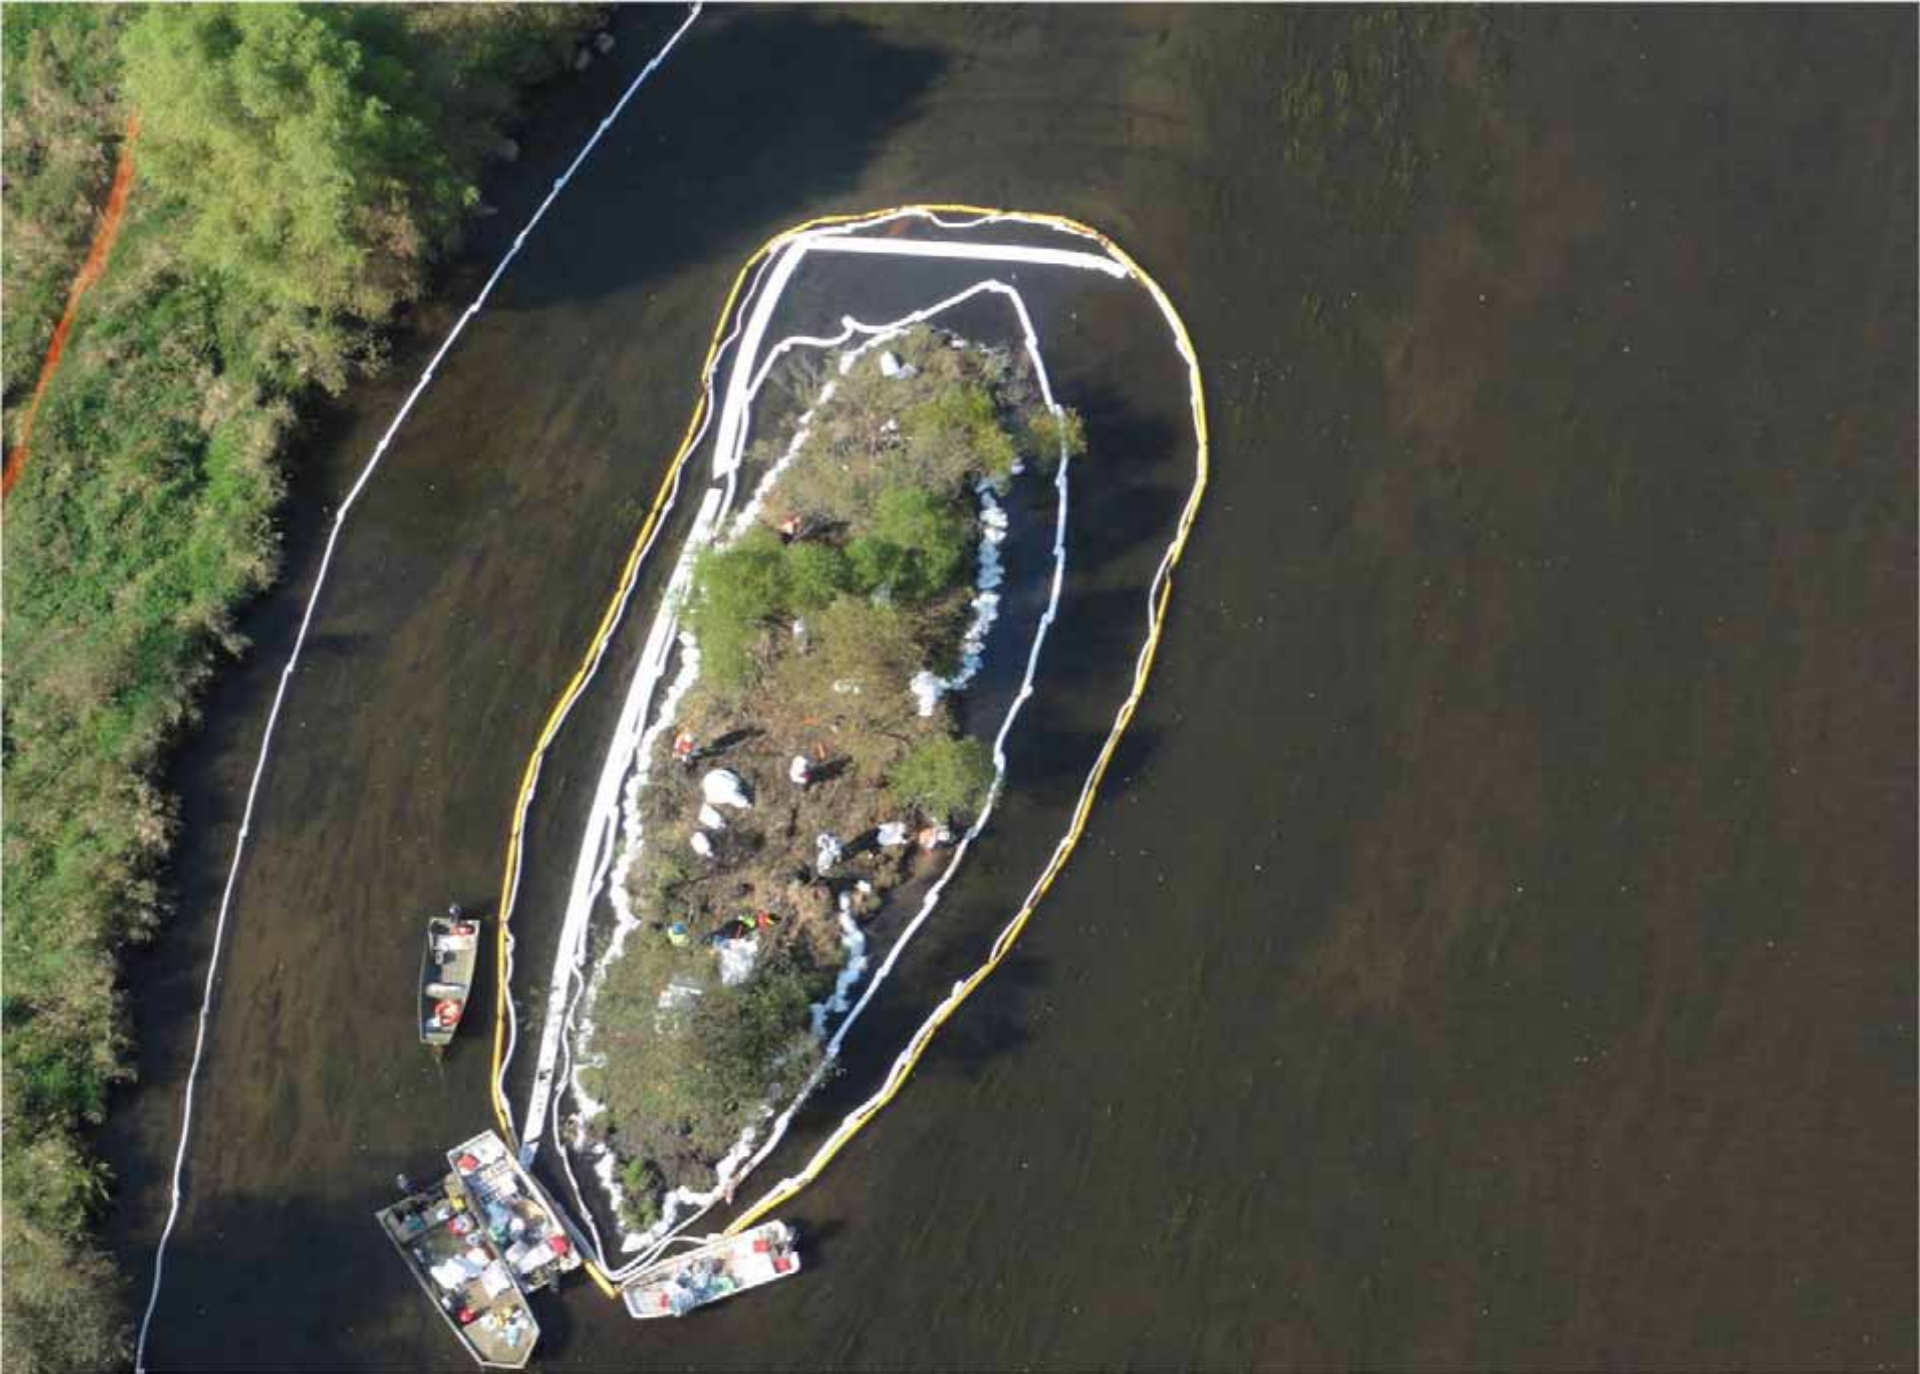
Example of sheening during week two and three of the response.

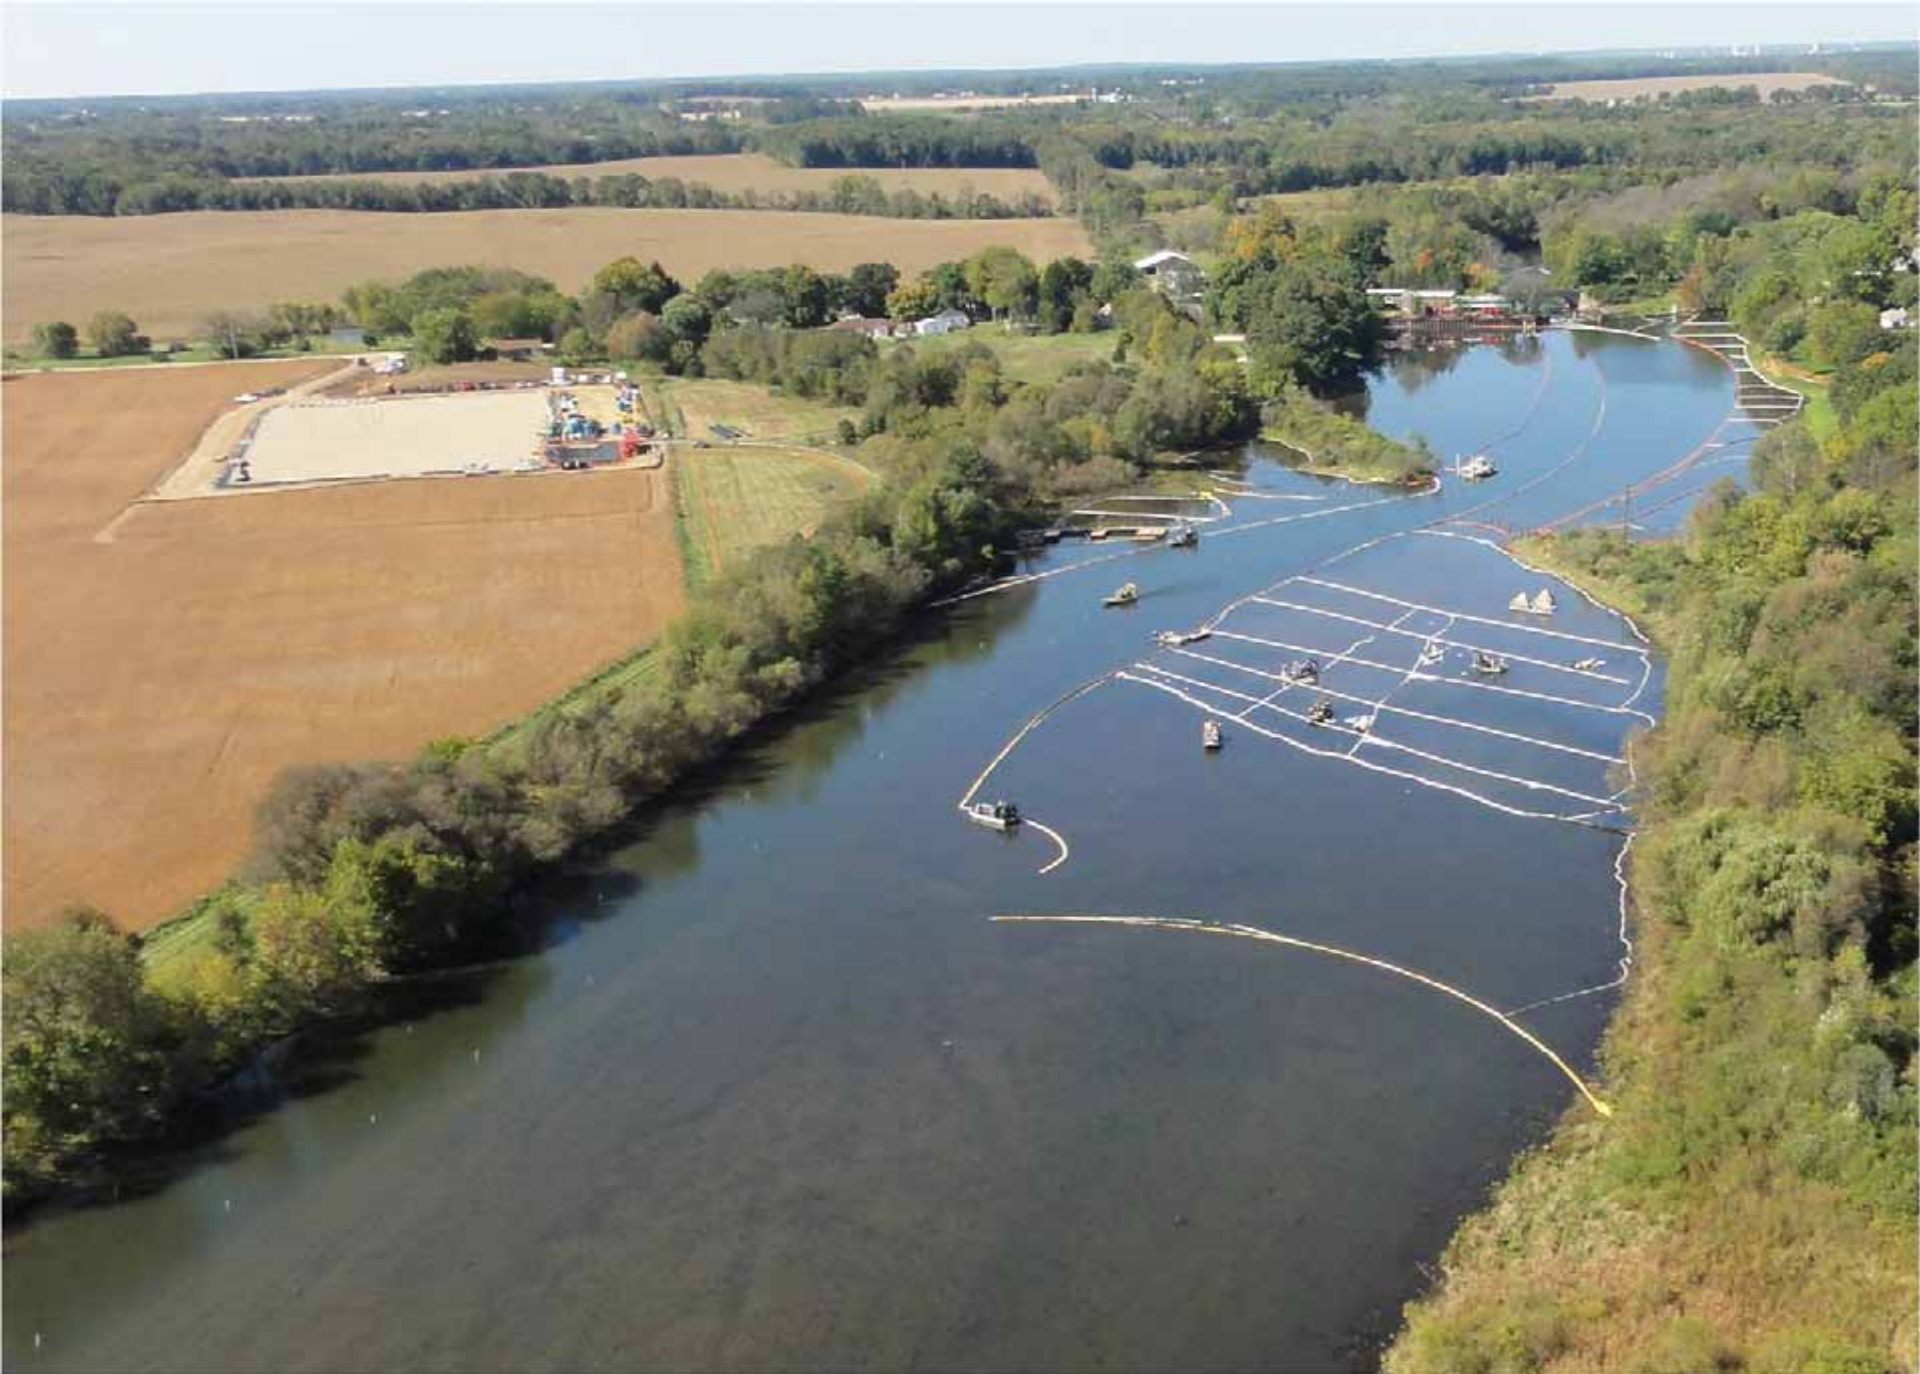
Containment booming established to control vegetation sheening upstream of Ceresco Dam.

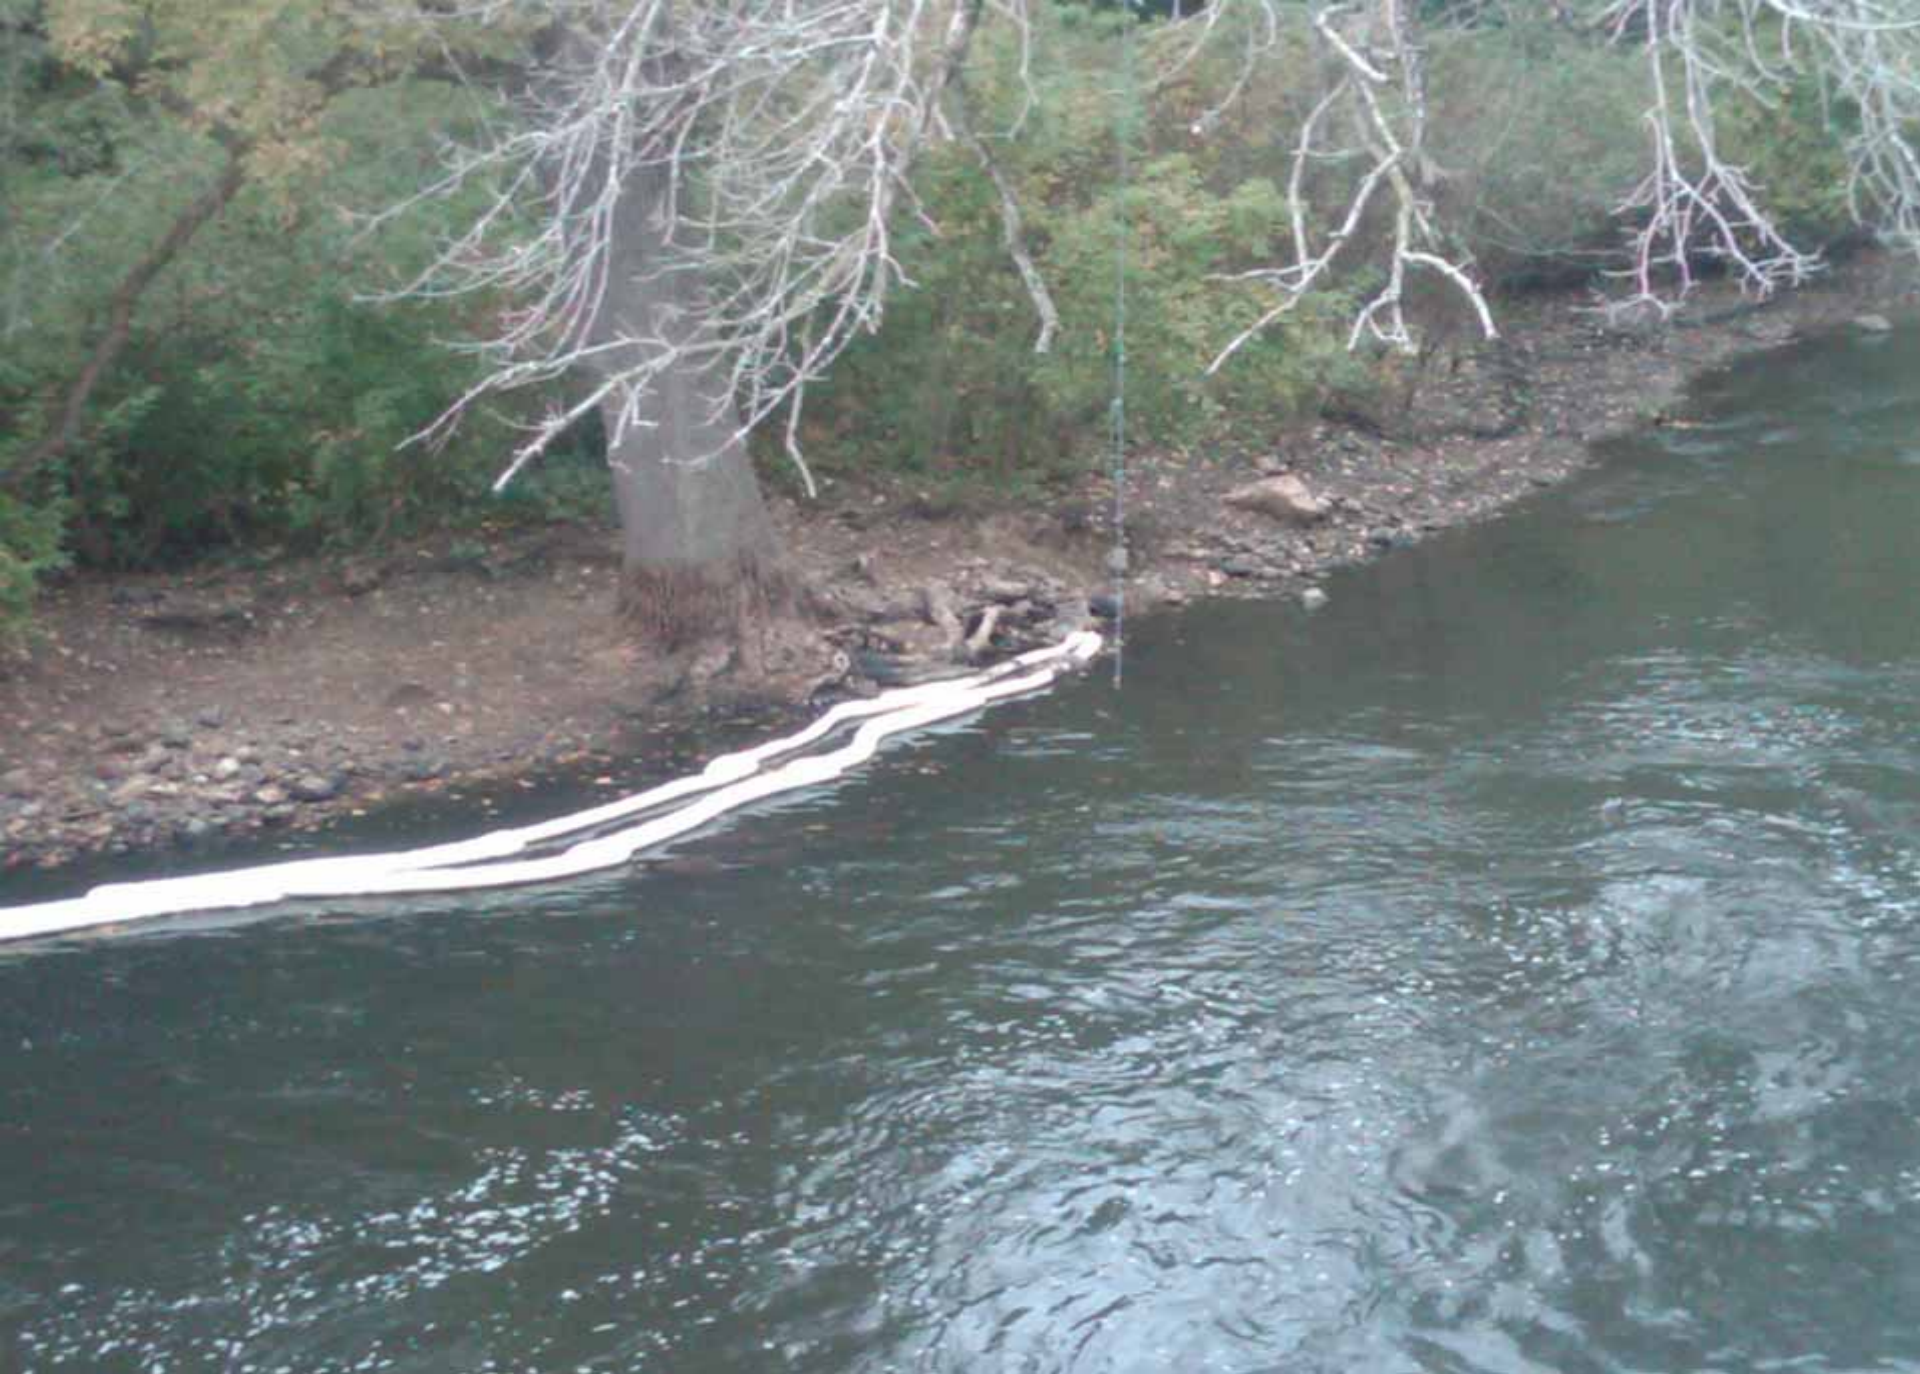
Condition of stream bank just downstream of Ceresco Dam in late July 2010.

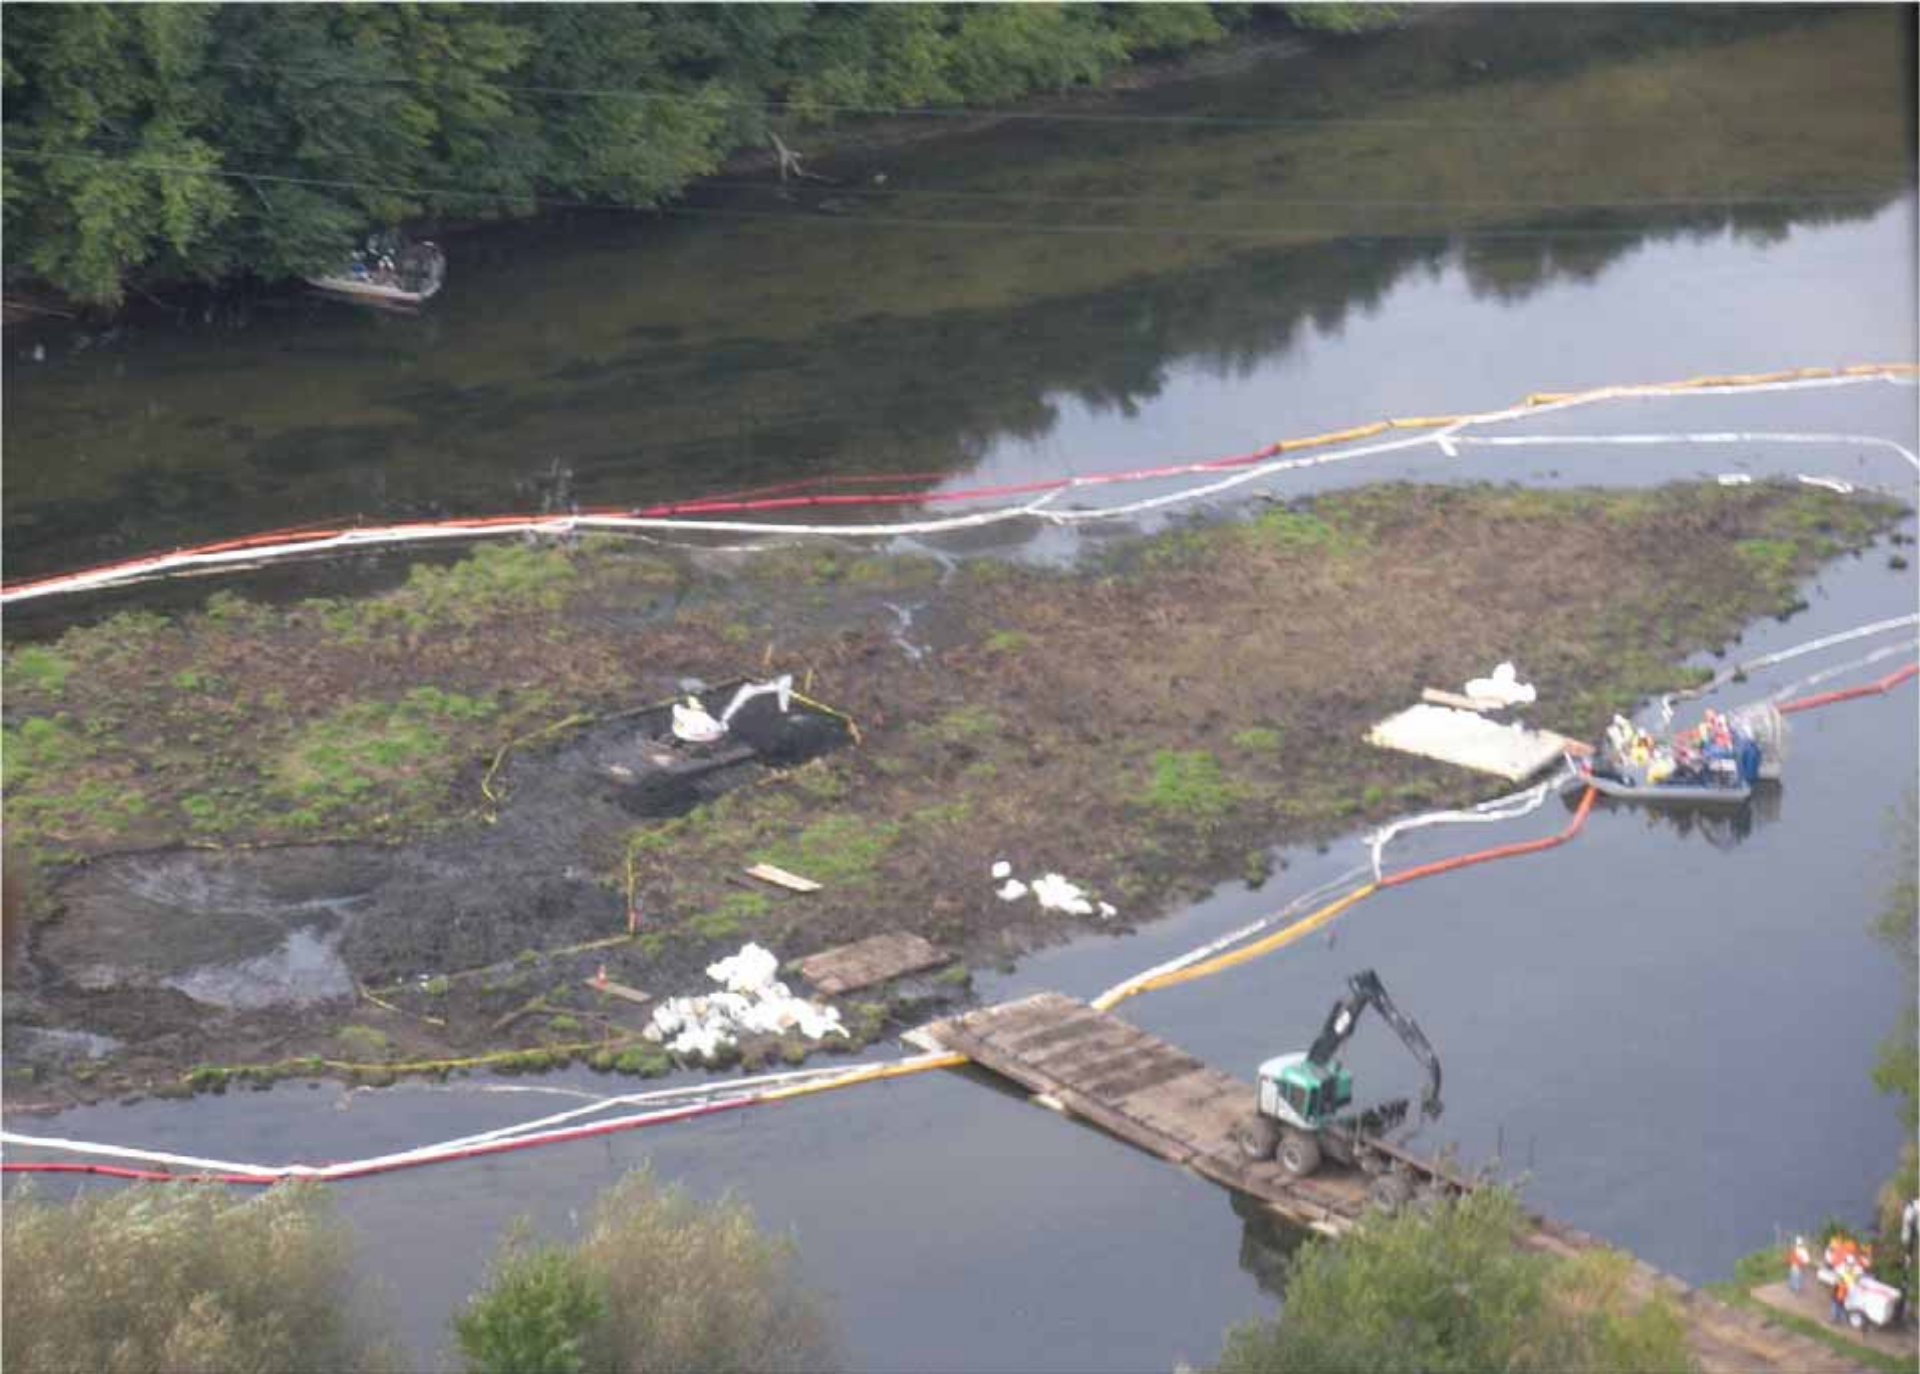
Riverbank restoration and long-term containment . Some areas on river will be monitored over time for potential contamination.

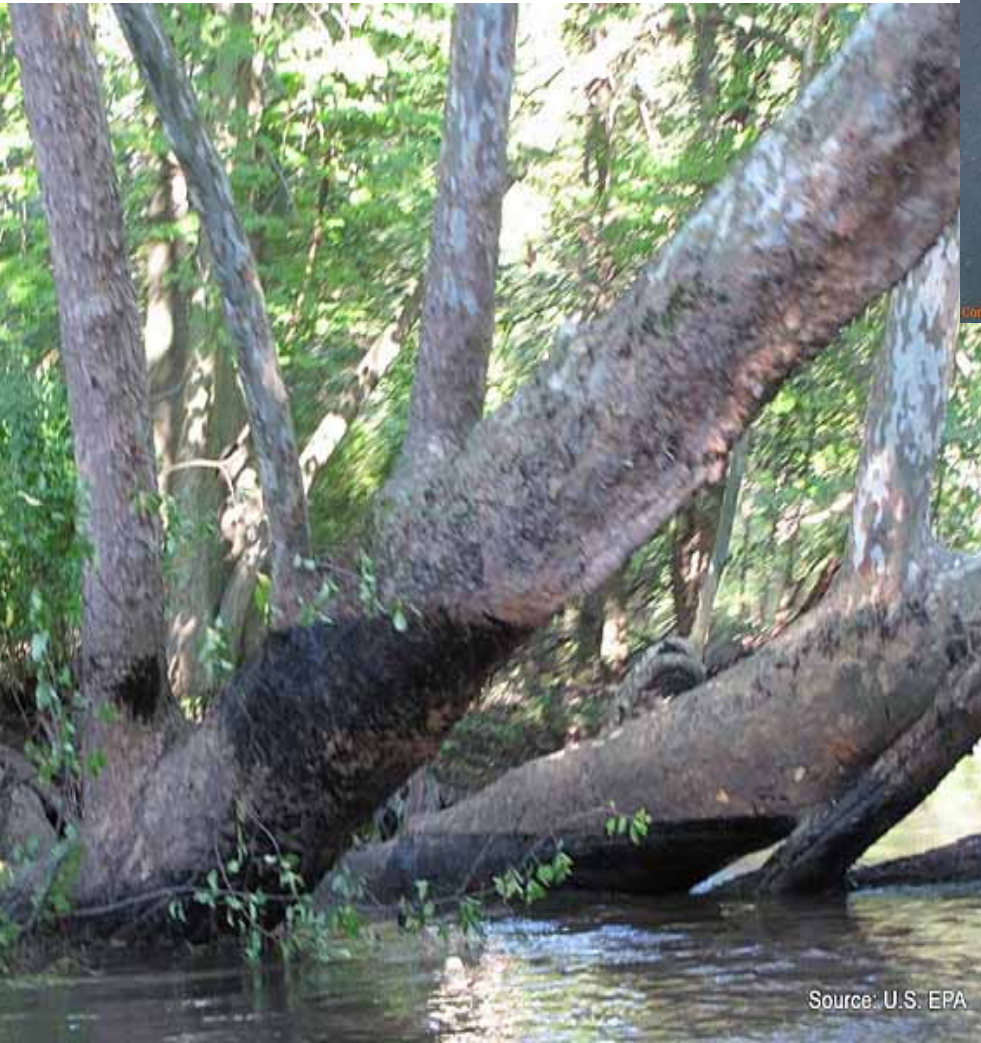
Residual contamination on islands will be monitored over time.

Stains on trees and rocks will fade over time and do not present health or environmental risks.

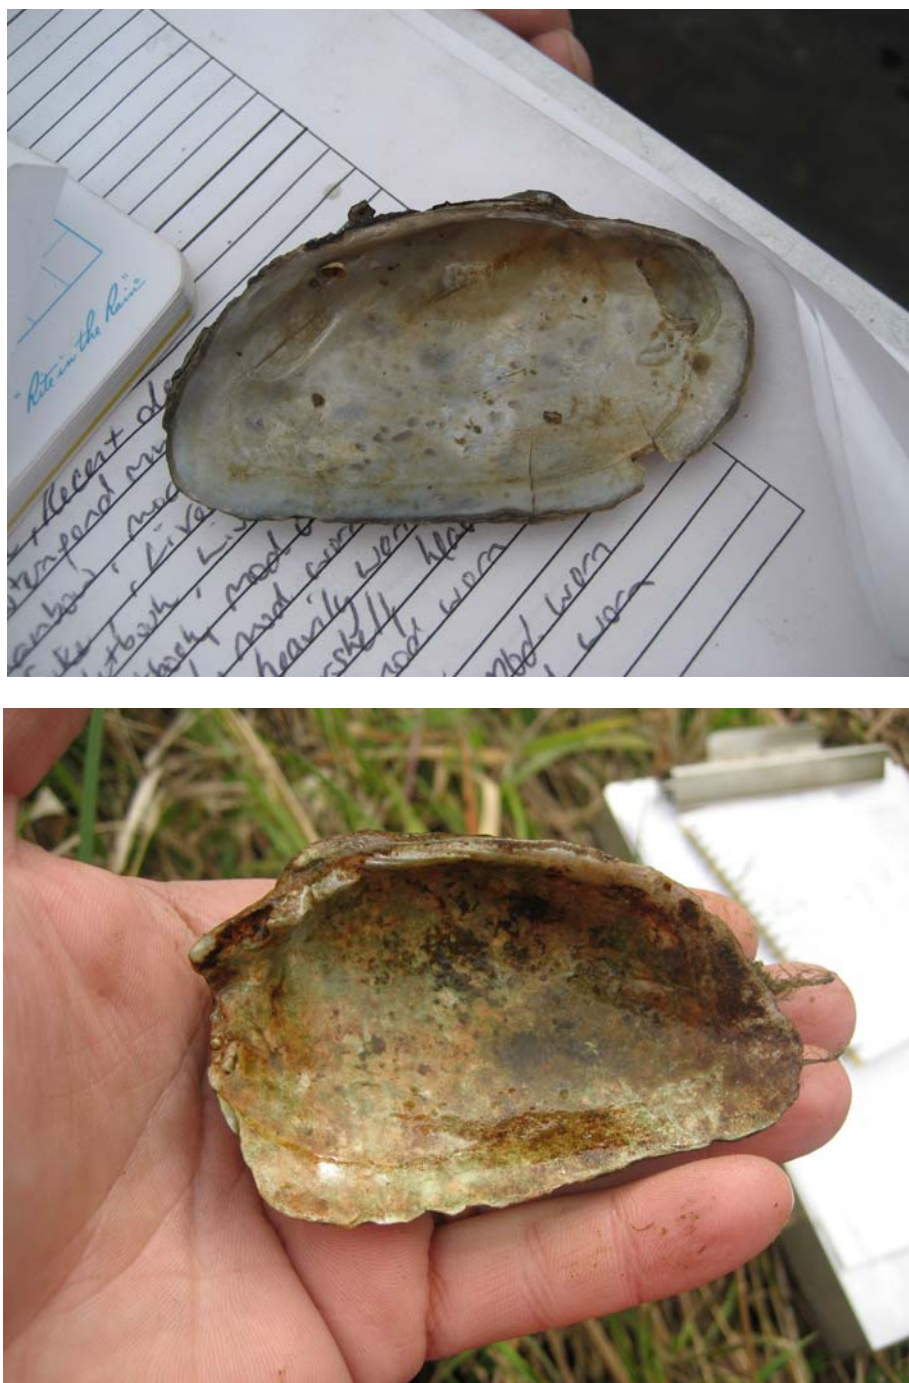
Figures 1 and 2 illustrate the difference between the two types of damage most relevant to this study: broken shells and crushed shells.

Figure 1. Photographs of shells that have been gradually worn to a fragile state over time to a point where they are easily broken, where broken is defined as damage caused by normal in-stream processes. Top: moderately worn 2 strange floater; bottom: heavily worn elktoe.

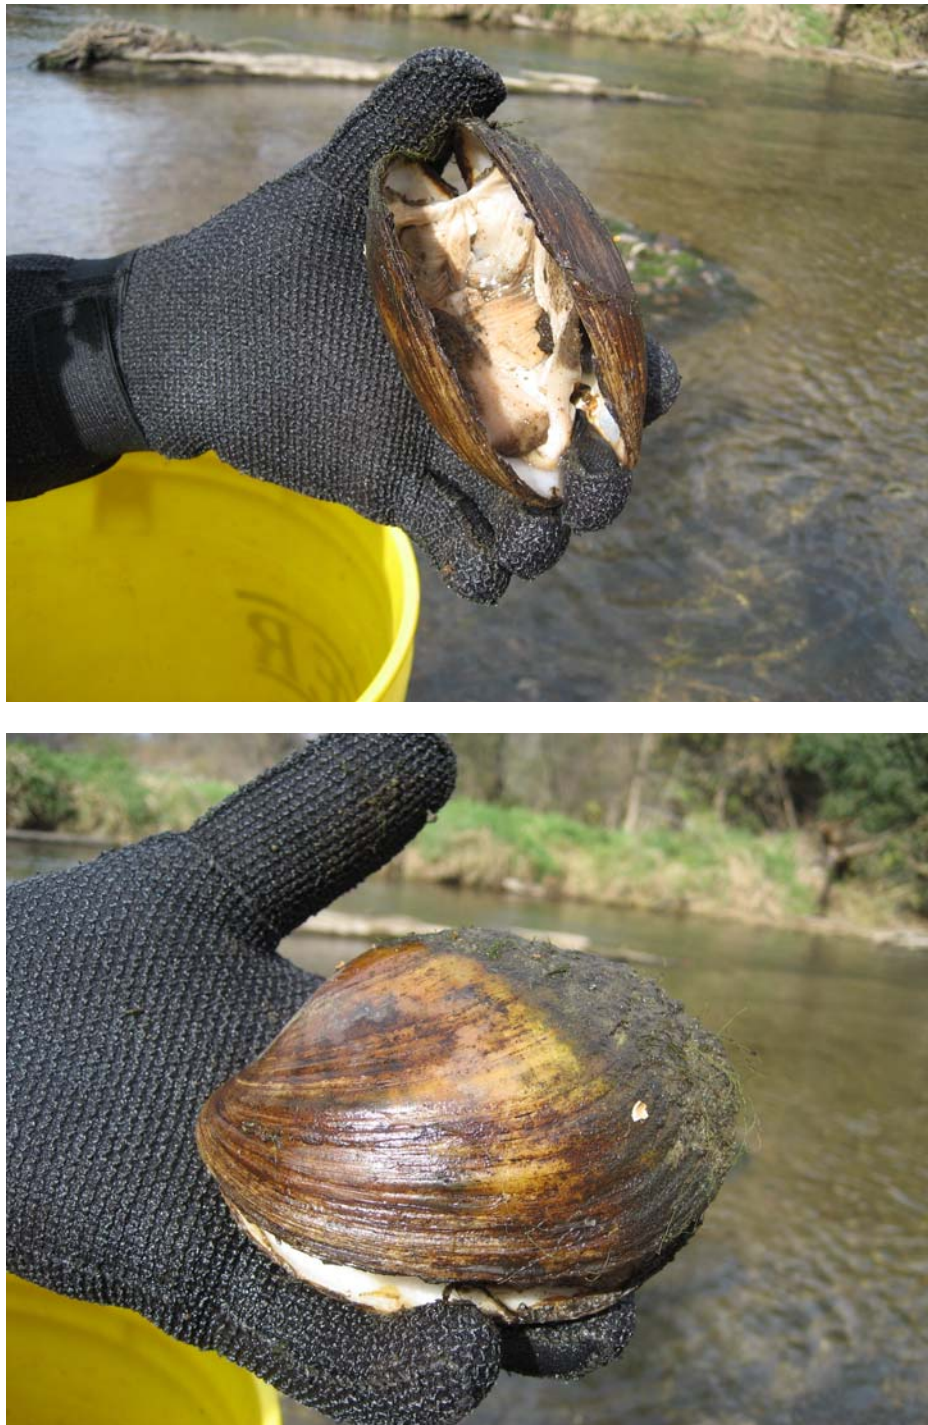
Figure 7. Photographs of a fresh dead pocketbook with soft tissue intact found in segment MS-2 just upriver from Squaw Creek confluence.

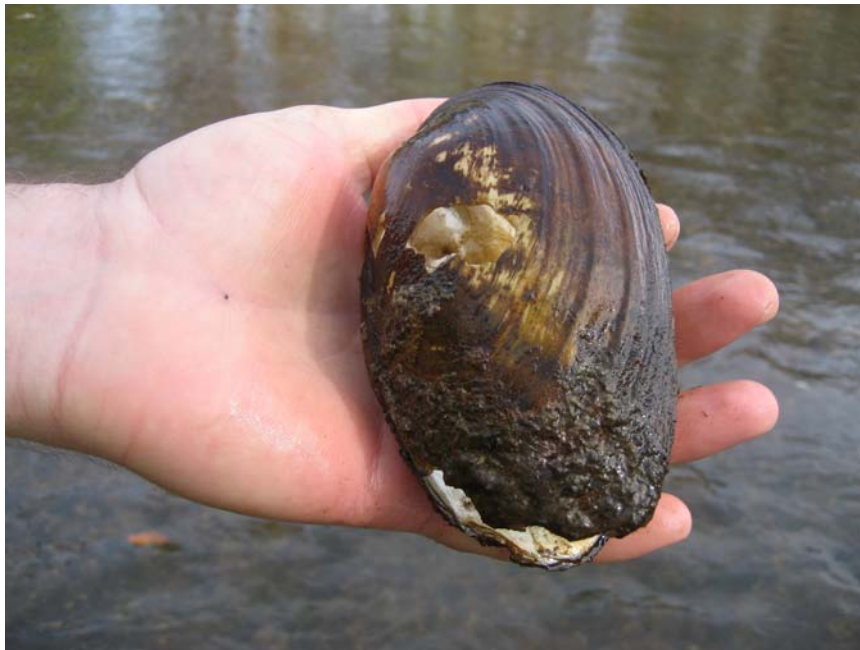
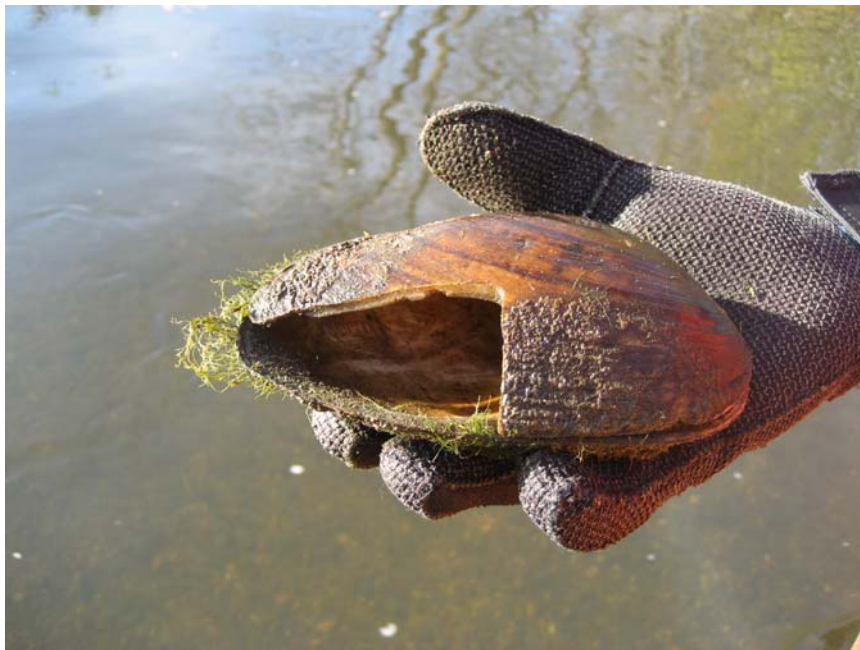
Figure 9. Photographs of crushed shells found downriver of boat ramp C1.5.
Photograph taken by J. Matousek on October 20, 2010.

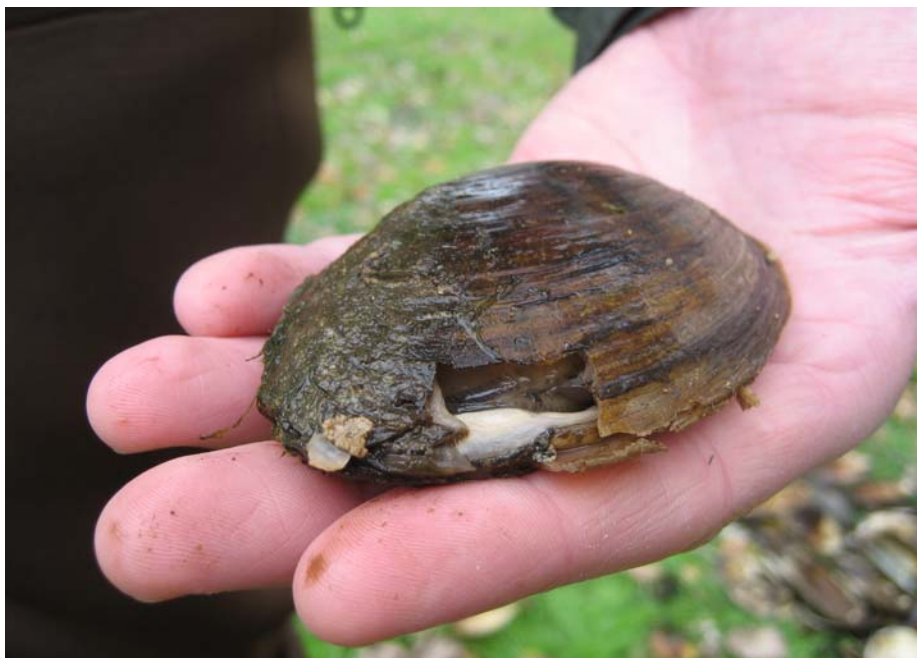
Figure 11. Photograph of a crushed live mucket. This mussel was found approximately 10 m downriver from boat ramp C3.2.
