## Preassessment Screen: U.S. Steel Site

### **Prepared by:**

1854 Treaty Authority (governed by the Bois Forte and Grand Portage Bands of Lake Superior Chippewa)  
Fond du Lac Band of Lake Superior Chippewa  
Minnesota Department of Natural Resources  
Minnesota Pollution Control Agency  
United States Department of Commerce (represented by the National Oceanic and Atmospheric Administration)  
United States Department of the Interior (represented by the Fish and Wildlife Service and Bureau of Indian Affairs)

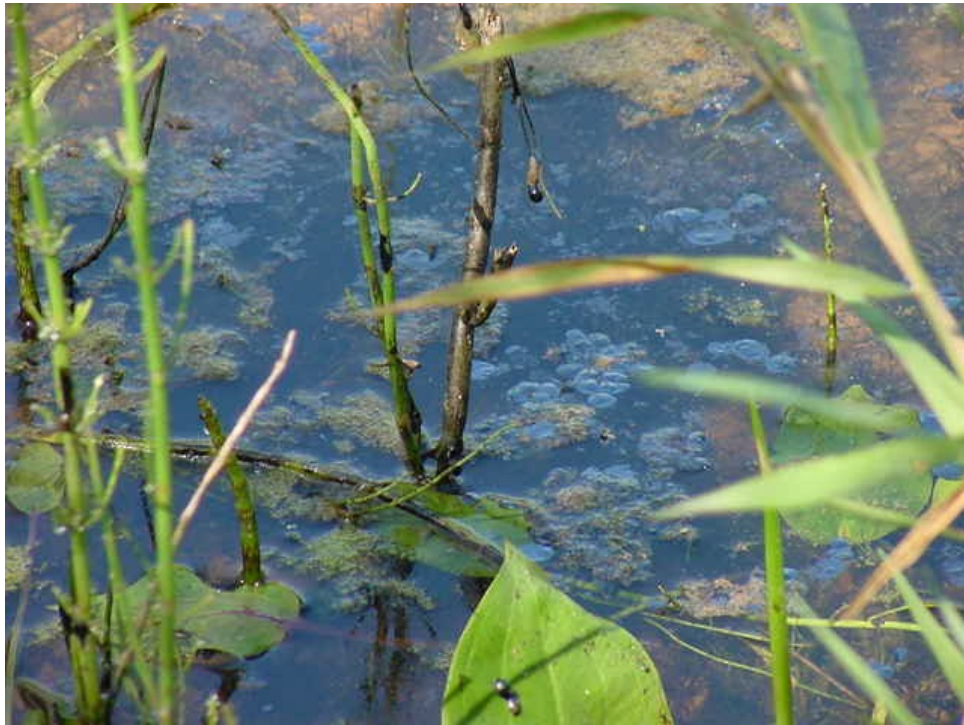
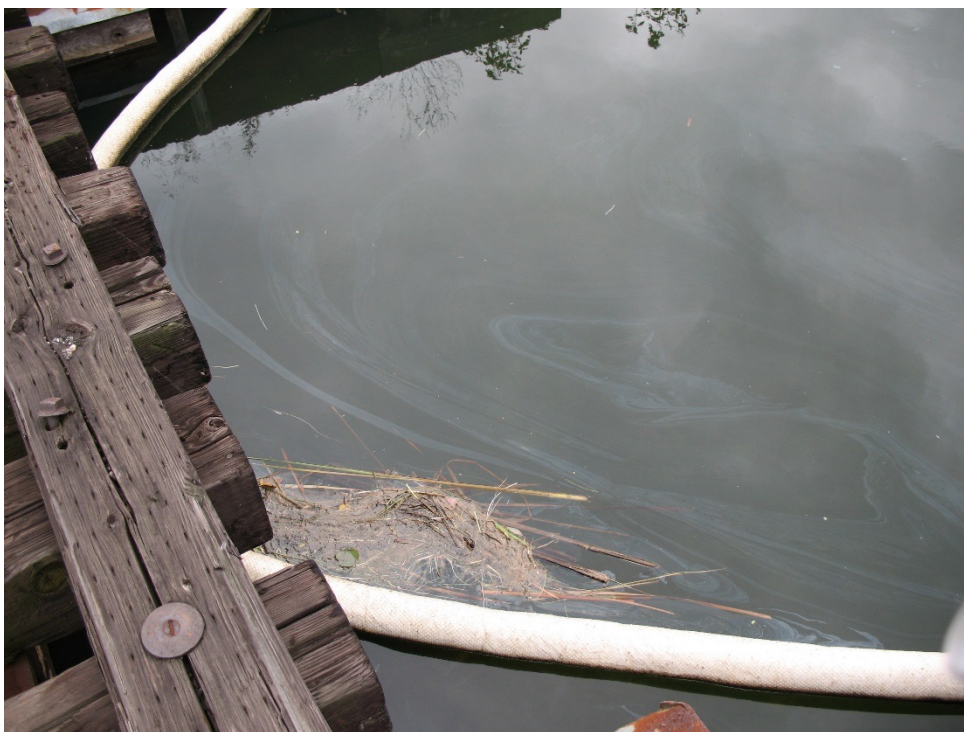
**Figure 5. Waste containment and PAH sheens are visible in surface waters in Unnamed Creek (top photograph) and the Wire Mill Pond (bottom photograph).**

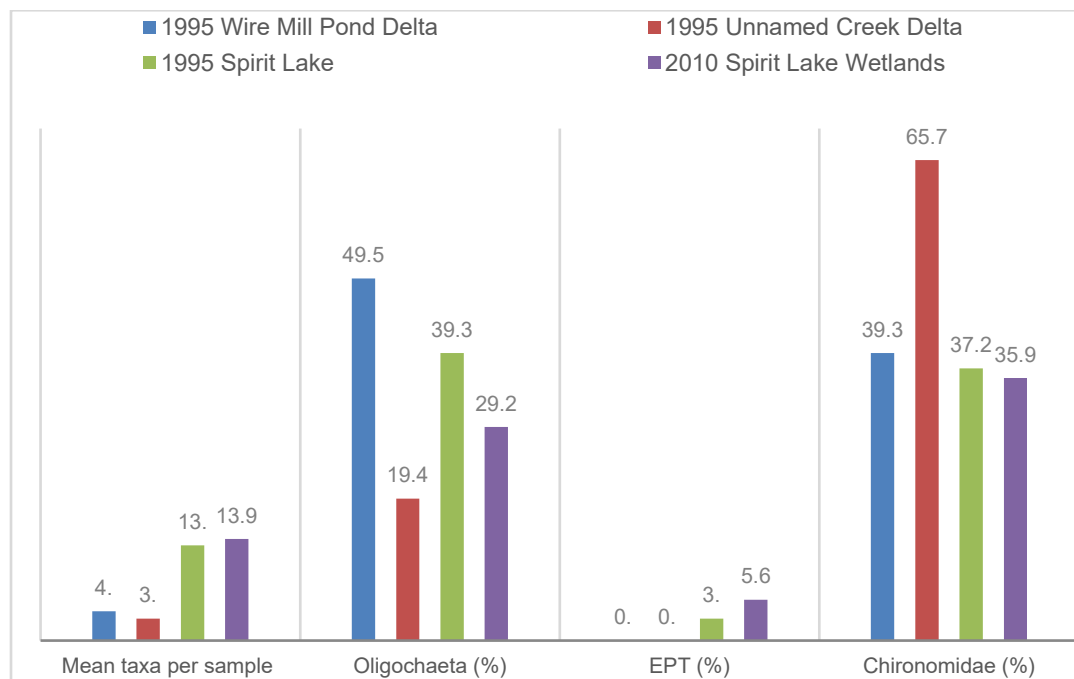
**Figure 11. Number of benthic invertebrates sampled by NRRI in 1995 and 2010.**

The results from the 2005 and 2010 surveys indicate that contamination from the U.S. Steel Site may have negative impacts on BI communities (Figure 10). There were fewer taxa at the sampling locations in the Unnamed Creek Delta and in the Wire Mill Pond Delta compared to samples collected farther out in Spirit Lake, at the reference location adjacent to Spirit Island, and in the Spirit Lake wetlands (blue dots downstream of Spirit Lake shown in Figure 10). Taxa that are sensitive to pollution [i.e., *Ephemeroptera*, *Plecoptera*, and *Trichoptera* (EPT)] were absent from the sampling locations in the Unnamed Creek Delta and in the Wire Mill Pond Delta (Figure 11). The sampling location in the Wire Mill Pond Delta had an abundance of *Oligochaeta* and the sampling location in the Unnamed Creek Delta had an abundance of *Chironomidae*, taxa that are highly tolerant to pollutants (Figure 11). The results of the community data surveys suggest that BIs may have been harmed as a result of exposure to hazardous substances in Spirit Lake.

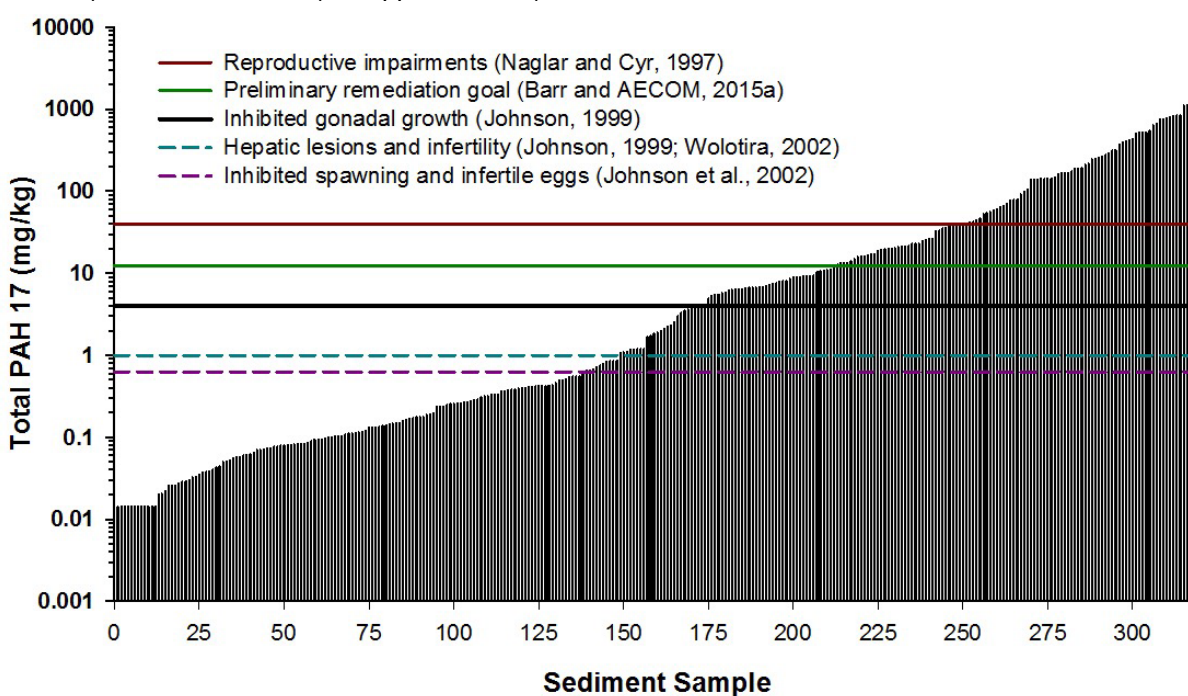
**Figure 12. A comparison of PAHs in sediment samples from the U.S. Steel Site to adverse effect levels.** In addition to the effect levels listed in this figure, samples also exceeded Level I SQT (1.61 ppm PAH 13) and Level II SQT (22.8 ppm PAH 13) values.

The Trustees compared concentrations of PAHs in the Site sediment, reported in the DIVER database, to literature-based values that were shown to cause adverse effects to fish. The Trustees also compared the sediment concentrations to the PRG (12.3 mg/kg) developed for U.S. Steel Site cleanup (Barr Engineering and AECOM, 2015a). As reported in the literature, TPAH concentrations ranging from 0.28 to 39.8 mg/kg can cause adverse effects to fish (Table 7; Figure 12). These effects levels are based on the sum of 15 to 18 PAHs, depending on the study (Table 7). For the PAS, the Trustees focused on comparing the sum of 17 PAHs (TPAH17) measured in Site sediment samples to the adverse effects levels reported in the literature. There was a high level of overlap between the congeners included in the sum of 17 PAHs from the U.S. Steel Site and the congeners contributing to the literature-derived adverse effects levels (Table 7). For the 318 samples analyzed for TPAH17 in the DIVER dataset, the average concentration was 78 mg/kg TPAH17, and the values ranged from 0.01 to 1,894 mg/kg. More than half the samples exceeded effects levels known to cause adverse effects to fish, confirming that fish have likely been exposed to PAHs in sediment above levels expected to cause adverse effects.

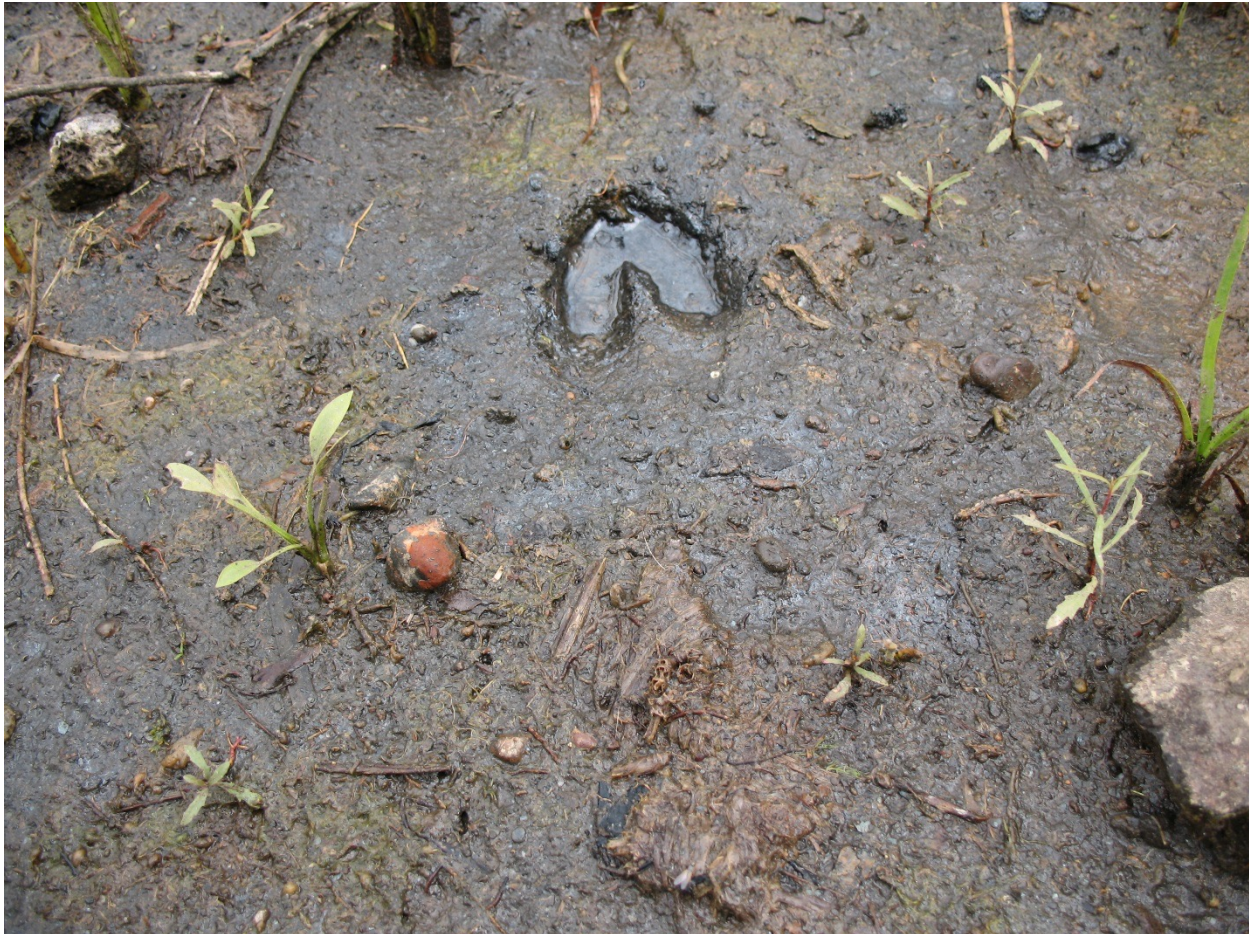
**Figure 15. Wildlife footprints visible in tar-contaminated sediment in the Site.** Photograph taken in 2007.

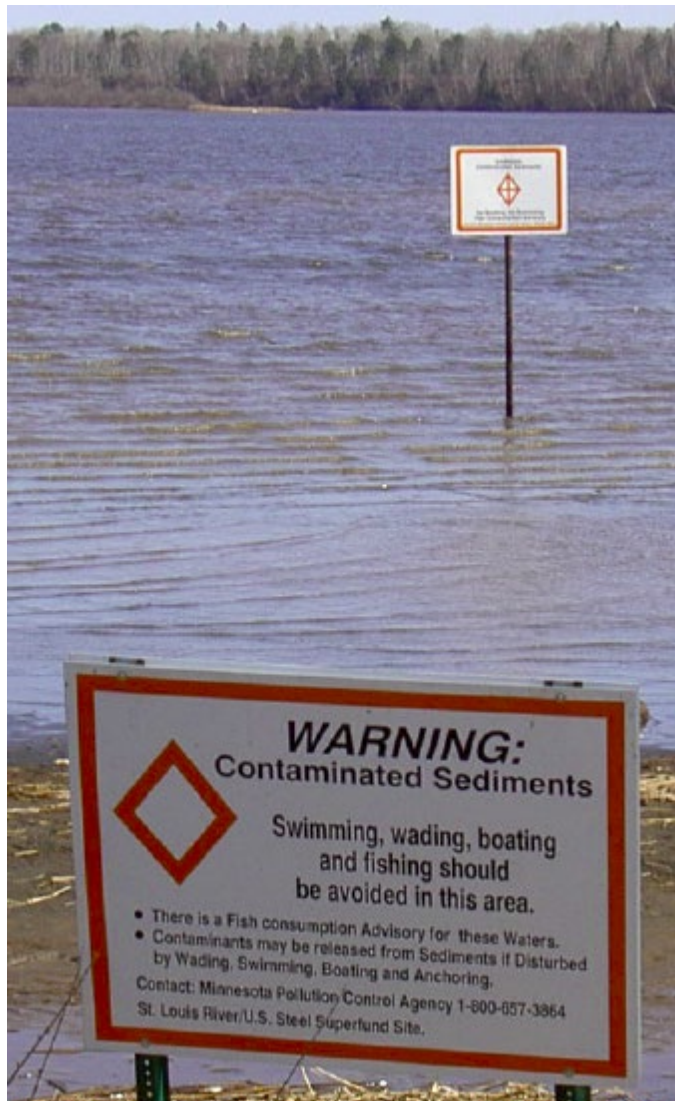
**Figure 16. Sign at the U.S. Steel Site warning the public that sediment is contaminated.**
