Alder Creek Restoration Project

2016 Monitoring Report Year 1

Wildlands PNW
Portland Harbor Holdings II, LLC
520 SW 6th Avenue, Suite 1210
Portland, OR 97204
503-241-4895
Contact: Julie Mentzer

December 2016
Revised March 2, 2017

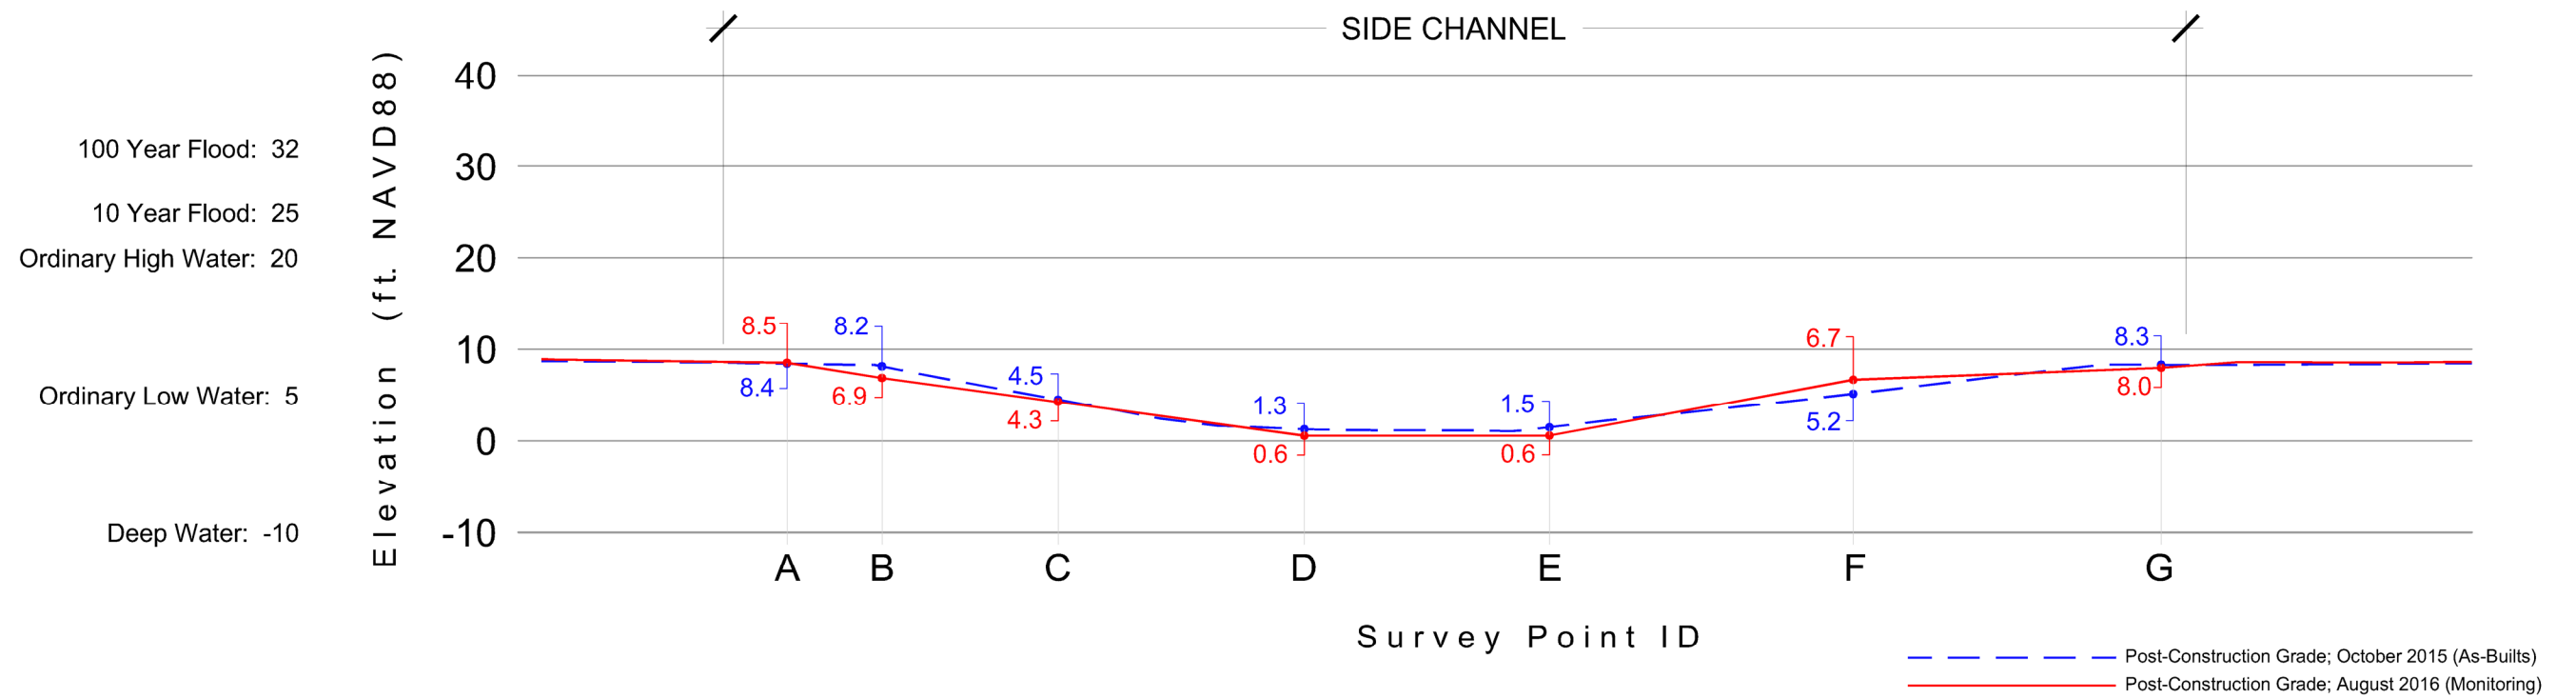
A Cross Section Enlargement A

Cross Section Enlargement A										
Survey Point ID	Elevation: October 2015	Elevation: August 2016	Elevation Change	Depth October 2015 relative to OHW (elevation 20.0)	Depth August 2016 relative to OHW (elevation 20.0)	Percent Change Relative to OHW 2015 to 2016		Absolute Percent Change Relative to OHW 2015 to 2016		
A	8.4	8.5	0.1	11.6	11.5	(11.5/11.6) =	99%	99 - 100 =	1%	
B	8.2	6.9	-1.3	11.9	13.1	(13.1/11.9) =	111%	111 - 100 =	11%	
C	4.5	4.3	-0.3	15.5	15.7	(15.7/15.5) =	102%	102 - 100 =	2%	
D	1.3	0.6	-0.7	18.7	19.4	(19.4/18.7) =	104%	104 - 100 =	4%	
E	1.5	0.6	-0.9	18.5	19.4	(19.4/18.5) =	105%	105 - 100 =	5%	
F	5.2	6.7	1.5	14.8	13.3	(13.3/14.8) =	90%	90 - 100 =	10%	
G	8.3	8.0	-0.3	11.7	12.0	(12.0/11.7) =	103%	103 - 100 =	3%	
Average Distance:			-0.3					Average :		5%

Changes of more than 20% in side channel depths from the as-builts were not found. Figures 6d and 6e show a comparison of the as-built channel depths to the Year 1 channel depths. The average percent change in channel depth was 4% on one transect and 5% on the other.

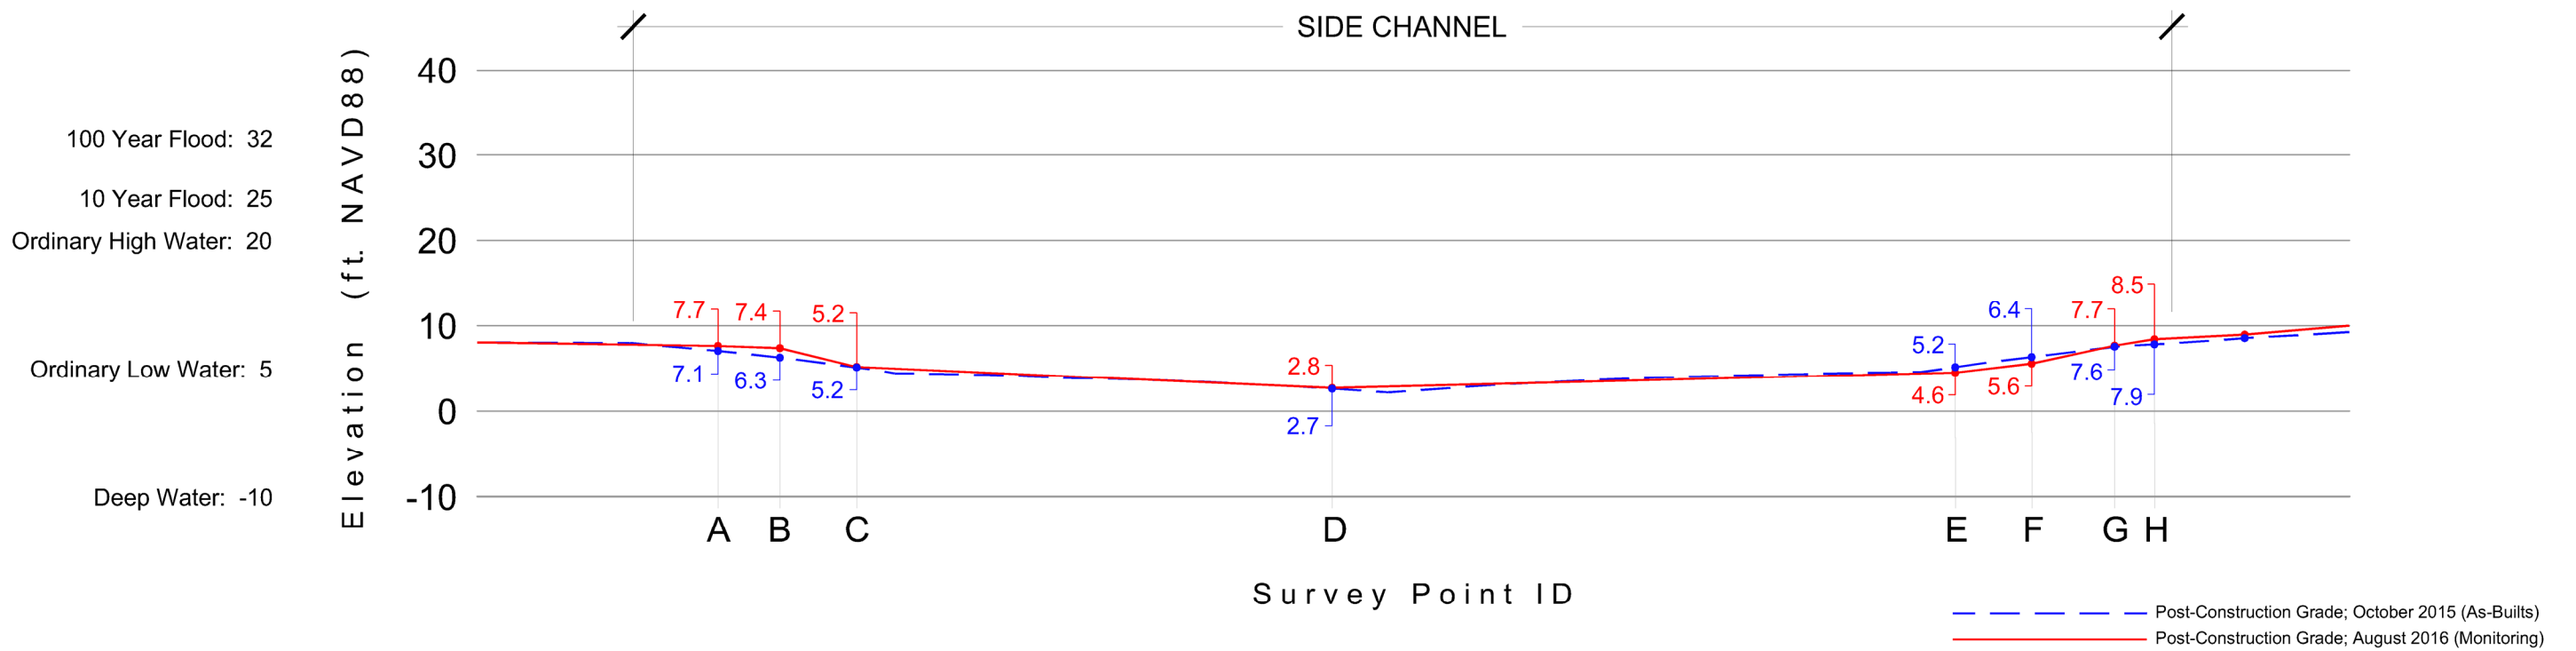
B Cross Section Enlargement B

Cross Section Enlargement B										
Survey Point ID	Elevation: October 2015	Elevation: August 2016	Elevation Change	Elevation: October 2015 distance from OHW (20.0)	Elevation: August 2016 distance from OHW (20.0)	Percent Change Relative to OHW 2015 to 2016		Absolute Percent Change Relative to OHW 2015 to 2016		
A	7.1	7.7	0.6	12.9	12.3	(12.3/12.9) =	95%	95 - 100 =	5%	
B	6.3	7.4	1.1	13.7	12.6	(12.6/13.7) =	92%	92 - 100 =	8%	
C	5.2	5.2	0.1	14.8	14.8	(14.8/14.8) =	100%	100 - 100 =	1%	
D	2.7	2.8	0.1	17.3	17.3	(17.3/17.3) =	100%	100 - 100 =	1%	
E	5.2	4.6	-0.6	14.8	15.4	(15.4/14.8) =	104%	104 - 100 =	4%	
F	6.4	5.6	-0.8	13.6	14.4	(14.4/13.6) =	106%	106 - 100 =	6%	
G	7.6	7.7	0.1	12.4	12.3	(12.3/12.4) =	99%	99 - 100 =	1%	
H	7.9	8.5	0.6	12.1	11.6	(11.6/12.1) =	95%	95 - 100 =	5%	
Average Distance:			0.1					Average :		4%
