Alder Creek Restoration Project

2018 Monitoring Report Year 3

Wildlands PNW
Portland Harbor Holdings II, LLC
520 SW 6th Avenue, Suite 1210
Portland, OR 97204
503-241-4895
Contact: Julie Mentzer

January 2019
Revised February 2020

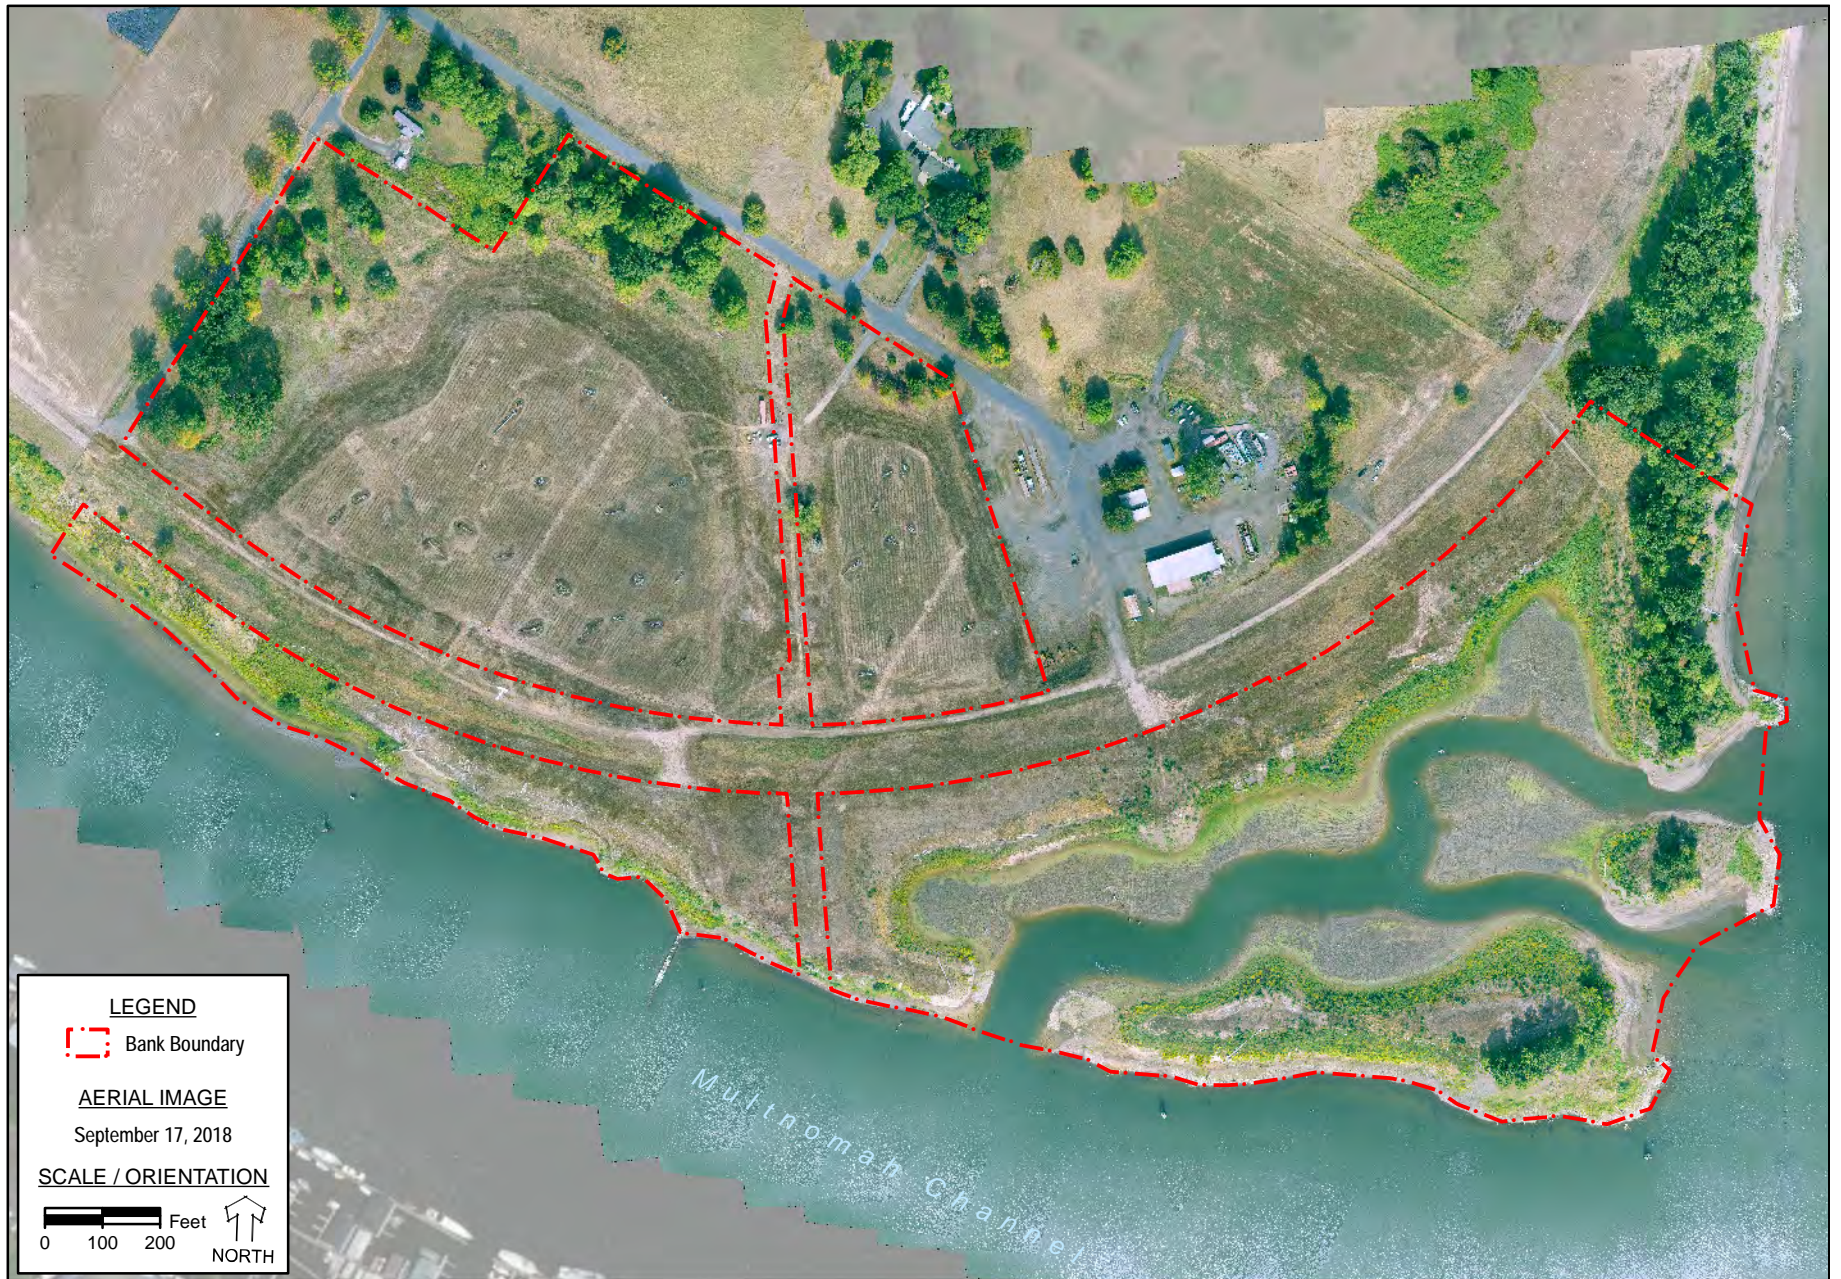
Figure 5a
Photo Location Map

A total of 10 permanent photo points was established for the Project to document overall site conditions and provide a basis for year-to-year comparisons. Multiple photos in different directions were taken on September 17, 2018 from each photo point. A map of the photo points and corresponding photos can be found in **Figures 5a-5b**. Photo-documentation will continue during Year 4 (2019).

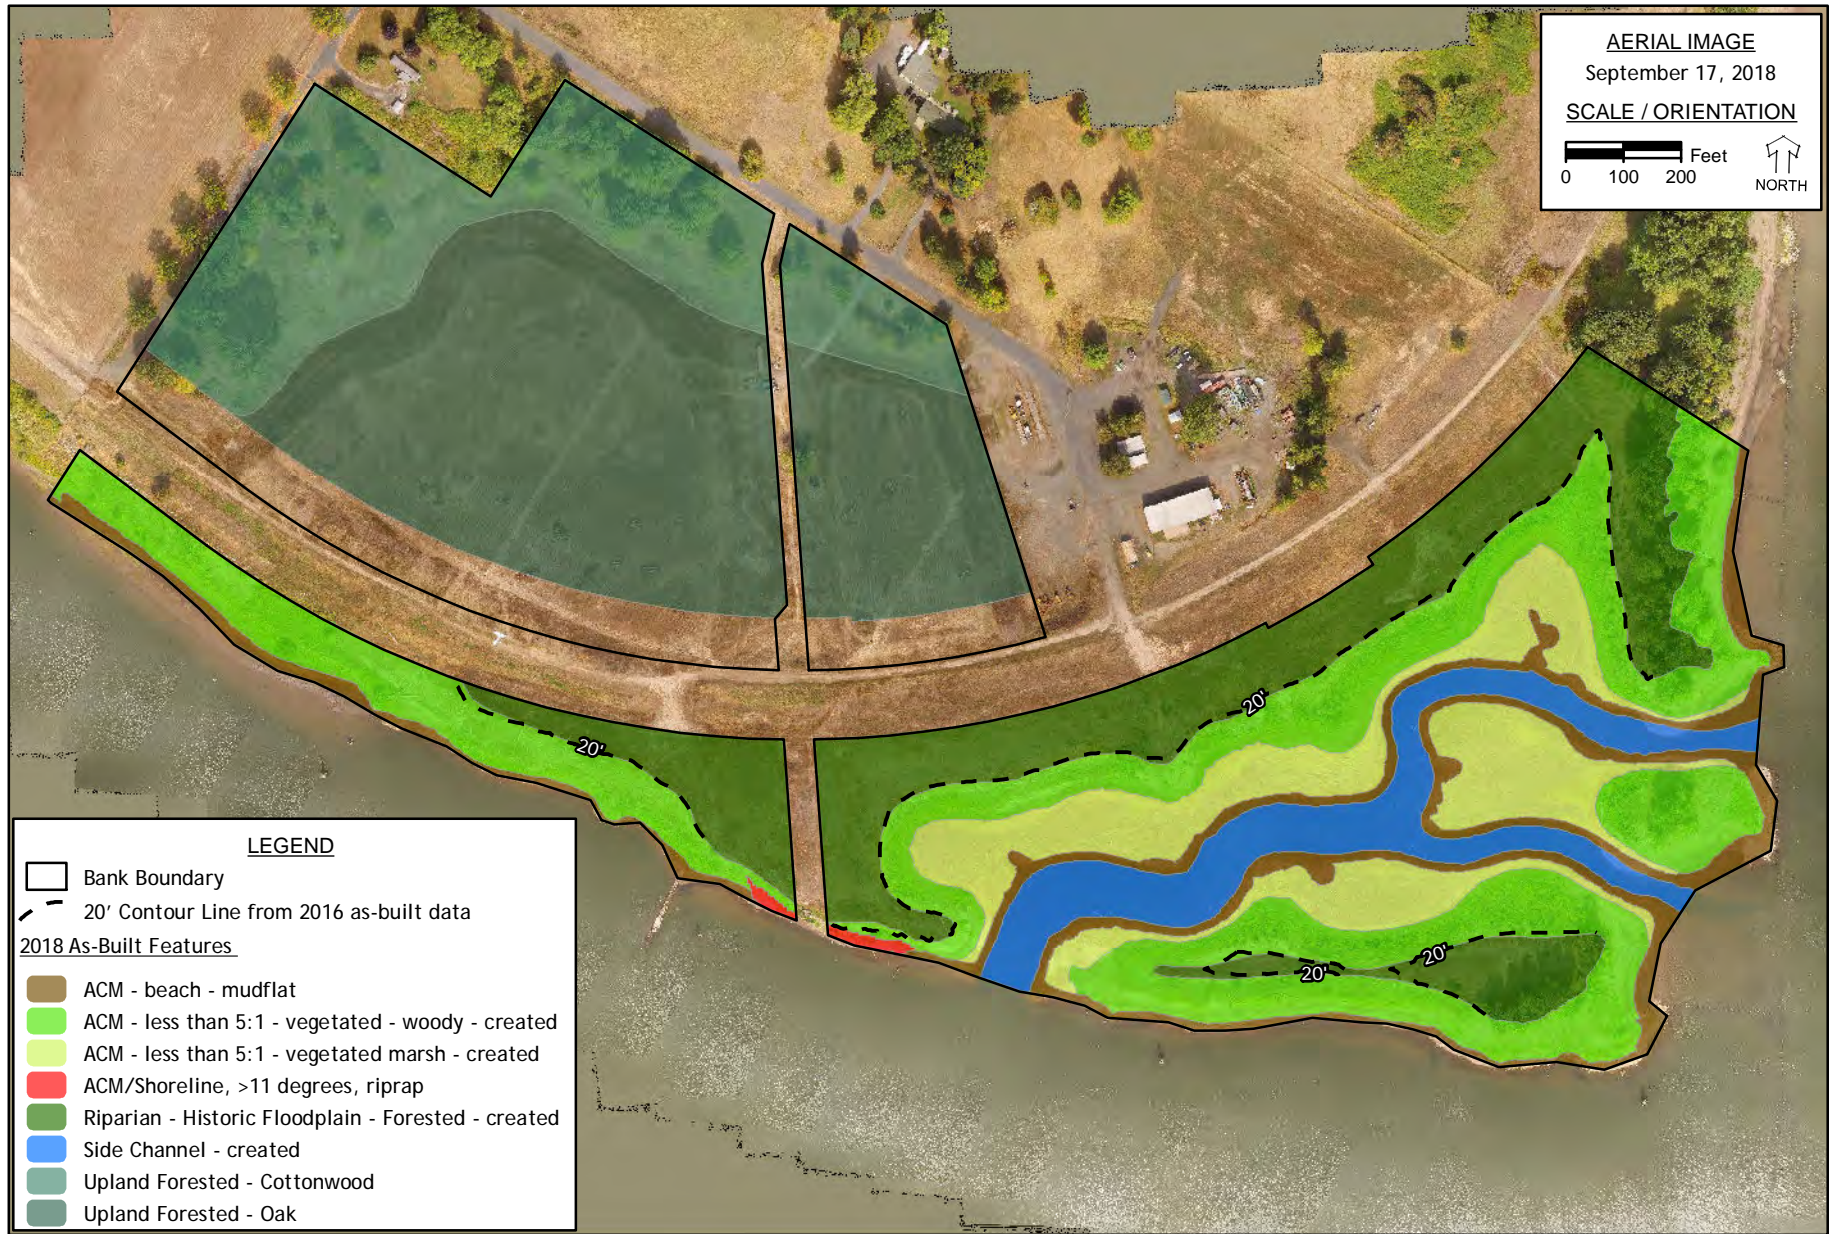
Figure 6c
Geomorphology

In order to determine if changes of more than 10% in active channel margin (ACM) acreage from the as-built surveys have occurred, the following method will be followed: For Years 3 and 5, additional elevation points will be taken along elevation 20 to determine if the acreage of active channel margin (ACM) has changed by 10% or more. However, as tree and shrub cover increases, surveying along elevation 20 may be increasingly difficult. If dense tree and shrub cover prohibits surveying along elevation 20, visual surveys will be conducted in Years 7 and 10 to record any observed changes. In addition, elevations will be recorded along the original transects to determine if the width of the ACM has changed along the transects.

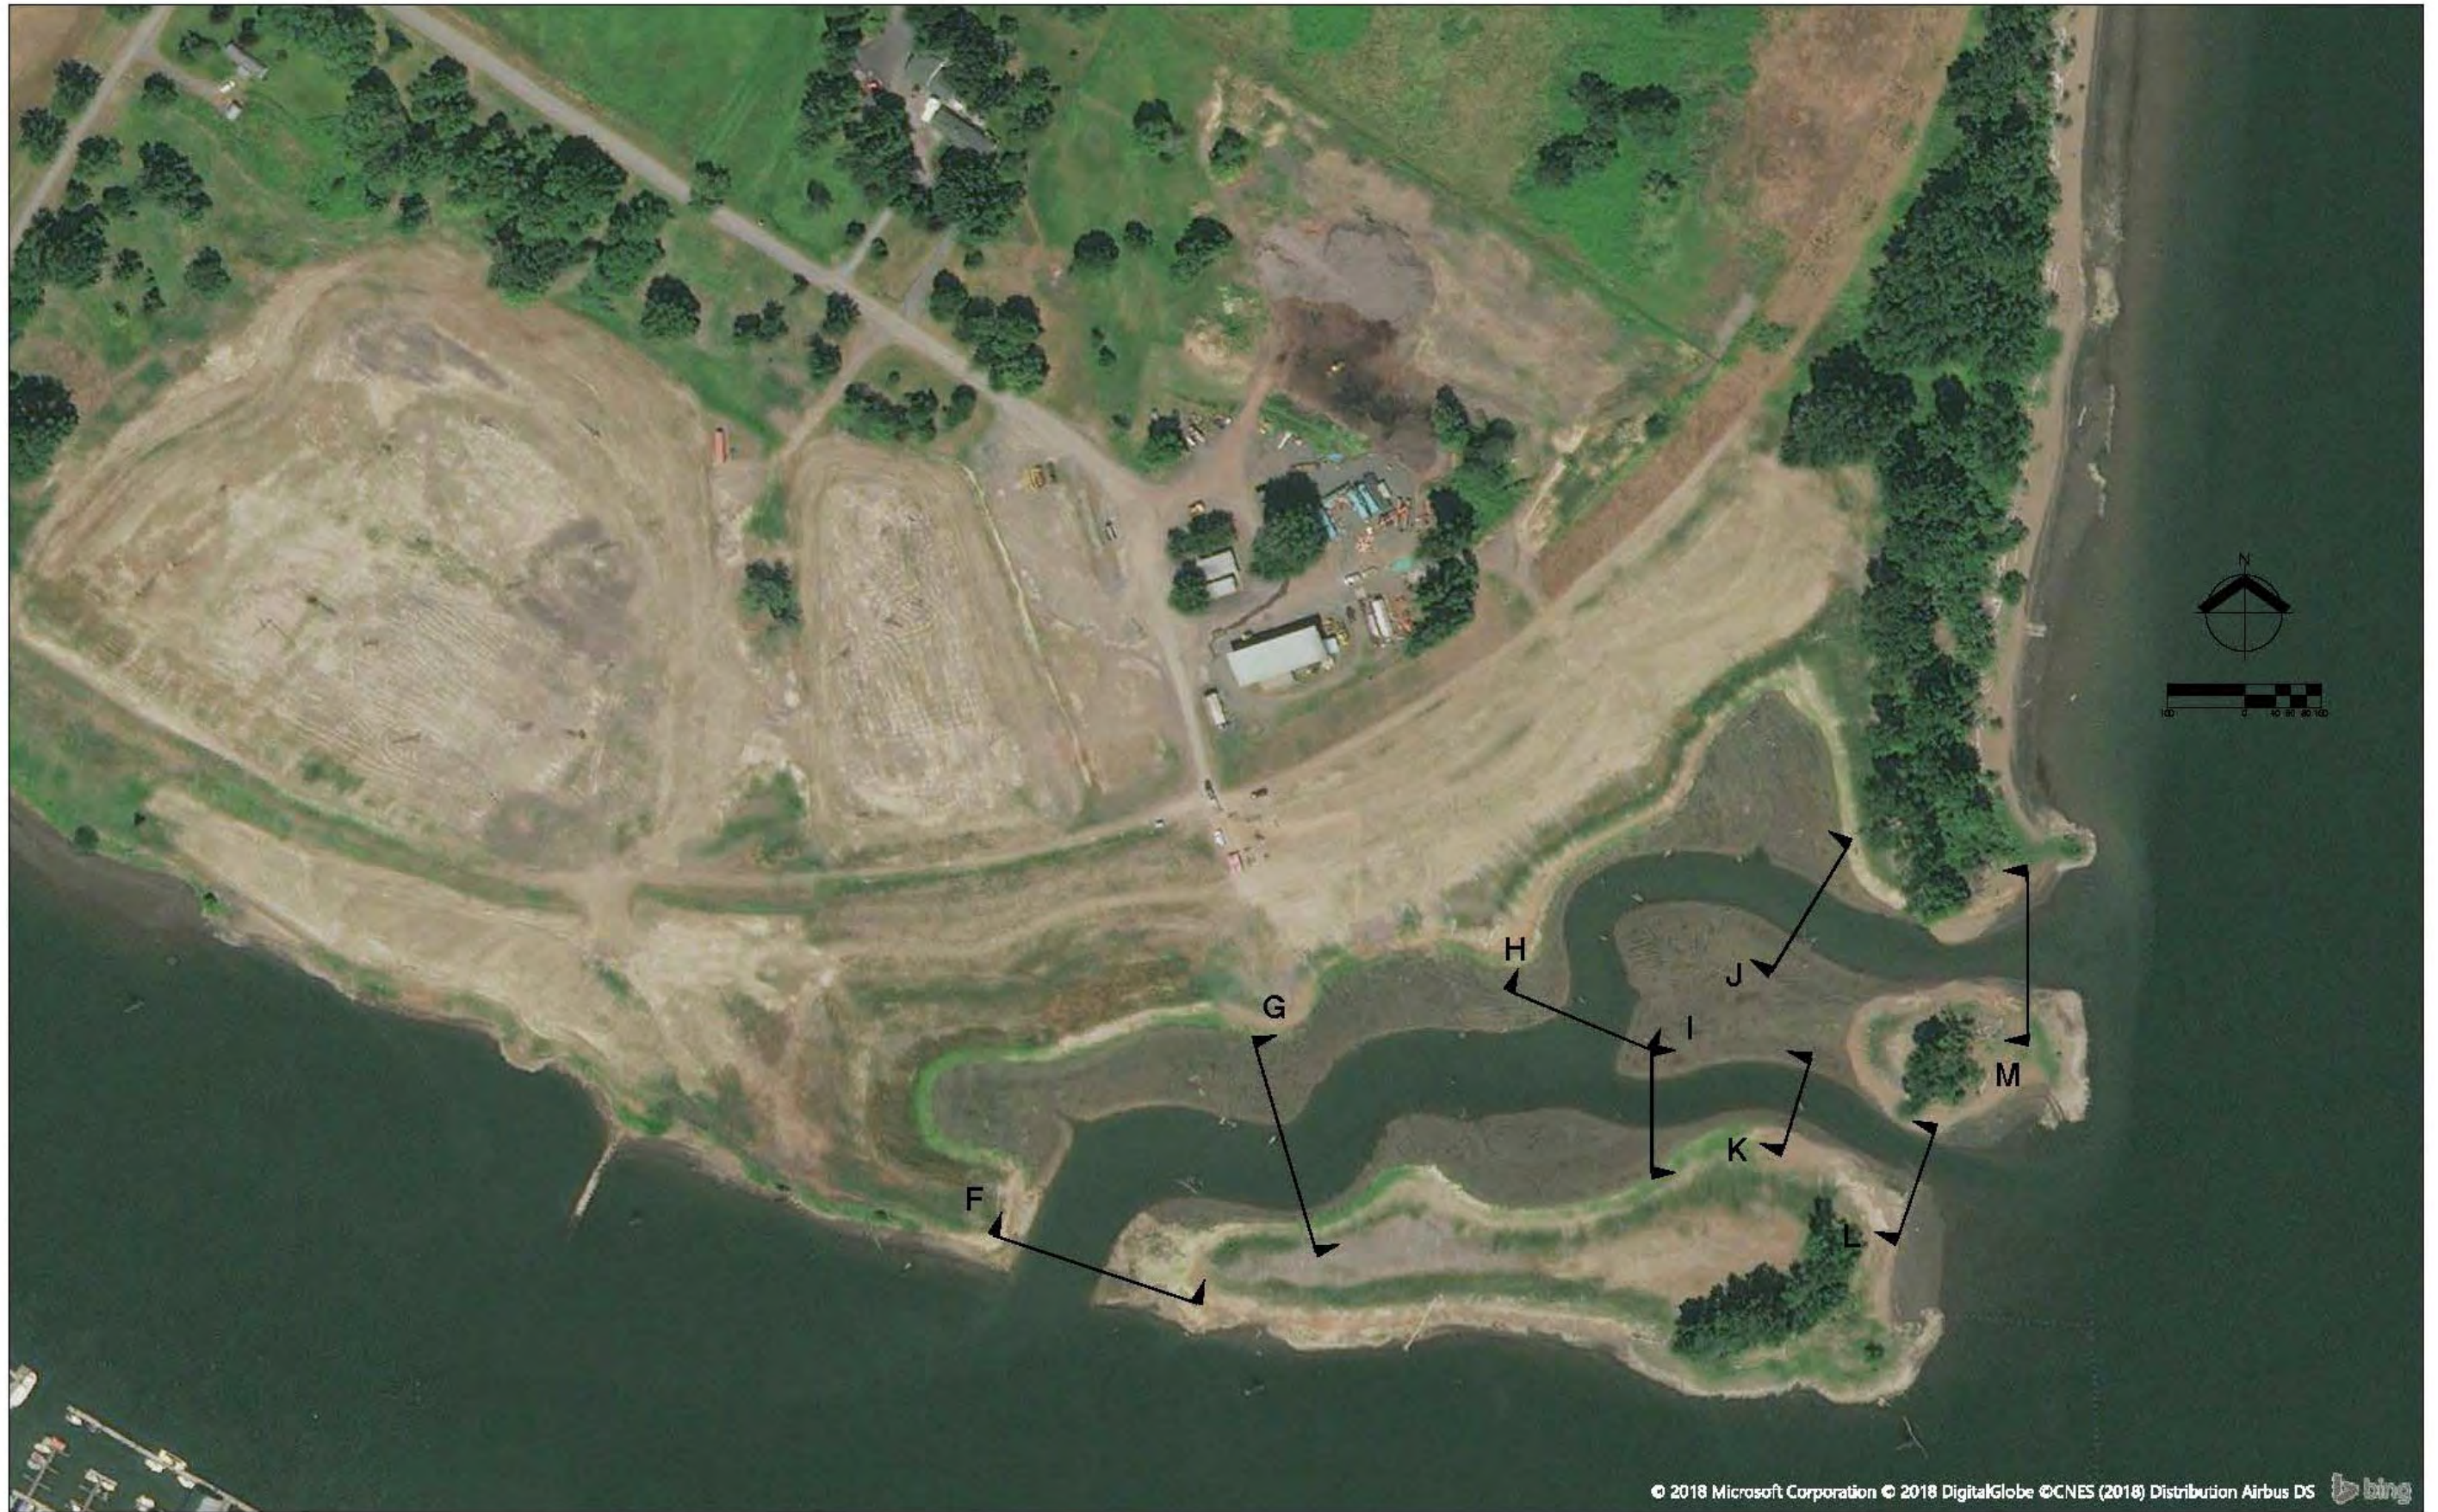
Frequent site visits have confirmed that constructed side channels and emergent marsh are flooding (i.e., filling and partially draining) in response to fluctuations in the daily tidal regime and seasonal river stages in the Willamette River and Multnomah Channel, as expected (**Figures 6c-6f**). Channel connections have remained open through 2018 and are not blocked or clogged from sediments or debris.

Cross Section F										
Survey Point ID	Elevation: October 2015	Elevation: October 2018	Elevation Change	Depth October 2015 relative to OHW (elevation 20.0)	Depth October 2018 relative to OHW (elevation 20.0)	Percent Change Relative to OHW 2015 to 2018		Absolute Percent Change Relative to OHW 2015 to 2018		
A	5.0	4.9	-0.1	15.0	15.1	(15.1/15.0) =	101%	101 - 100 =	1%	
B	0.6	2.8	+2.2	19.4	17.2	(17.2/19.4) =	89%	89 - 100 =	11%	
C	1.1	1.7	+0.6	18.9	18.3	(18.3/18.9) =	97%	97 - 100 =	3%	
D	1.4	1.8	+0.4	18.6	18.2	(18.2/18.6) =	98%	98 - 100 =	2%	
E	5.0	5.1	+0.1	15.0	14.9	(14.9/15.0) =	99%	99 - 100 =	1%	
Average Distance:			0.7					Average:		4%

In order to determine whether side channel depths have changed more than 20% from the as-built surveys, eight transects crossing the side channels were surveyed. The locations and results of those surveys are shown on **Figures 6d-6l**. The channel depths were measured from the OHWM. Using the average change across the eight transects, the change in side channel depth was 3.6%. This is well below the 20% threshold. Transect L showed the most change at 9%; however, it appears that the side channel in this area has shifted slightly since there are points that are deeper as well as points that are shallower.

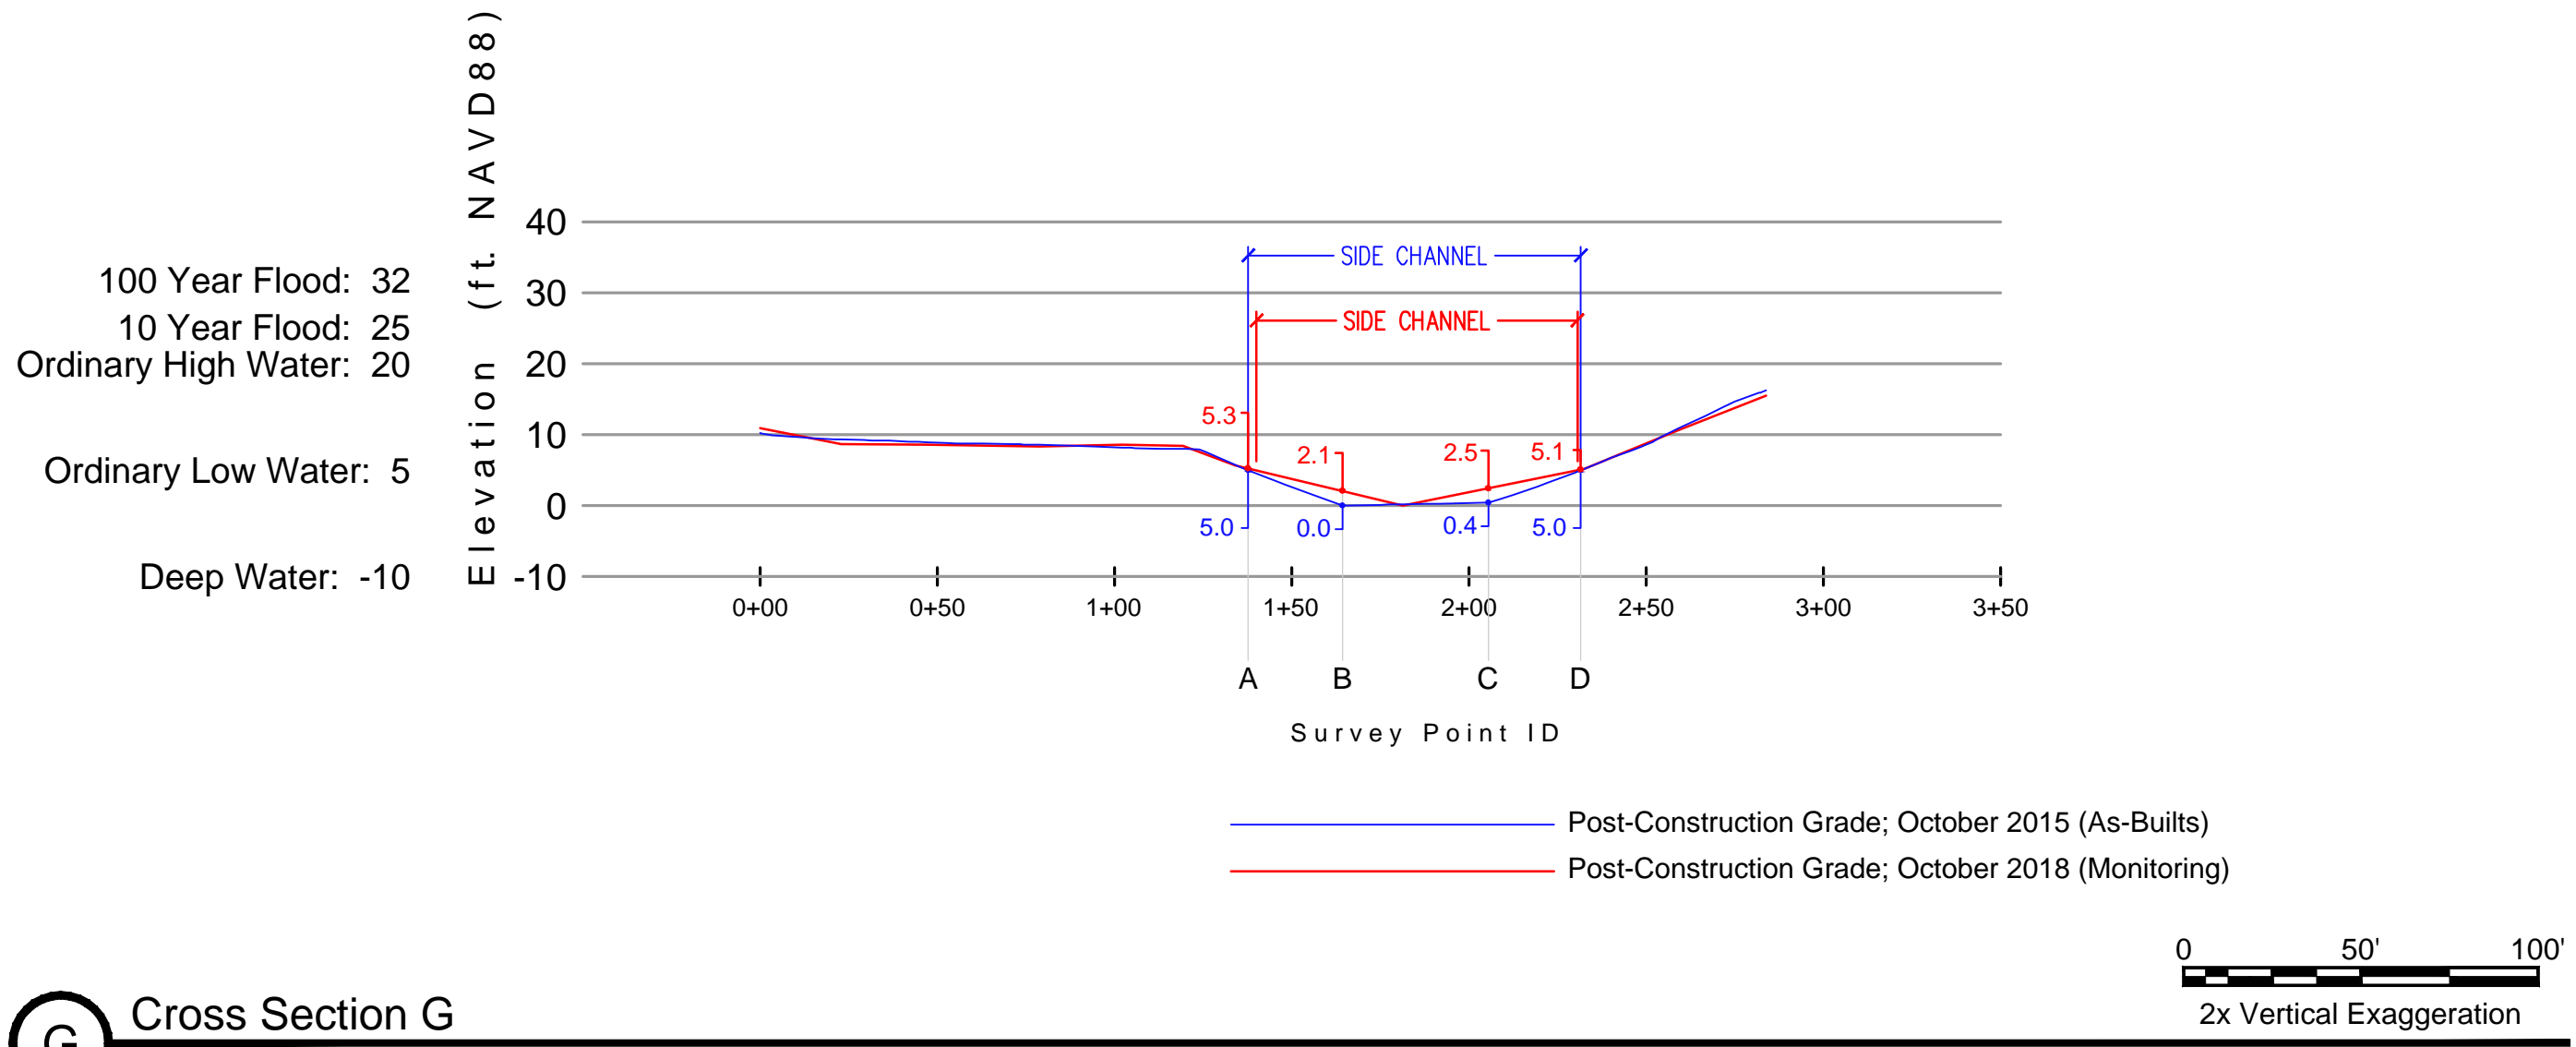
G Cross Section G

Cross Section G										
Survey Point ID	Elevation: October 2015	Elevation: October 2018	Elevation Change	Depth October 2015 relative to OHW (elevation 20.0)	Depth October 2018 relative to OHW (elevation 20.0)	Percent Change Relative to OHW 2015 to 2018		Absolute Percent Change Relative to OHW 2015 to 2018		
A	5.0	5.3	+0.3	15.0	14.7	(14.7/15.0) =	98%	98 - 100 =	2%	
B	0.0	2.1	+2.1	20.0	17.9	(17.9/20.0) =	90%	90 - 100 =	10%	
C	0.4	2.5	+2.1	19.6	17.5	(19.6/17.5) =	112%	112 - 100 =	12%	
D	5.0	5.1	+0.1	15.0	14.9	(14.9/14.6) =	102%	102 - 100 =	2%	
Average Distance:			1.2					Average:		7%

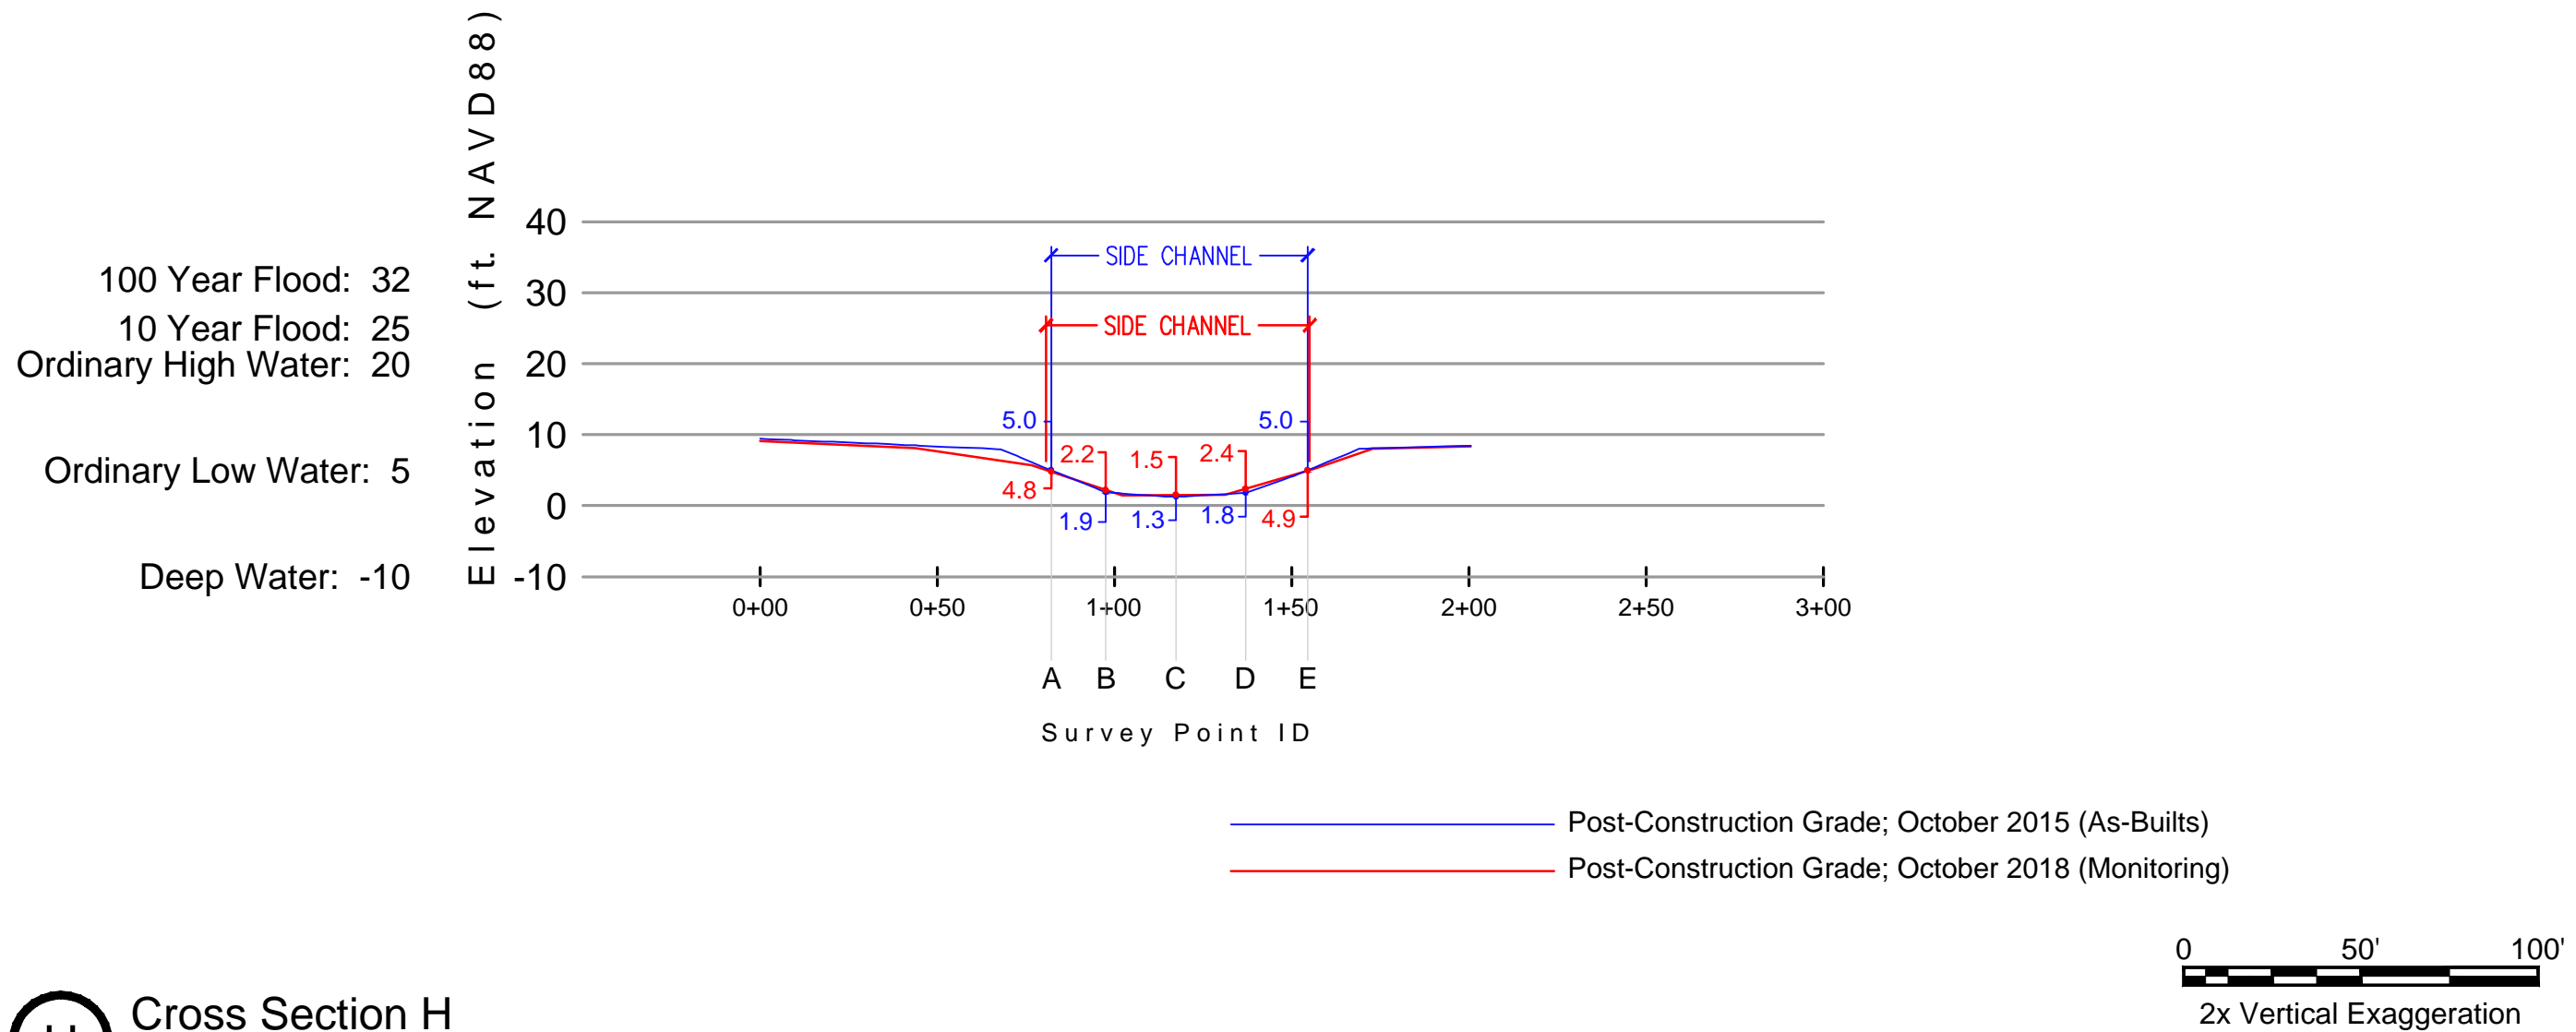
H Cross Section H

Cross Section H										
Survey Point ID	Elevation: October 2015	Elevation: October 2018	Elevation Change	Depth October 2015 relative to OHW (elevation 20.0)	Depth October 2018 relative to OHW (elevation 20.0)	Percent Change Relative to OHW 2015 to 2018	Absolute Percent Change Relative to OHW 2015 to 2018			
A	5.0	4.8	-0.2	15.0	15.2	(15.2/15.0) =	101%	101-100 =	1%	
B	1.9	2.2	+0.3	18.1	17.8	(17.8/18.1) =	98%	98-100 =	2%	
C	1.3	1.5	+0.2	18.7	18.5	(18.5/18.7) =	99%	99-100 =	1%	
D	1.8	2.4	+0.6	18.2	17.6	(17.6/18.2) =	97%	97-100 =	3%	
E	5.0	4.9	-0.1	15.0	15.1	(15.1/15.0) =	101%	101-100 =	1%	
Average Distance:			0.3					Average:		2%

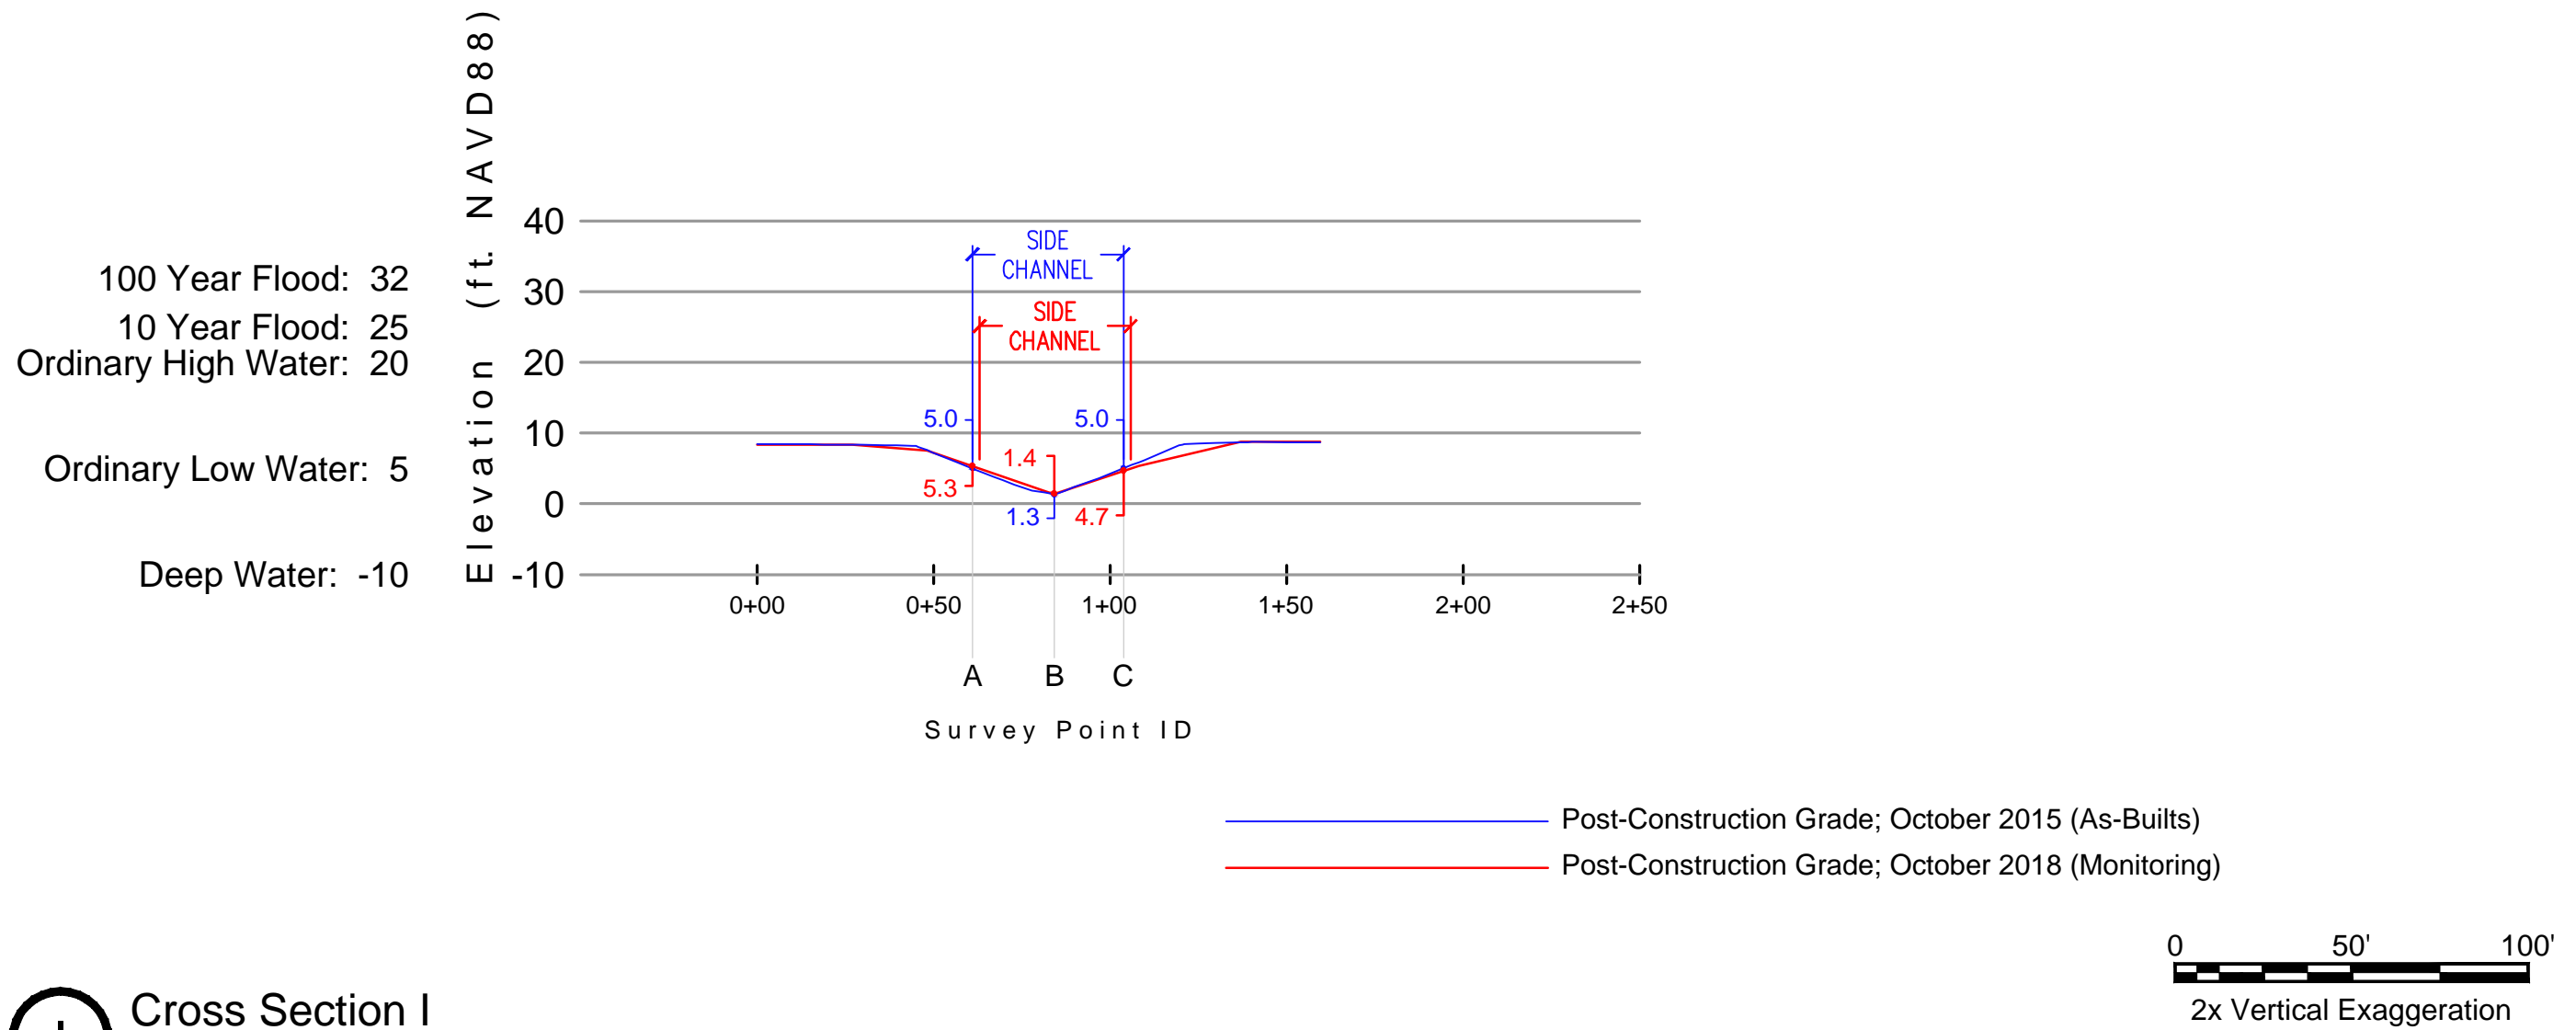
I Cross Section I

Cross Section I									
Survey Point ID	Elevation: October 2015	Elevation: October 2018	Elevation Change	Depth October 2015 relative to OHW (elevation 20.0)	Depth October 2018 relative to OHW (elevation 20.0)	Percent Change Relative to OHW 2015 to 2018		Absolute Percent Change Relative to OHW 2015 to 2018	
A	5.0	5.3	+0.3	15.0	14.7	(14.7/15.0) =	98%	98 - 100 =	2%
B	1.3	1.4	+0.1	18.7	18.6	(18.6/18.7) =	99%	99 - 100 =	1%
C	5.0	4.7	-0.3	15.0	15.3	(15.3/15.0) =	102%	102 - 100 =	2%
Average Distance:			0.2					Average:	2%

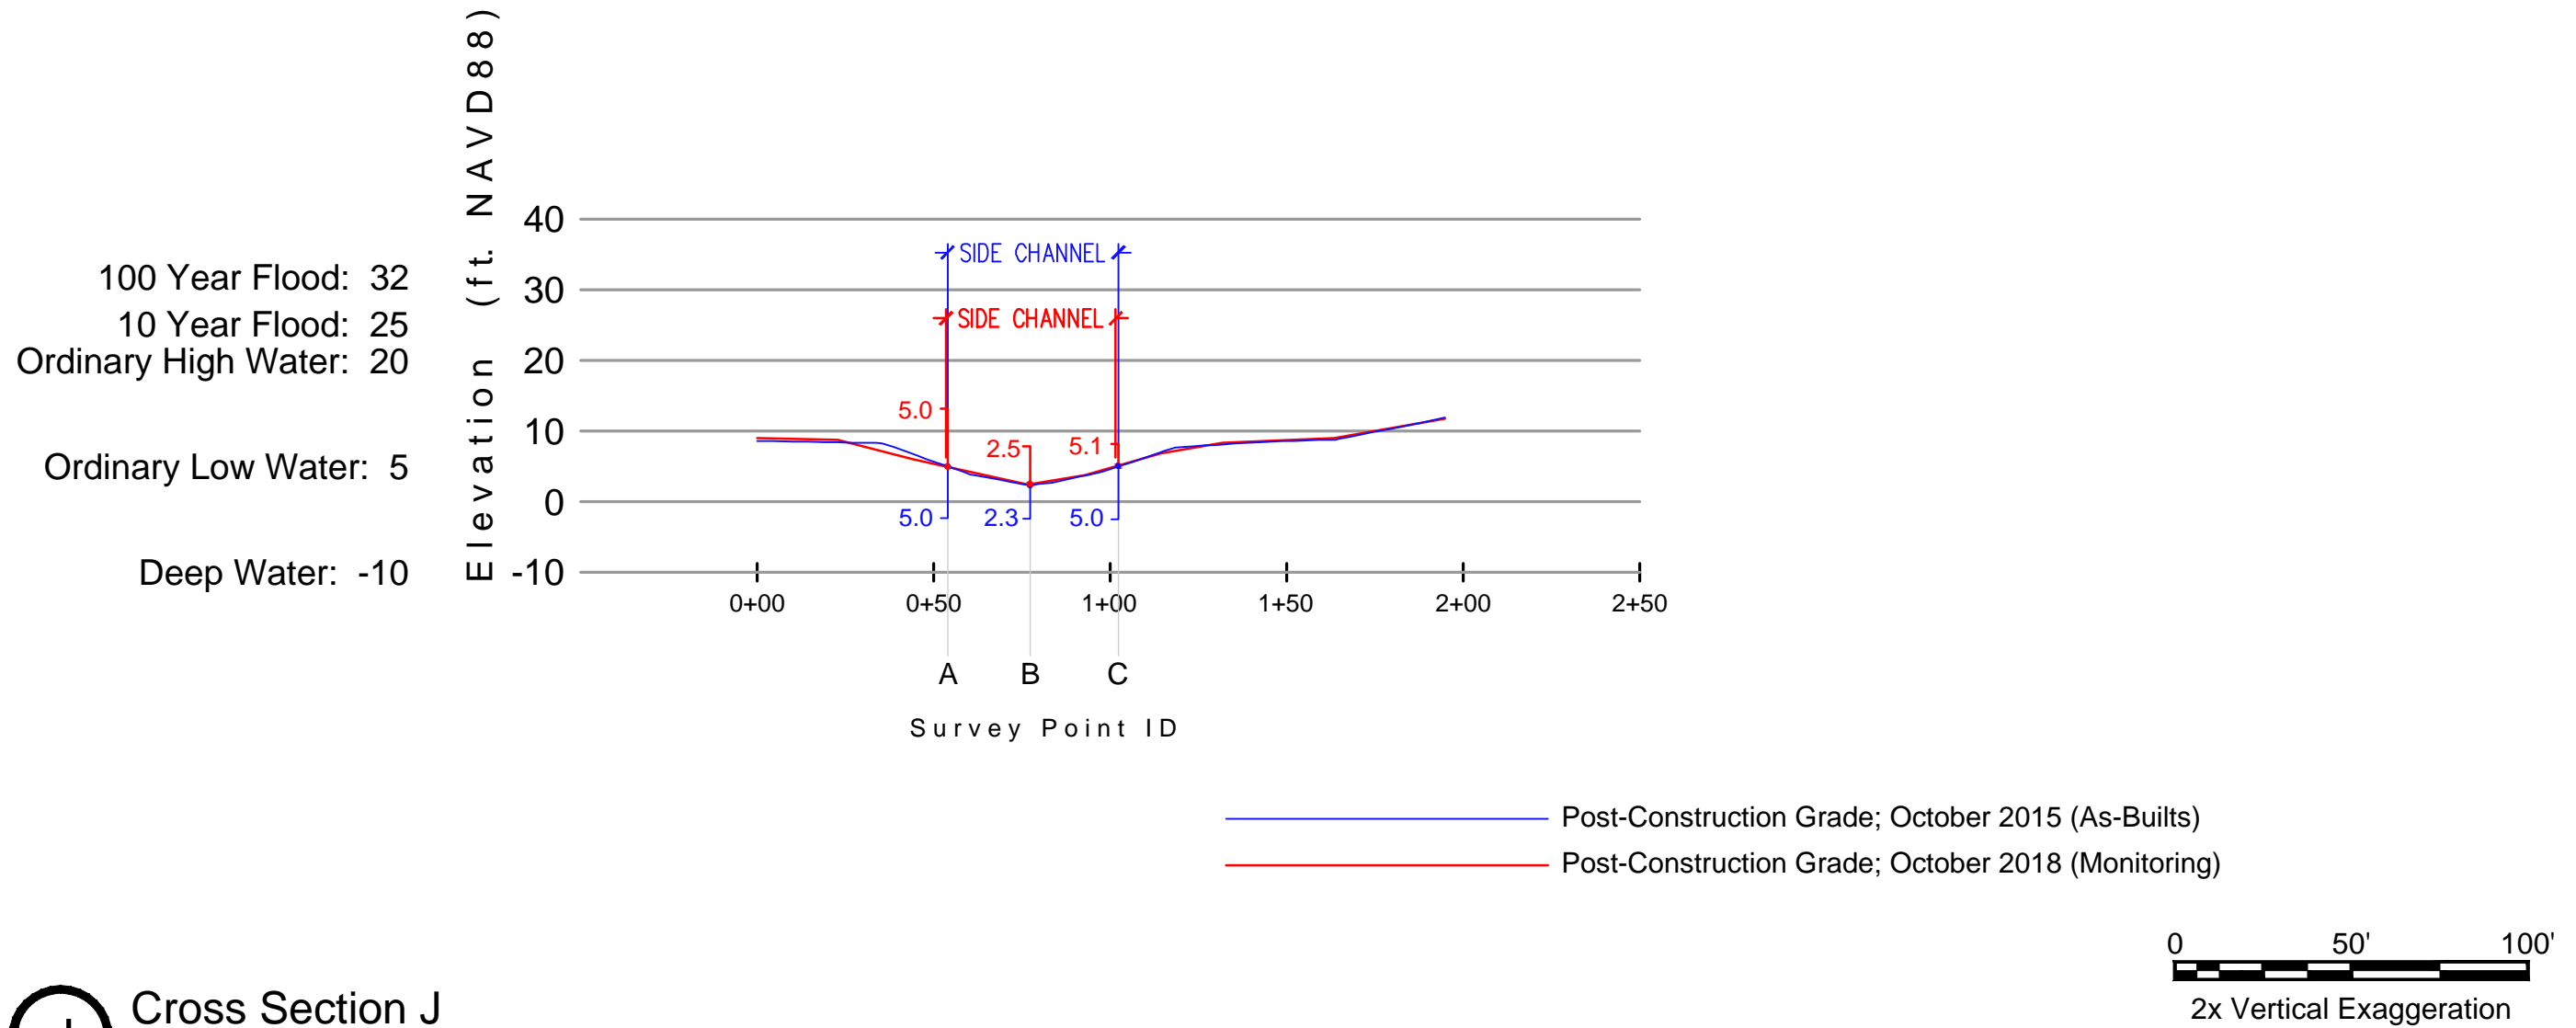
J Cross Section J

Cross Section J									
Survey Point ID	Elevation: October 2015	Elevation: October 2018	Elevation Change	Depth October 2015 relative to OHW (elevation 20.0)	Depth October 2018 relative to OHW (elevation 20.0)	Percent Change Relative to OHW 2015 to 2018		Absolute Percent Change Relative to OHW 2015 to 2018	
A	5.0	5.0	0.0	15.0	15.0	(15.0/15.0) =	100%	100-100 =	0%
B	2.3	2.5	+0.2	17.7	17.5	(17.5/17.7) =	99%	99-100 =	1%
C	5.0	5.1	+0.1	15.0	14.9	(14.9/15.0) =	99%	99-100 =	1%
Average Distance:			0.1					Average:	1%
