Alder Creek Restoration Project

2018 Monitoring Report Year 3

Wildlands PNW
Portland Harbor Holdings II, LLC
520 SW 6th Avenue, Suite 1210
Portland, OR 97204
503-241-4895
Contact: Julie Mentzer

January 2019
Revised February 2020

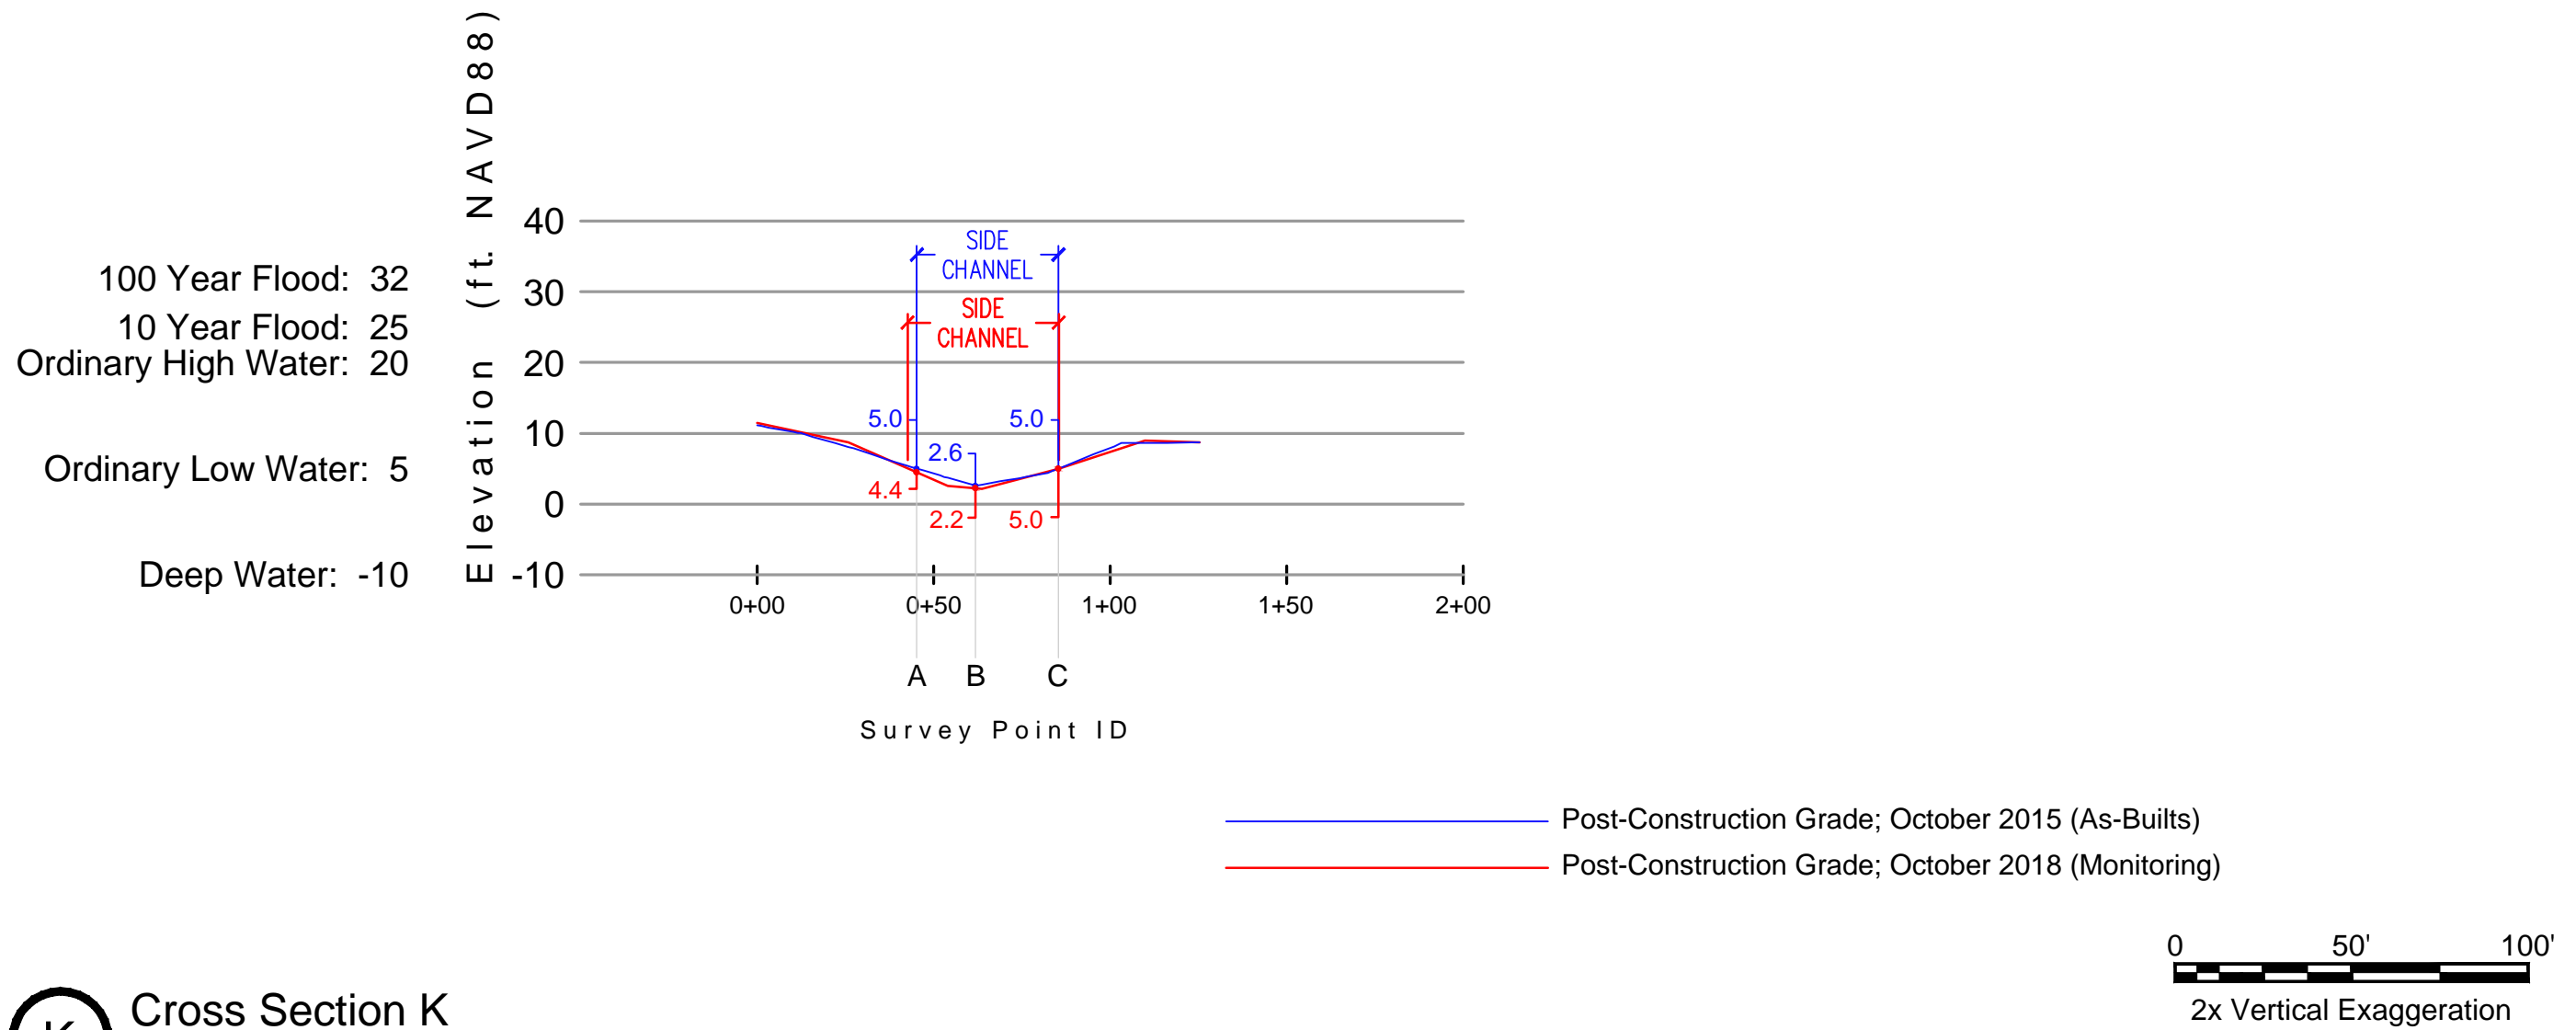
K Cross Section K

Cross Section K									
Survey Point ID	Elevation: October 2015	Elevation: October 2018	Elevation Change	Depth October 2015 relative to OHW (elevation 20.0)	Depth October 2018 relative to OHW (elevation 20.0)	Percent Change Relative to OHW 2015 to 2018	Absolute Percent Change Relative to OHW 2015 to 2018		
A	5.0	4.4	-0.6	15.0	15.6	(15.6/15.0) = 104%	104 - 100 =	4%	
B	2.6	2.2	-0.4	17.4	17.8	(17.8/17.4) = 102%	102 - 100 =	2%	
C	5.0	5.0	0.0	15.0	15.0	(15.0/15.0) = 100%	100 - 100 =	0%	
Average Distance:			0.3					Average: 2%

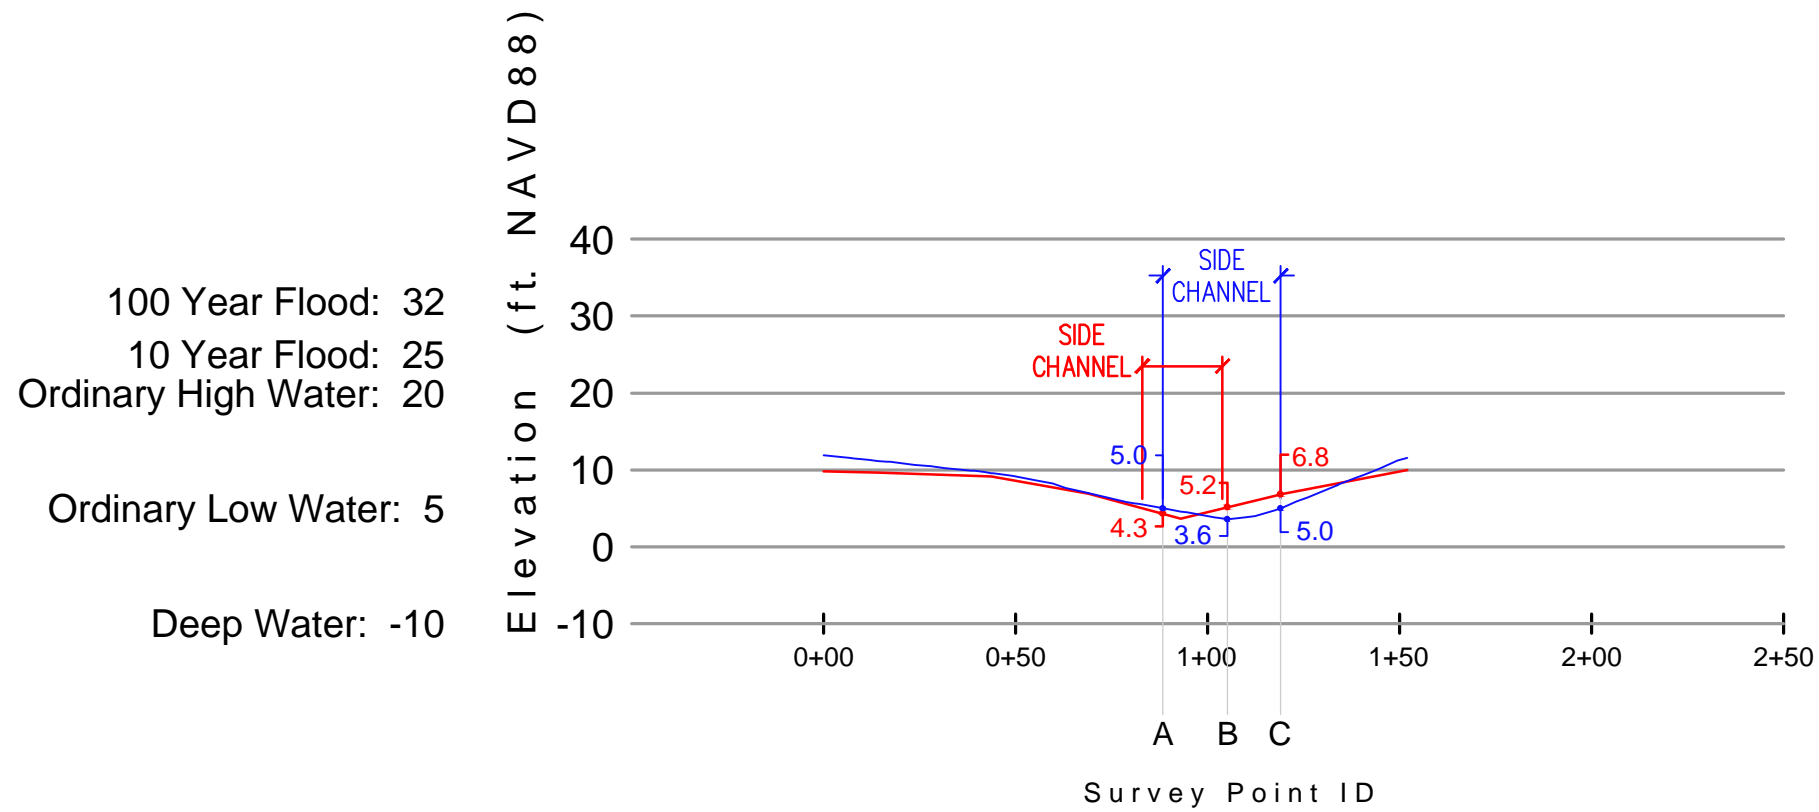
Cross Section L									
Survey Point ID	Elevation: October 2015	Elevation: October 2018	Elevation Change	Depth October 2015 relative to OHW (elevation 20.0)	Depth October 2018 relative to OHW (elevation 20.0)	Percent Change Relative to OHW 2015 to 2018	Absolute Percent Change Relative to OHW 2015 to 2018		
A	5.0	4.3	-0.7	15.0	15.7	(15.7/15.0) = 105%	105 - 100 =	5%	
B	3.6	5.2	+1.6	16.4	14.8	(14.8/16.4) = 90%	90 - 100 =	10%	
C	5.0	6.8	+1.8	15.0	13.2	(13.2/15.0) = 88%	88 - 100 =	12%	
Average Distance:			1.4				Average:		9%

— Post-Construction Grade; October 2015 (As-Builts)
— Post-Construction Grade; October 2018 (Monitoring)

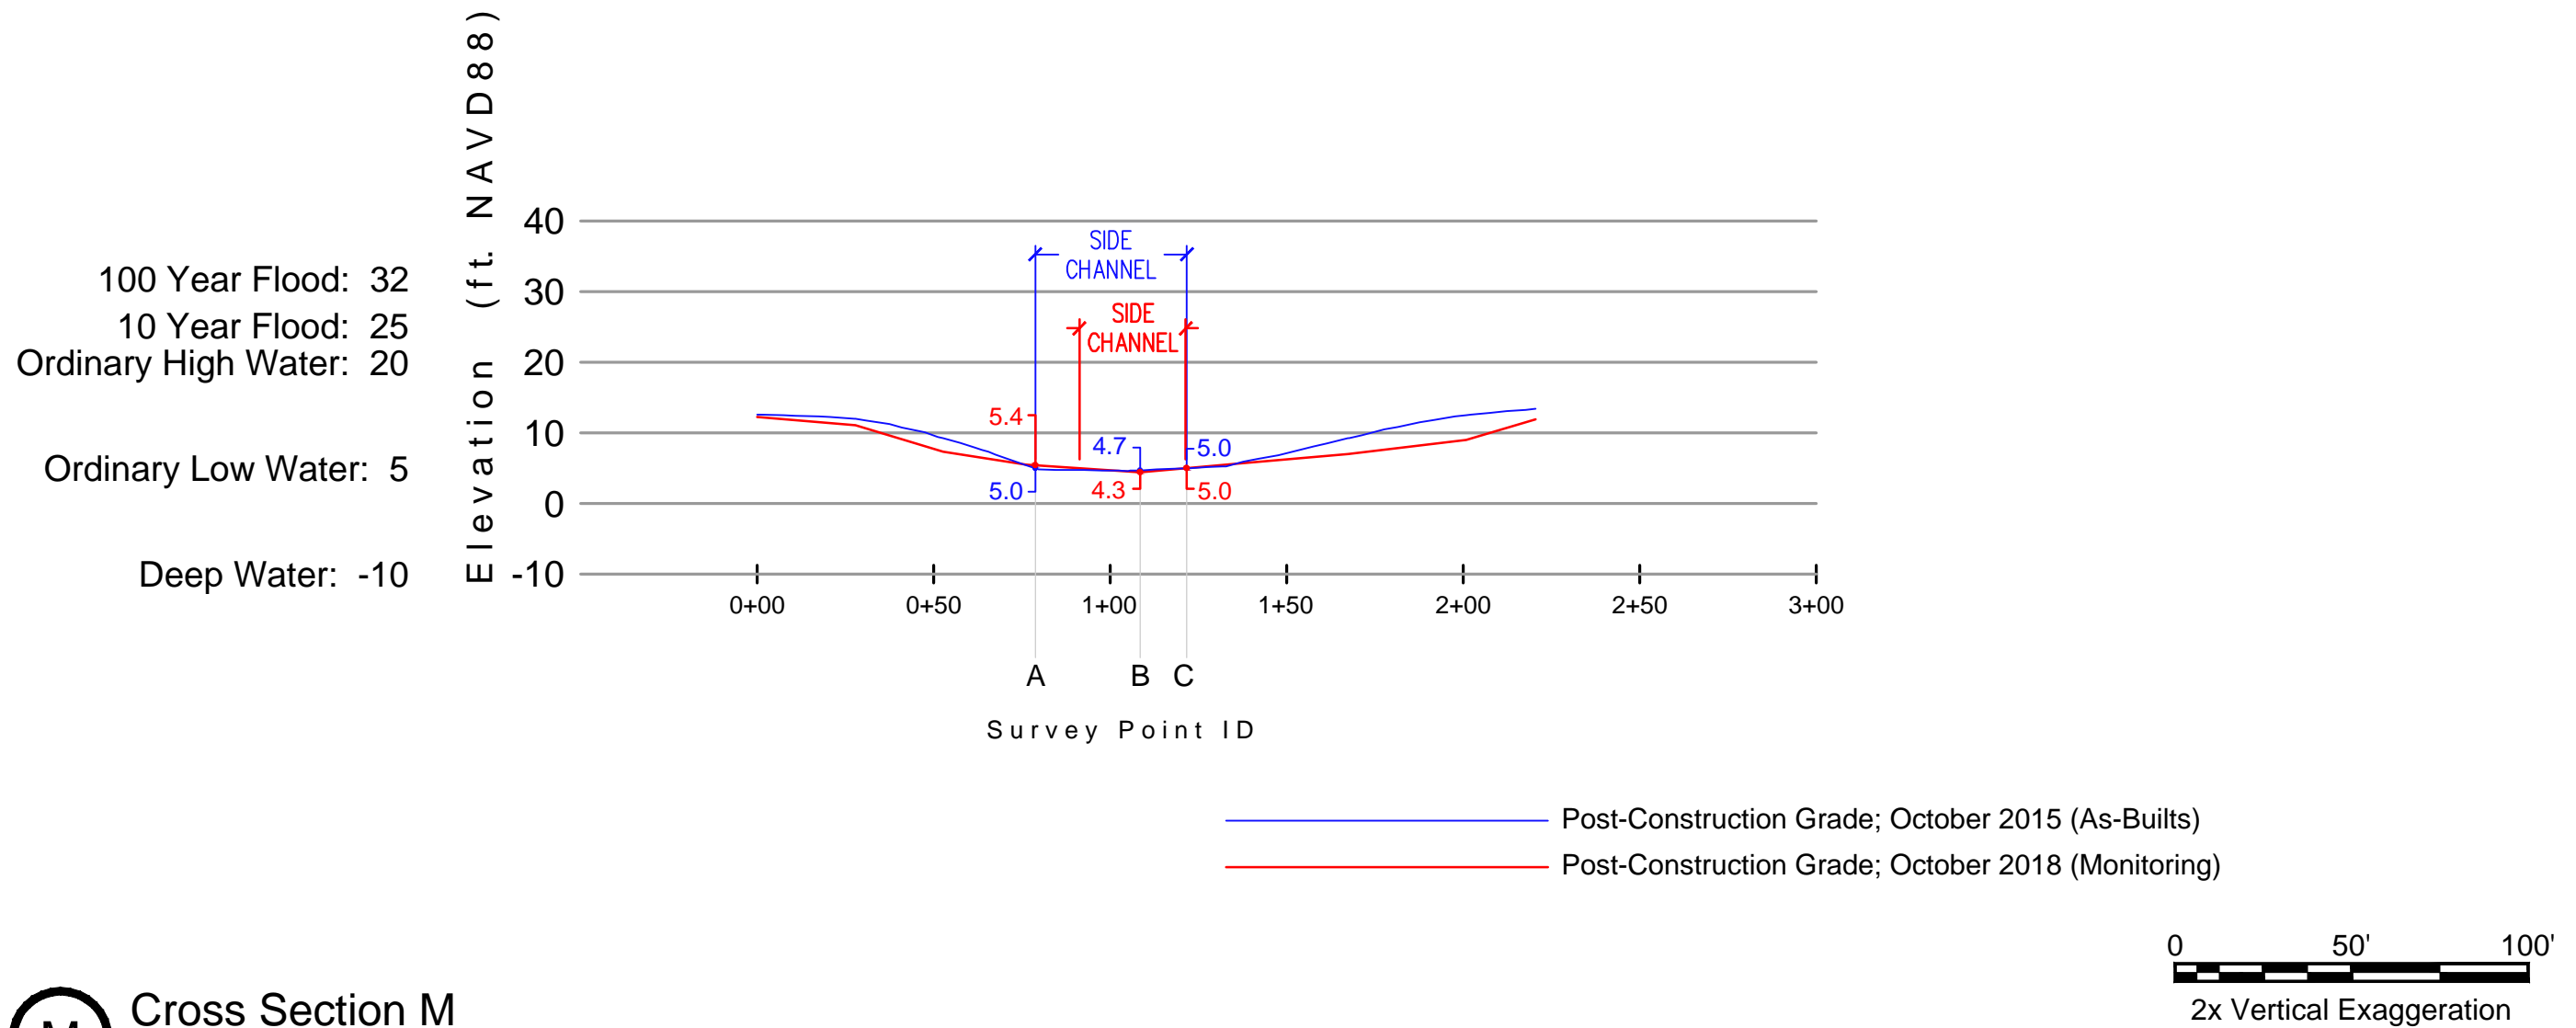
M Cross Section M

Cross Section M									
Survey Point ID	Elevation: October 2015	Elevation: October 2018	Elevation Change	Depth October 2015 relative to OHW (elevation 20.0)	Depth October 2018 relative to OHW (elevation 20.0)	Percent Change Relative to OHW 2015 to 2018	Absolute Percent Change Relative to OHW 2015 to 2018		
A	5.0	5.4	+0.4	15.0	14.6	(14.6/15.0) = 97%	97 - 100 =	3%	
B	4.7	4.3	-0.4	15.3	15.7	(15.7/15.3) = 103%	103 - 100 =	3%	
C	5.0	5.0	0.0	15.0	15.0	(15.0/15.0) = 100%	100 - 100 =	0%	
Average Distance:			0.3					Average: 2%

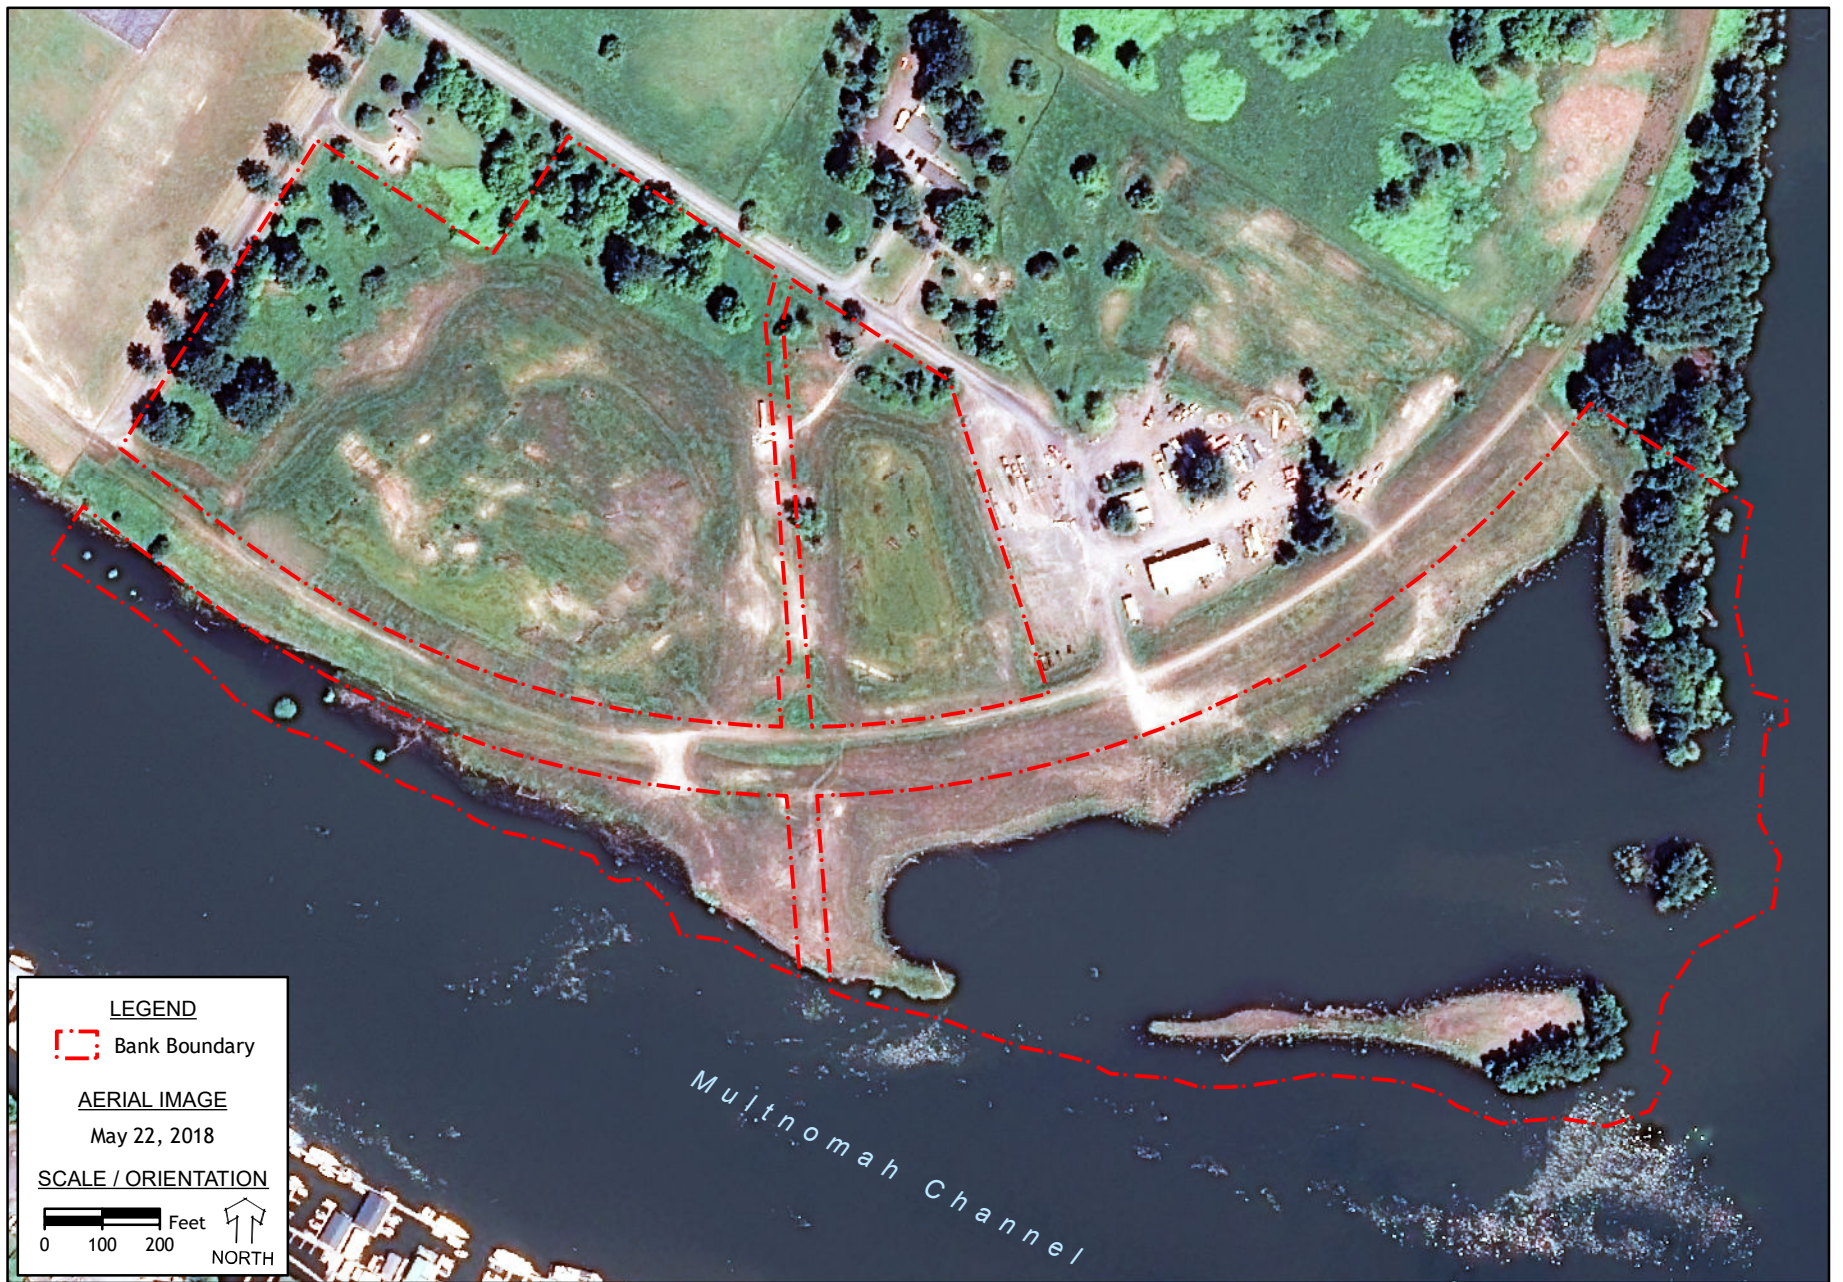
Figure 6m
Aerial Photo Taken on 05/22/2018

Wildlands' staff attempted to use a drone to take aerial photos of high water events during the 2018 monitoring period; however, the drone is unable to be used in windy or rainy conditions. Additionally, if there is significant cloud cover, aerial photos cannot be taken. As a result, Wildlands was unable to capture an aerial photo of the site during a high water event; however, a satellite photo was available for 5/22/2018 which was within a few days of the highest water event of 2018 (**Figure 6m**). The water level captured by the satellite photo was translated to GIS to calculate the acres of inundation when the photo was taken. The photo shows approximately 20 acres of ACM inundated on 5/22/2018. The information obtained from the satellite photos was compared to the Columbia Slough gauge data for accuracy. The Columbia Slough gauge data (converted to NAVD 88) shows an approximate water level of 20 feet on 5/22/2018 (the day the aerial was taken), and the high water level of 20.7 on 5/17/18.

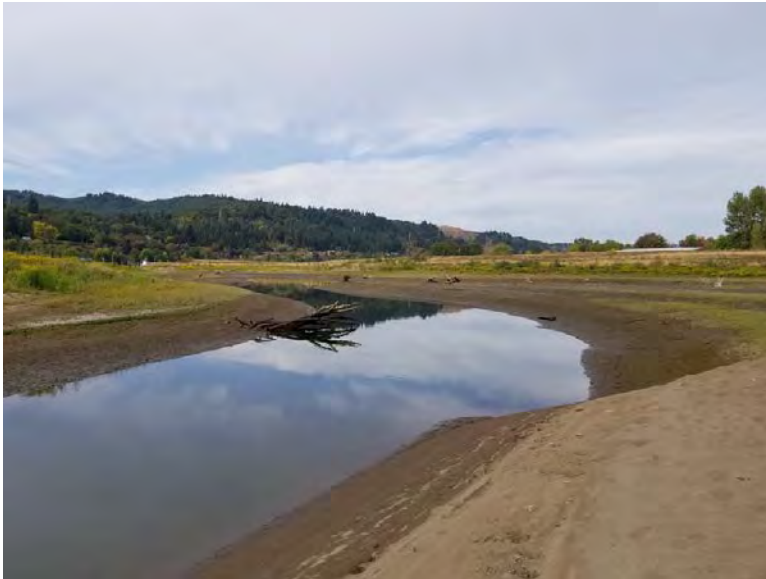
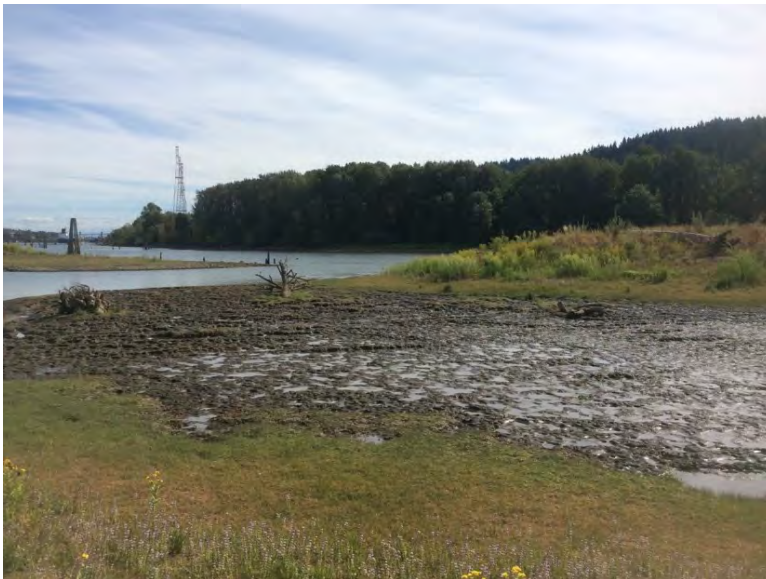
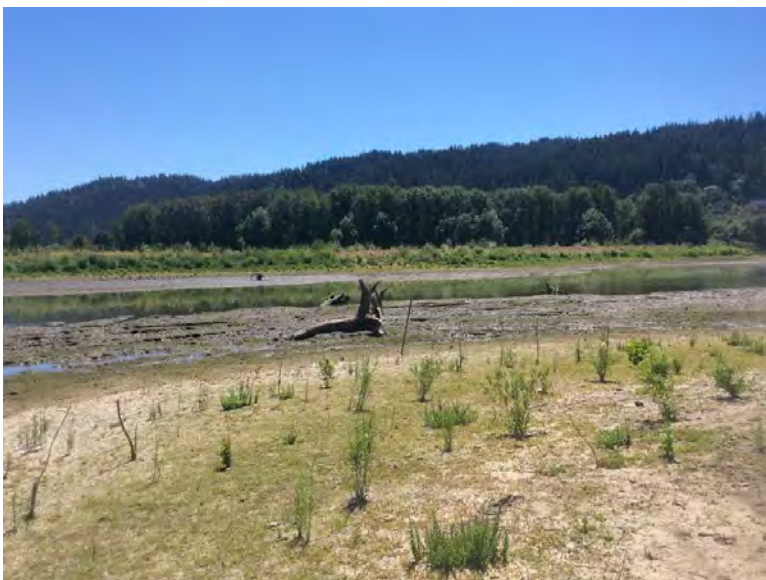
Figure 7
Large Woody Debris

Large woody debris monitoring took place on September 21, 2018. A total of 68 pieces of large woody debris were observed on the project in 2018. Of those, 43 were identified as being originally installed LWD and the remaining 25 as being naturally recruited. Currently the Project is exceeding the 80% required LWD retention performance standard for Year 3. Photos of the LWD observed during surveys can be found in **Figure 7**. The remaining habitat complexity features of downed wood, debris piles, and rock piles all remain in good condition. Monitoring of the large woody debris and other habitat complexity features will continue in Year 5 (2020).

If the amount of large wood on-site fails to meet performance standards in Years 2, 3, 5, 7 or 10 and if existing conditions and hydraulics will allow the retention of replacement materials, LWD will be installed in the interior channels (and marsh/mudflat where appropriate) to achieve the targeted density.

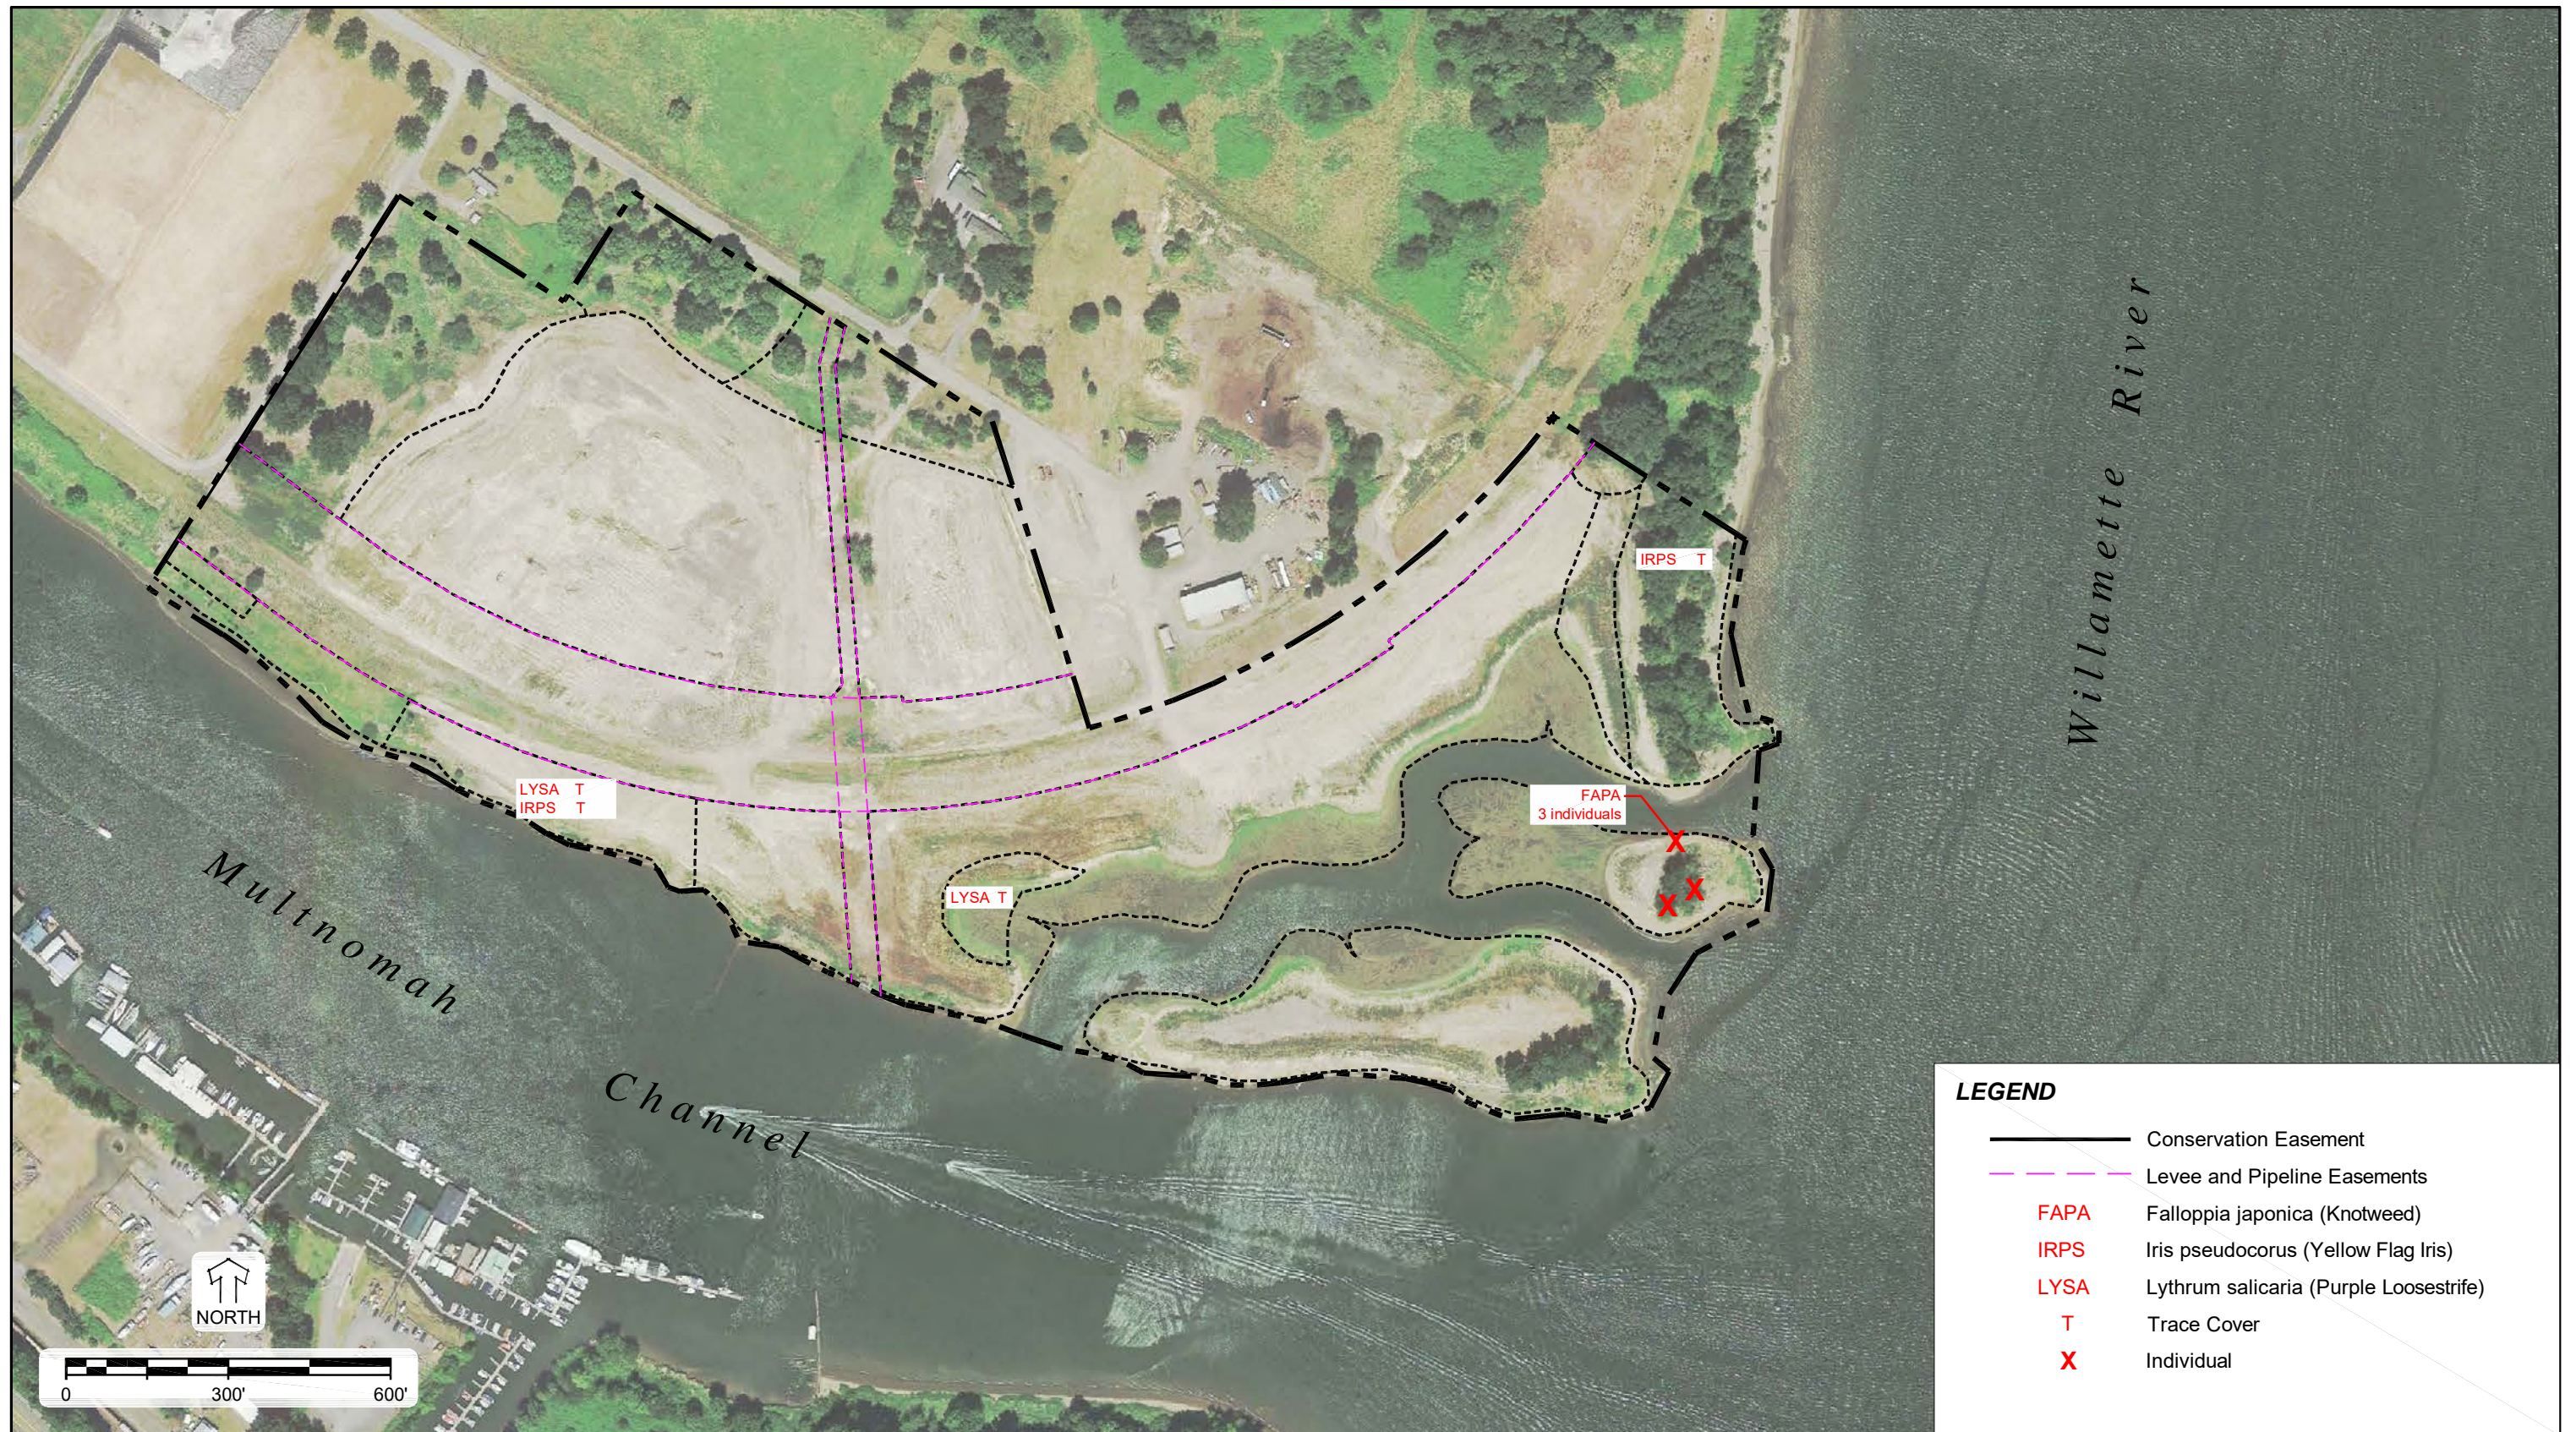
During 2018, Wildlands’ biologists visited the Project weekly to look for presence of “zero-untreated species”. No giant knotweed, Himalayan knotweed, or butterfly bush was observed on the Project site. A small amount of purple loosestrife, yellow flag iris, and 3 individuals of Japanese knotweed were identified (See **Figure 8**). All instances of these species were removed (**Table 8**).

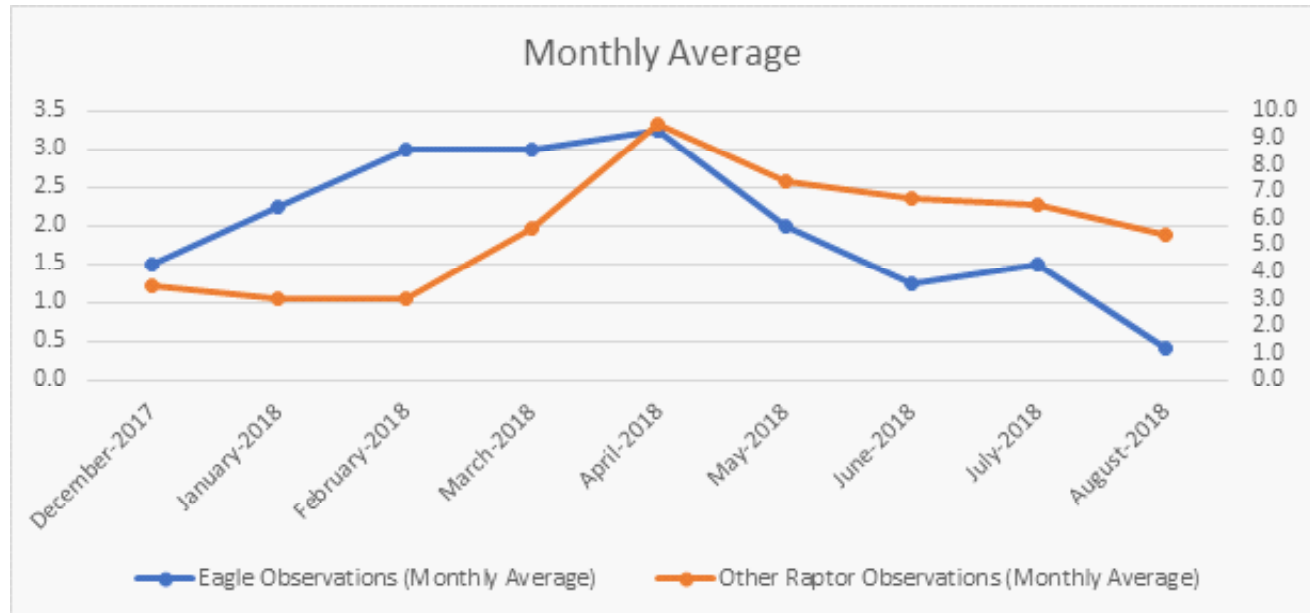
Mean black eagle and other raptor observations, by month.

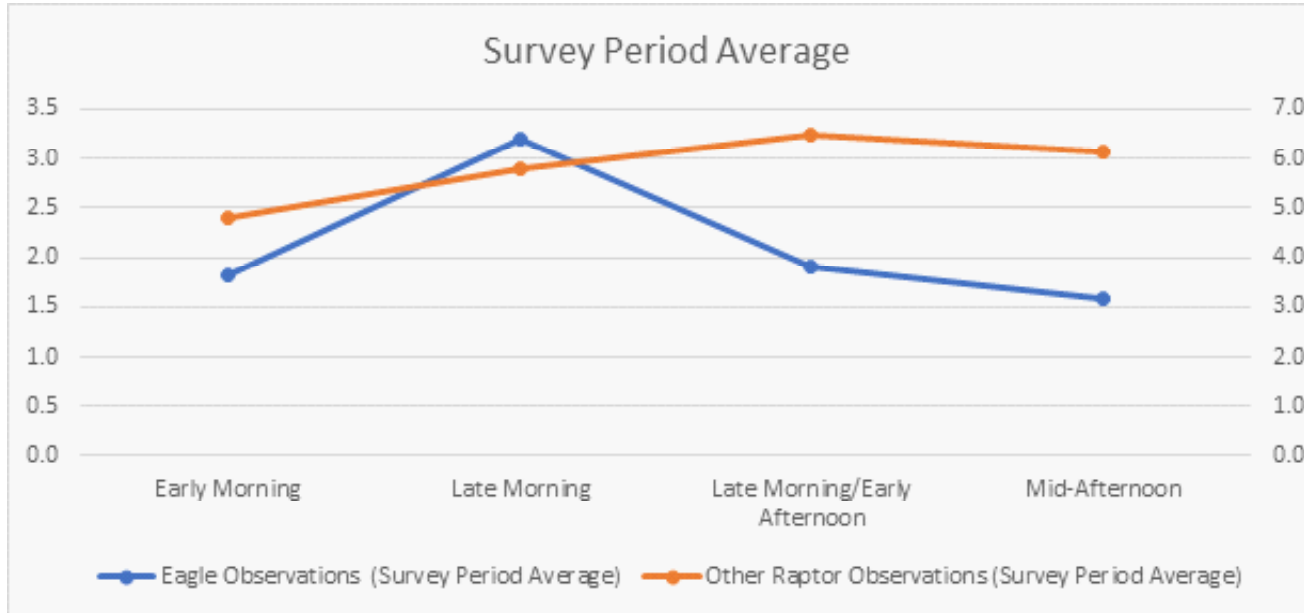
Mean bald eagle and other raptor observations, by time of day.¹

¹Early Morning= 6:00 A.M. to 9:00 A.M., Late Morning= 9:00A.M. to 10:45 A.M., Late Morning/Early Afternoon= 10:45 A.M. to 2:15 P.M., Mid-Afternoon= 2:15 P.M. to 5:30 P.M.

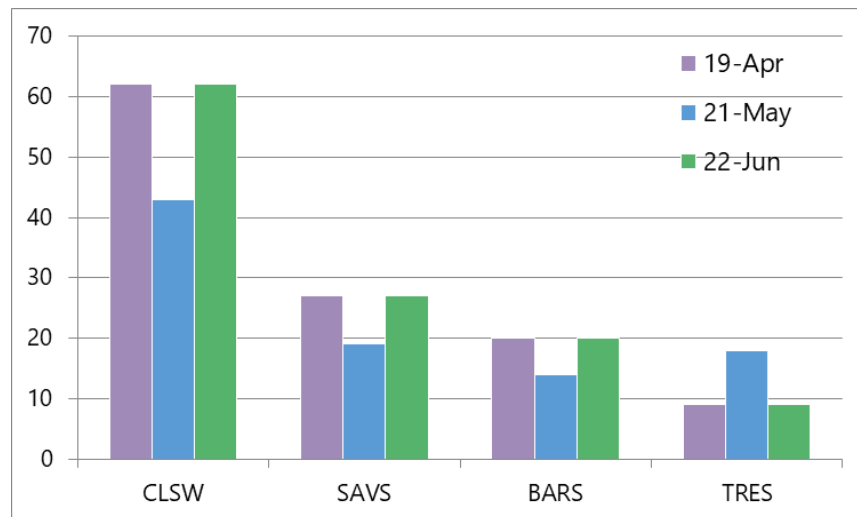
Surveys were conducted on April 19, May 21, and June 22 of 2018. The most abundant species overall were cliff swallow (*Petrochelidon pyrrhonota*), savannah sparrow (*Passerculus sandwichensis*), barn swallow (*Hirundo rustica*) and tree swallow (*Tachycineta bicolor*, Figure 1)¹. The average total number of species detected over the three visits was 45 and the average total number of individuals was 224² (Figure 2). The average proportion of nonnative individuals overall was three percent (Figures 3 and 4).

Figure 1. Top species counted in point count surveys, by total overall abundance

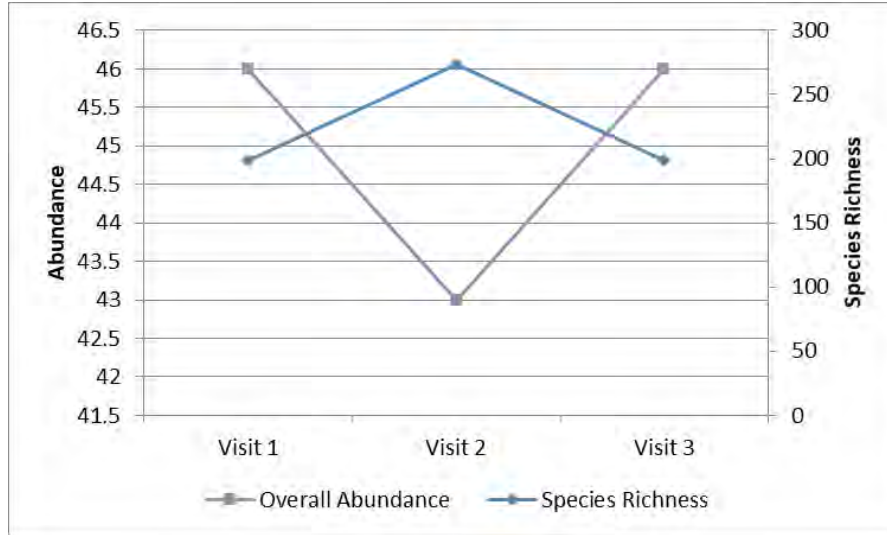
Figure 2. Species Abundance and Species Richness, by visit

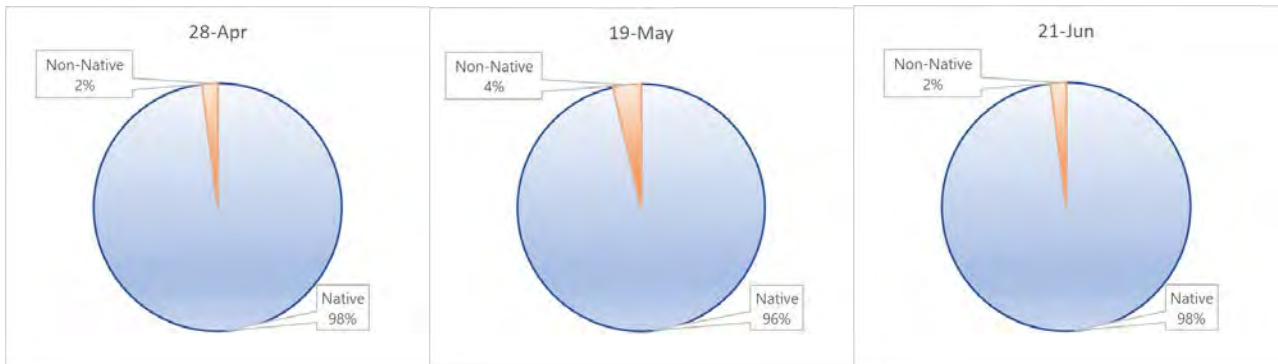
Figure 3. Percentage of native and non-native species by visit

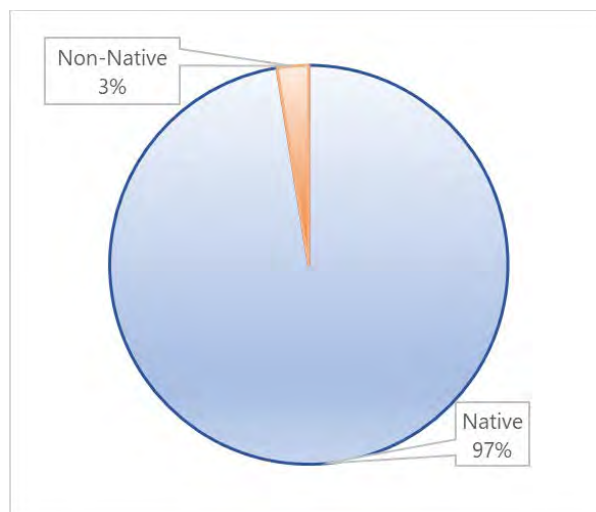
Figure 4. Percentage of native and non-native species over all visits
