2019 Rinearson Monitoring Annual Report

Rinearson Natural Area

August 27, 2020

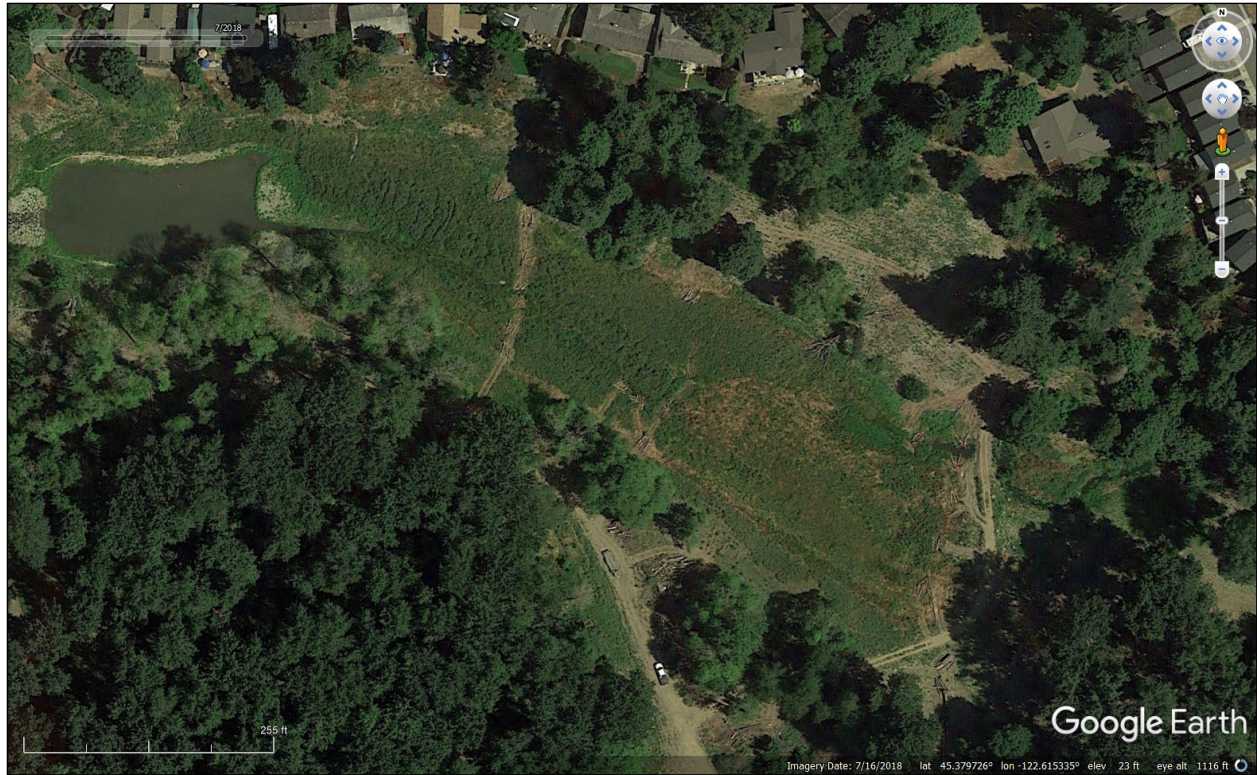
Figure 1 July 16, 2018, Google Earth aerial of the Rinearson Natural Area prior to Phase II planting efforts of winter 2018/2019.

Figure 1 shows the Rinearson site prior to Phase II planting efforts, and Figure 2 shows the site after all new plantings were installed. The new plantings covered an area of about 1 acre. In spring of 2019, it was observed that many of the new plantings were being harvested by beavers as both forage and dam building material (Figure 3).

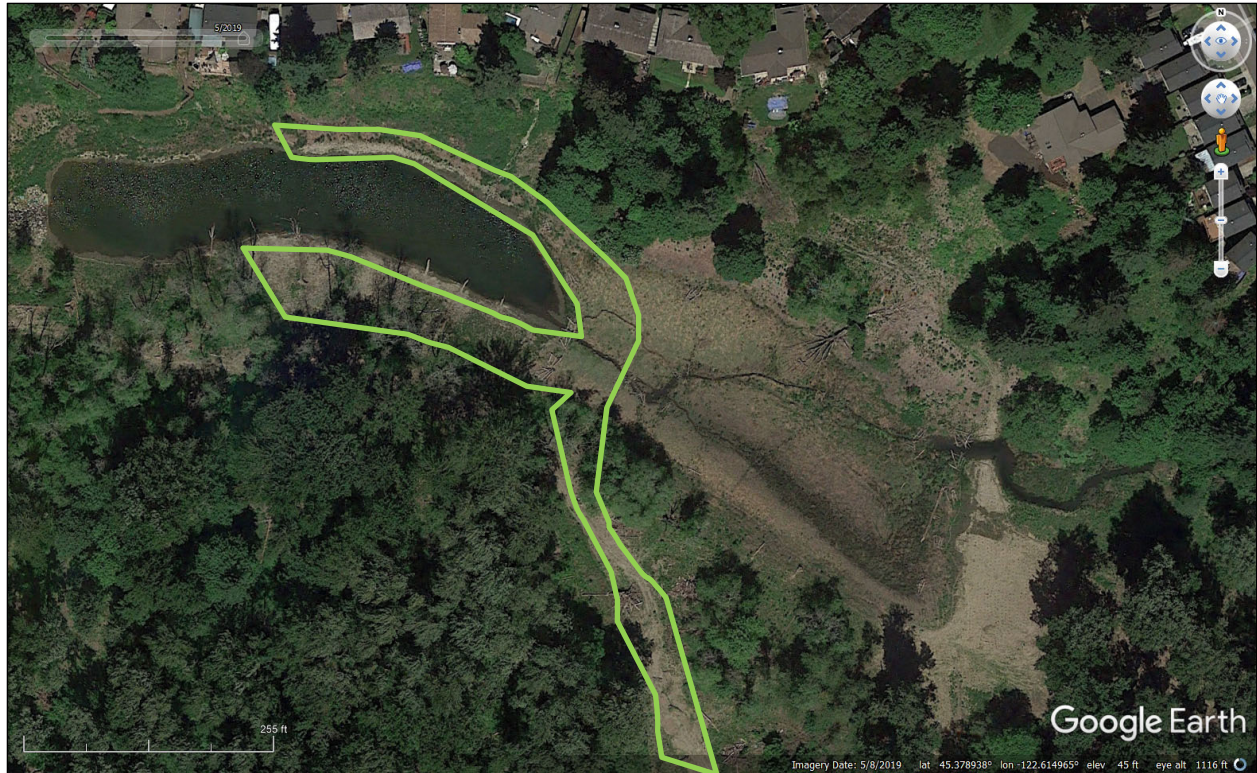
Figure 2 May 8, 2019, Google Earth aerial of the Rinearson Natural Area after the Phase II planting efforts of winter 2018/2019. The green polygon shows approximate extents of the Phase II planting.

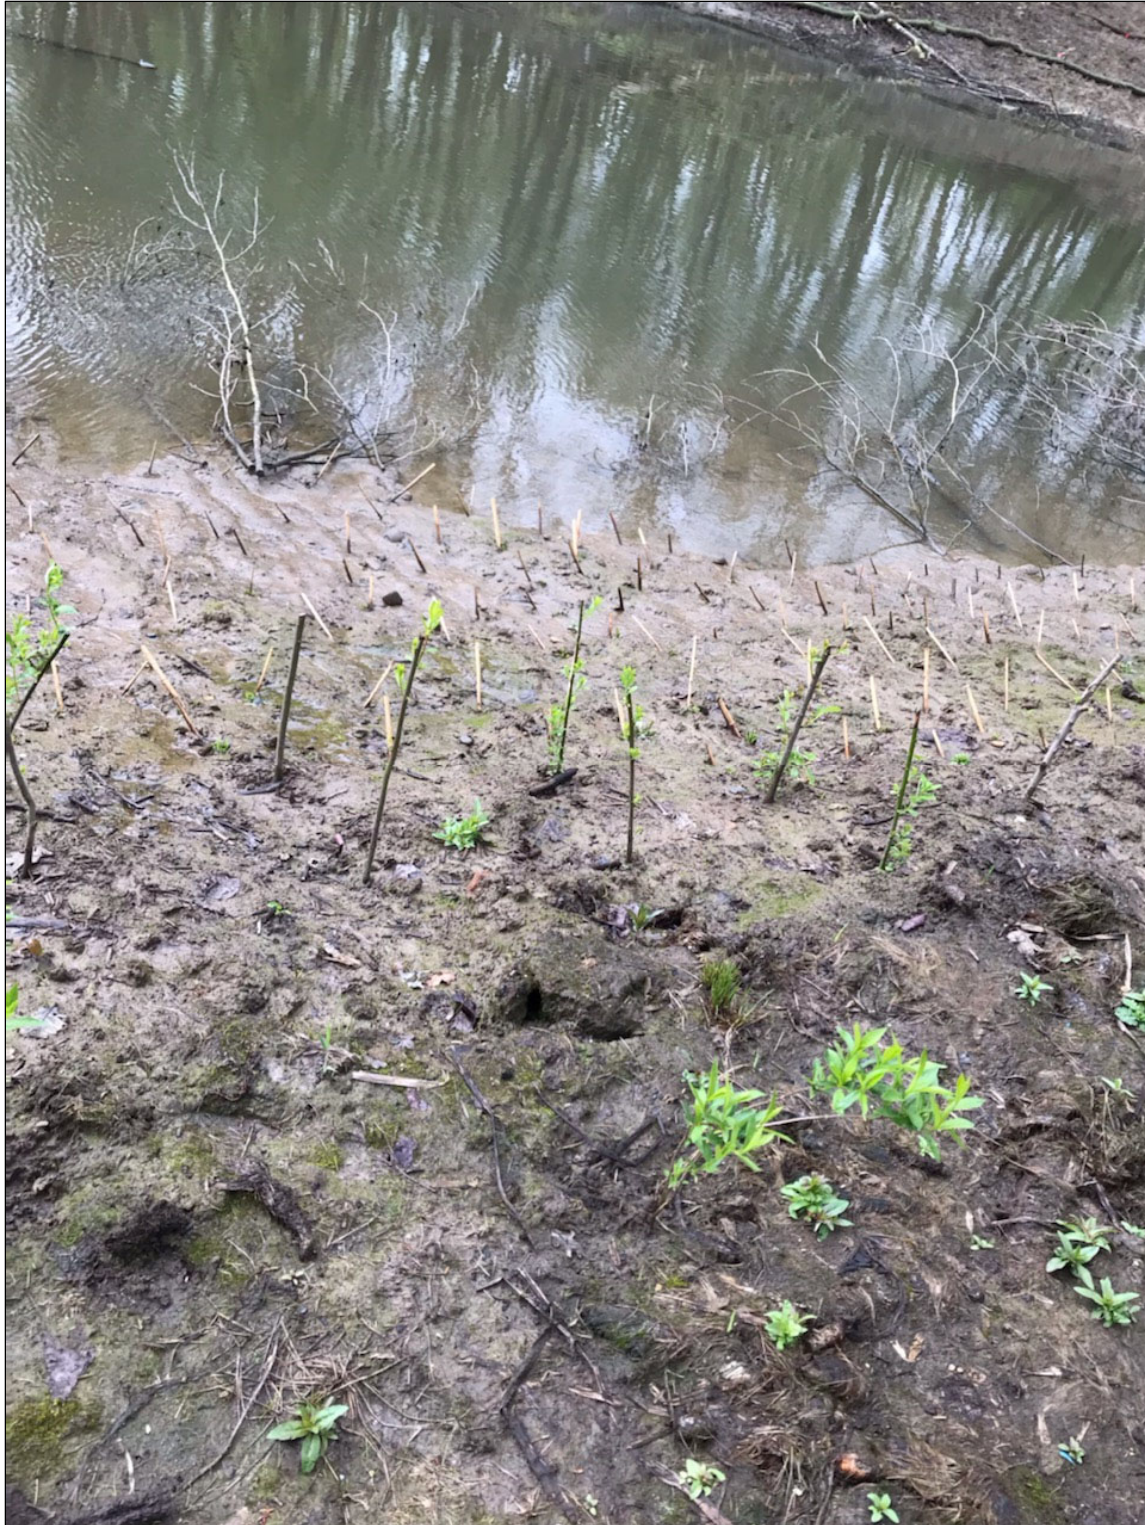
Figure 3 Spring 2019 photograph showing Phase II plantings with signs of new leaf formation and browse effects.

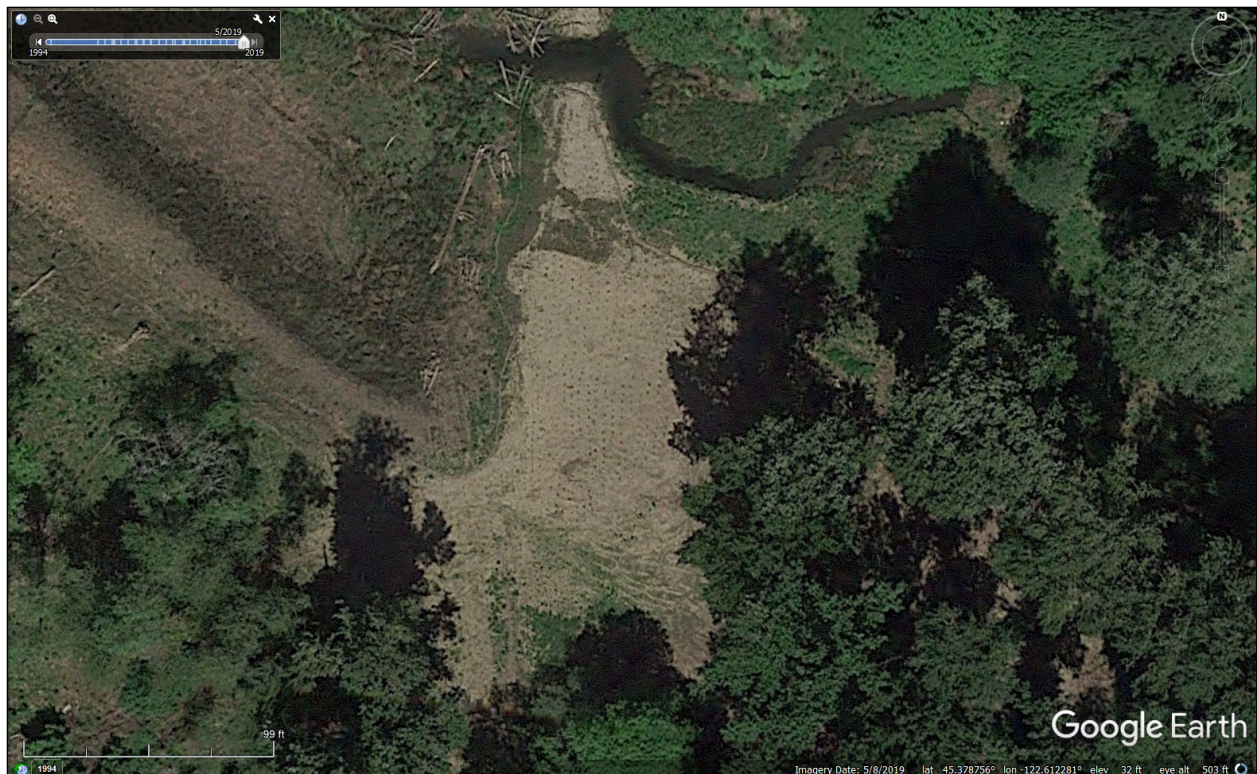
Figure 4 Closer view of 2017 plantings as visible in the May 8, 2019, Google Earth aerial of the Rinearson Natural Area. The 2017 plantings are visible as rows of dots in the beige area and were sprayed and hand weeded in 2019 for invasive species control.

Figure 4 shows a closer view of one area that was planted in 2017 and received hand weeding and spray treatments for invasive species control in 2019.

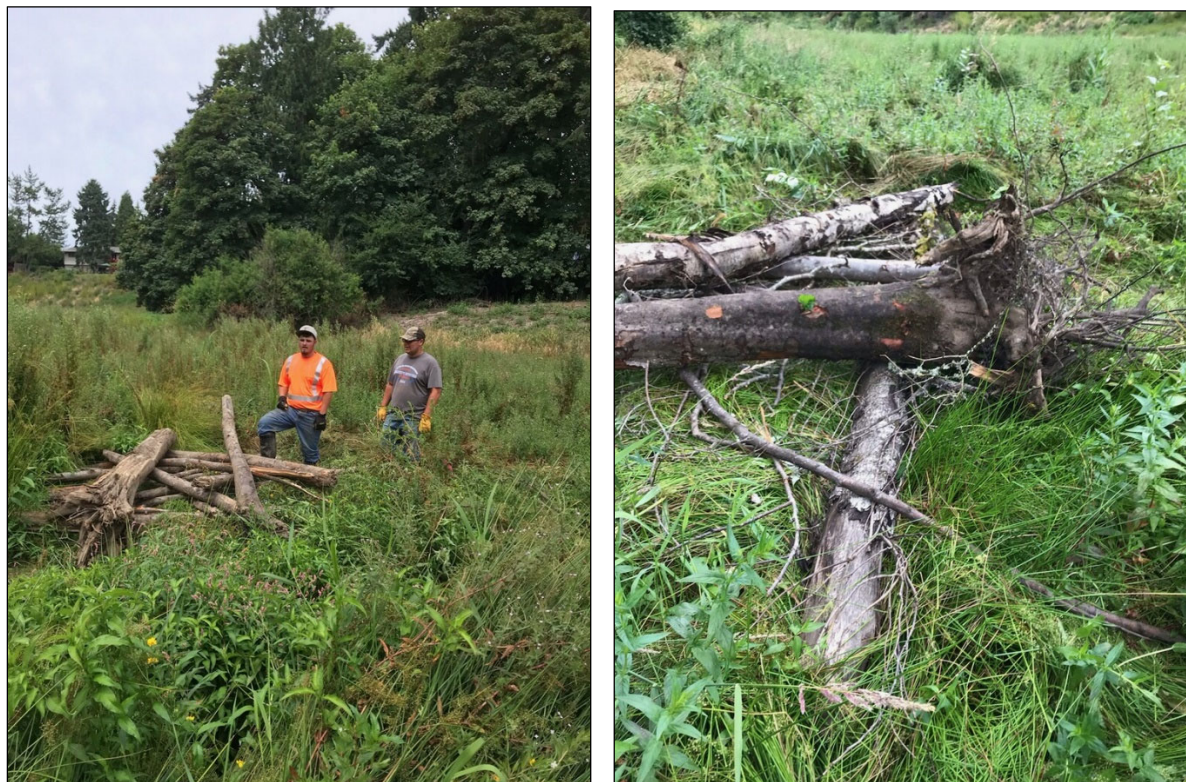
In 2019, log structures were maintained by hand as described in the Log (Appendix A). Beavers had eaten and removed the vertical log members that functioned as ties. Beavers used those “ties” to construct dams at the site. Figure 5 shows the log structures with verticals gone prior to 2019 maintenance. In October of 2019, crew members re-installed vertical log pieces by hand using post pounders. Results of the maintenance effort are shown in Figure 6, with new crossing vertical “tie” logs brightly colored and freshly purchased. During 2019 maintenance, all log structures were located per the original intent of their design as documented in Appendix C (2018 Log Structure Engineering Plans).

Figure 5 Log structures in 2019 prior to maintenance activities.

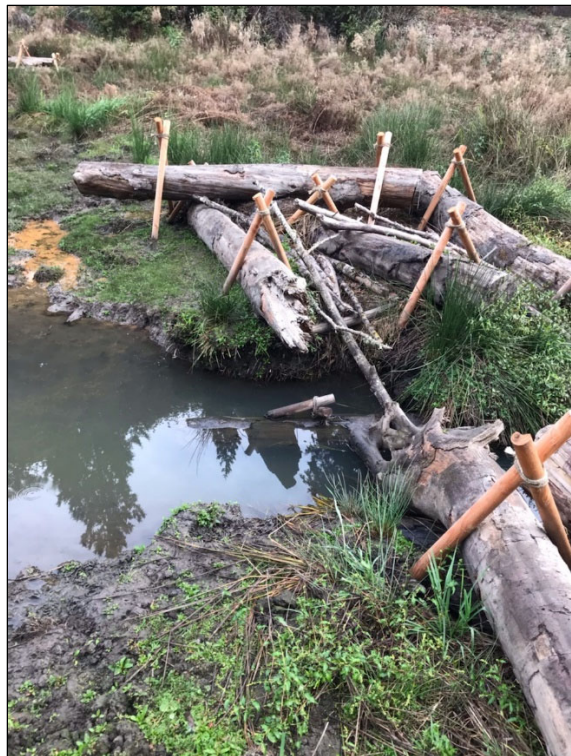
Figure 6 Log structures with completed maintenance showing new “ties” and crossing vertical logs brightly colored and freshly purchased. The new vertical members were installed by hand to avoid impacts to the wetland.

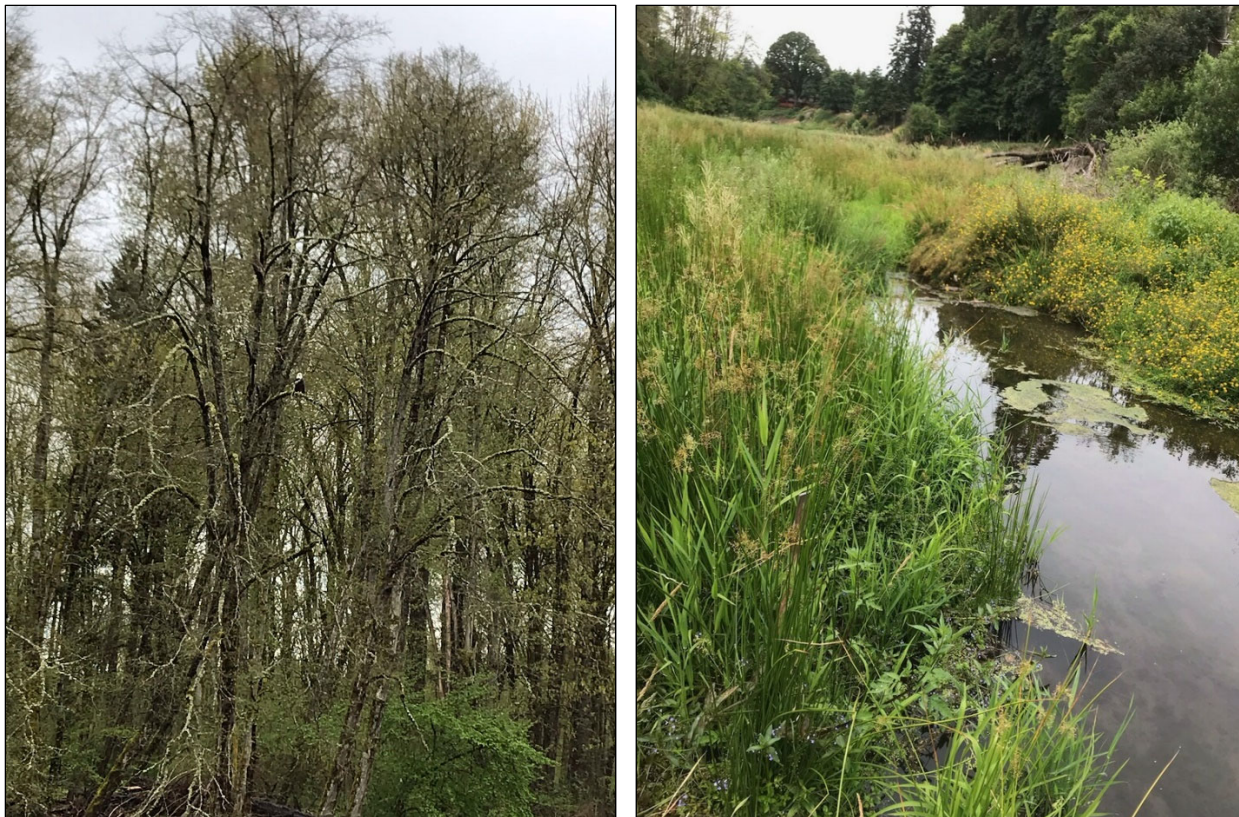
Figure 7 Photograph at left showing one of many examples of documented use of the Rinearson Natural Area by bald eagles in 2019. Photograph at right taken in August 2019 showing a beaver dam at the upper end of the project near the upstream most constructed log structures. As of June 17, 2020, this dam still exists as do several others.

The Sponsor has agreed with The Trustees Council not to disturb beaver dams in any way and to observe the site for any changes to beaver dam locations by private landowners or others. The Sponsor plans to remove and dispose of any remaining erosion control netting.

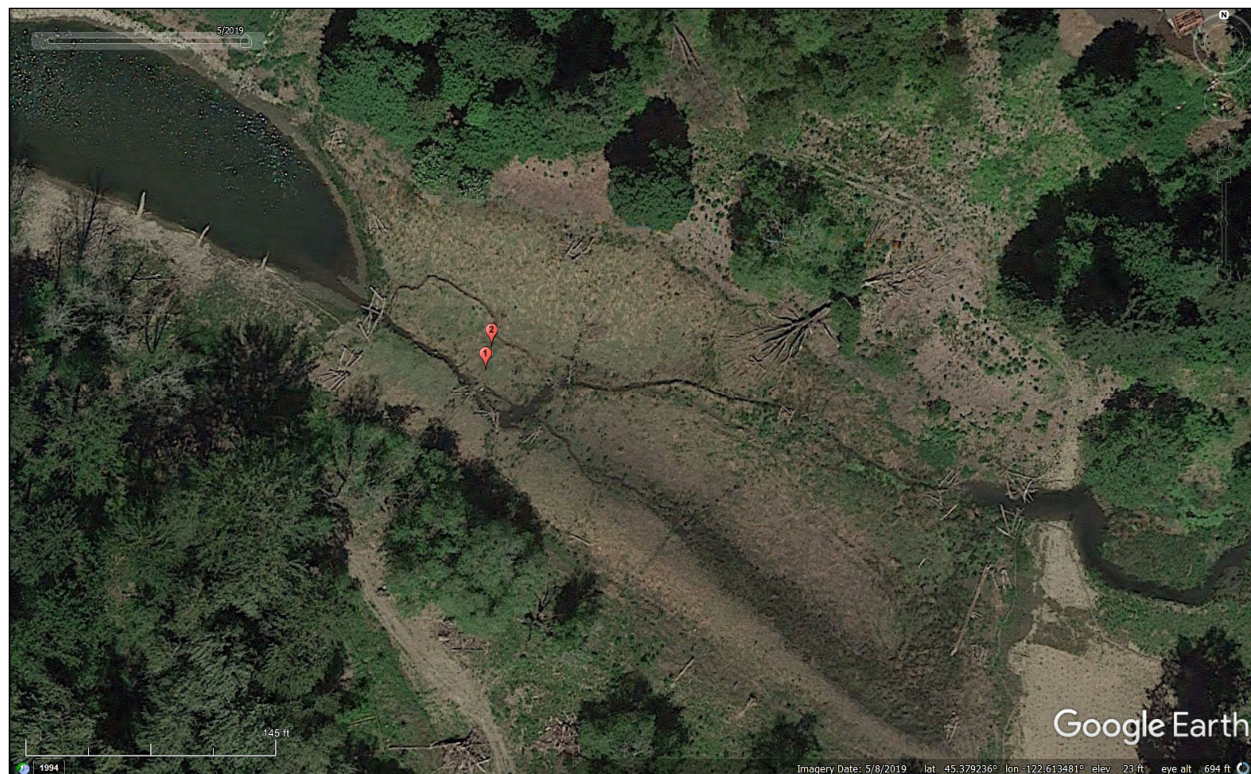
Headcuts were monitored at the Rinearson site on July 17, 2019, and again on April 3, 2020. Figure 8 shows the locations of both headcut monitoring efforts as originally reported to Lauren Senkyr of the National Oceanic and Atmospheric Administration (NOAA) Federal for both of those dates. The headcuts had no movement horizontally over these 2 years. Original headcut monitoring efforts were communicated per Appendix D (Headcut Documents). Both headcuts (#1 and #2) decreased in height. As of May 2020, the original channel that had formed the headcuts had dispersed flow across the entire width of the large pond due to beaver activity. Hence, the headcuts have partially filled with sediment and, most likely, will continue to do so.

Figure 8 Locations of headcuts #1 and #2 did not change from July 17, 2019, to April 3, 2020. Their vertical height was reduced in size.

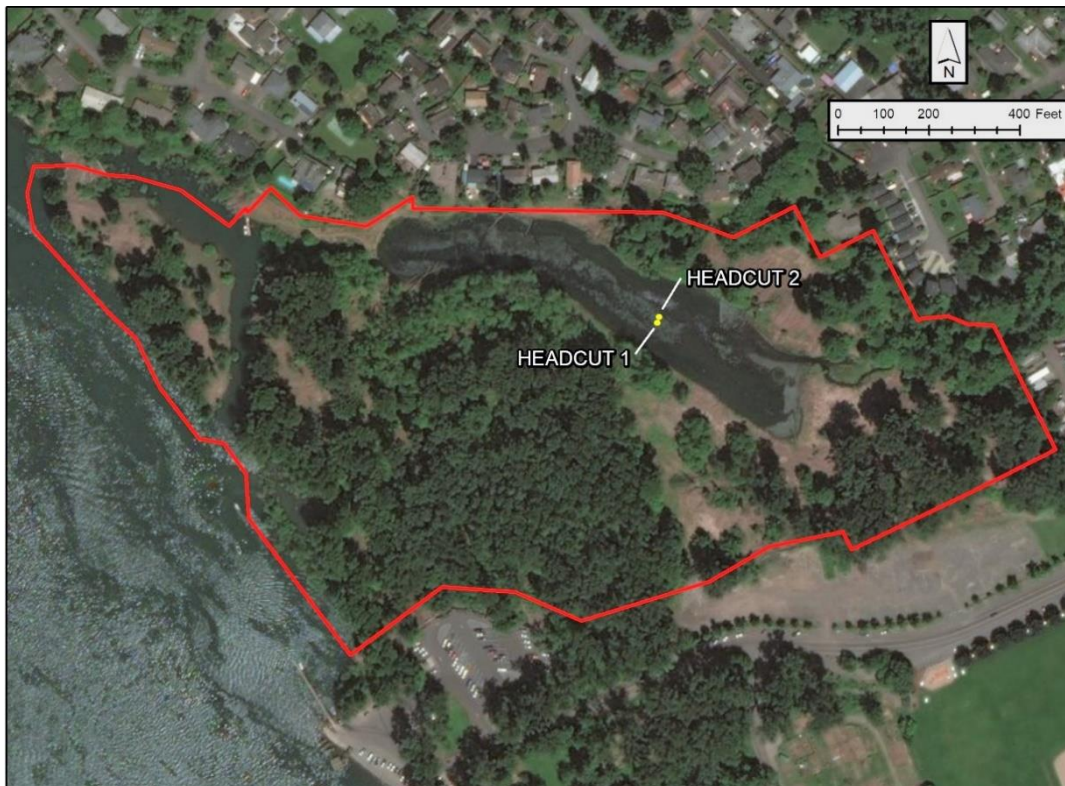
Rinearson Project
Current location of Headcuts 1 and 2 as of July 17, 2019. Please see coordinates, and headcuts height below.

Headcut #1
45° 22' 46.13" N
122° 36' 49.14 W
18 inches in Height

Headcut #2
45° 22' 46.27" N
122° 36' 49.09" W
14 inches in Height

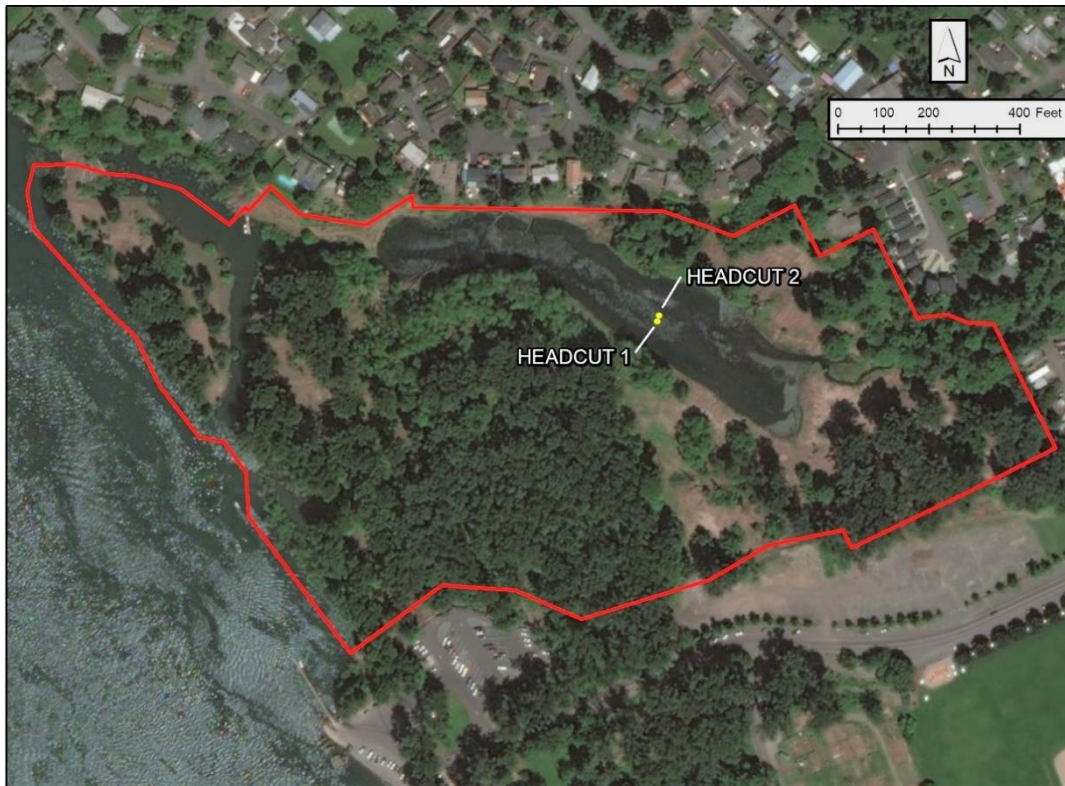
Rinearson Project
Current location of Headcuts 1 and 2 as of April 3, 2020. Please see coordinates, and headcut height below.

Headcut #1
45° 22' 46.13" N
122° 36' 49.14 W
14 inches in Height

Headcut #2
45° 22' 46.27" N
122° 36' 49.09" W
9 inches in Height
