2020 Rinearson Monitoring Annual Report

Rinearson Natural Area

December 2020

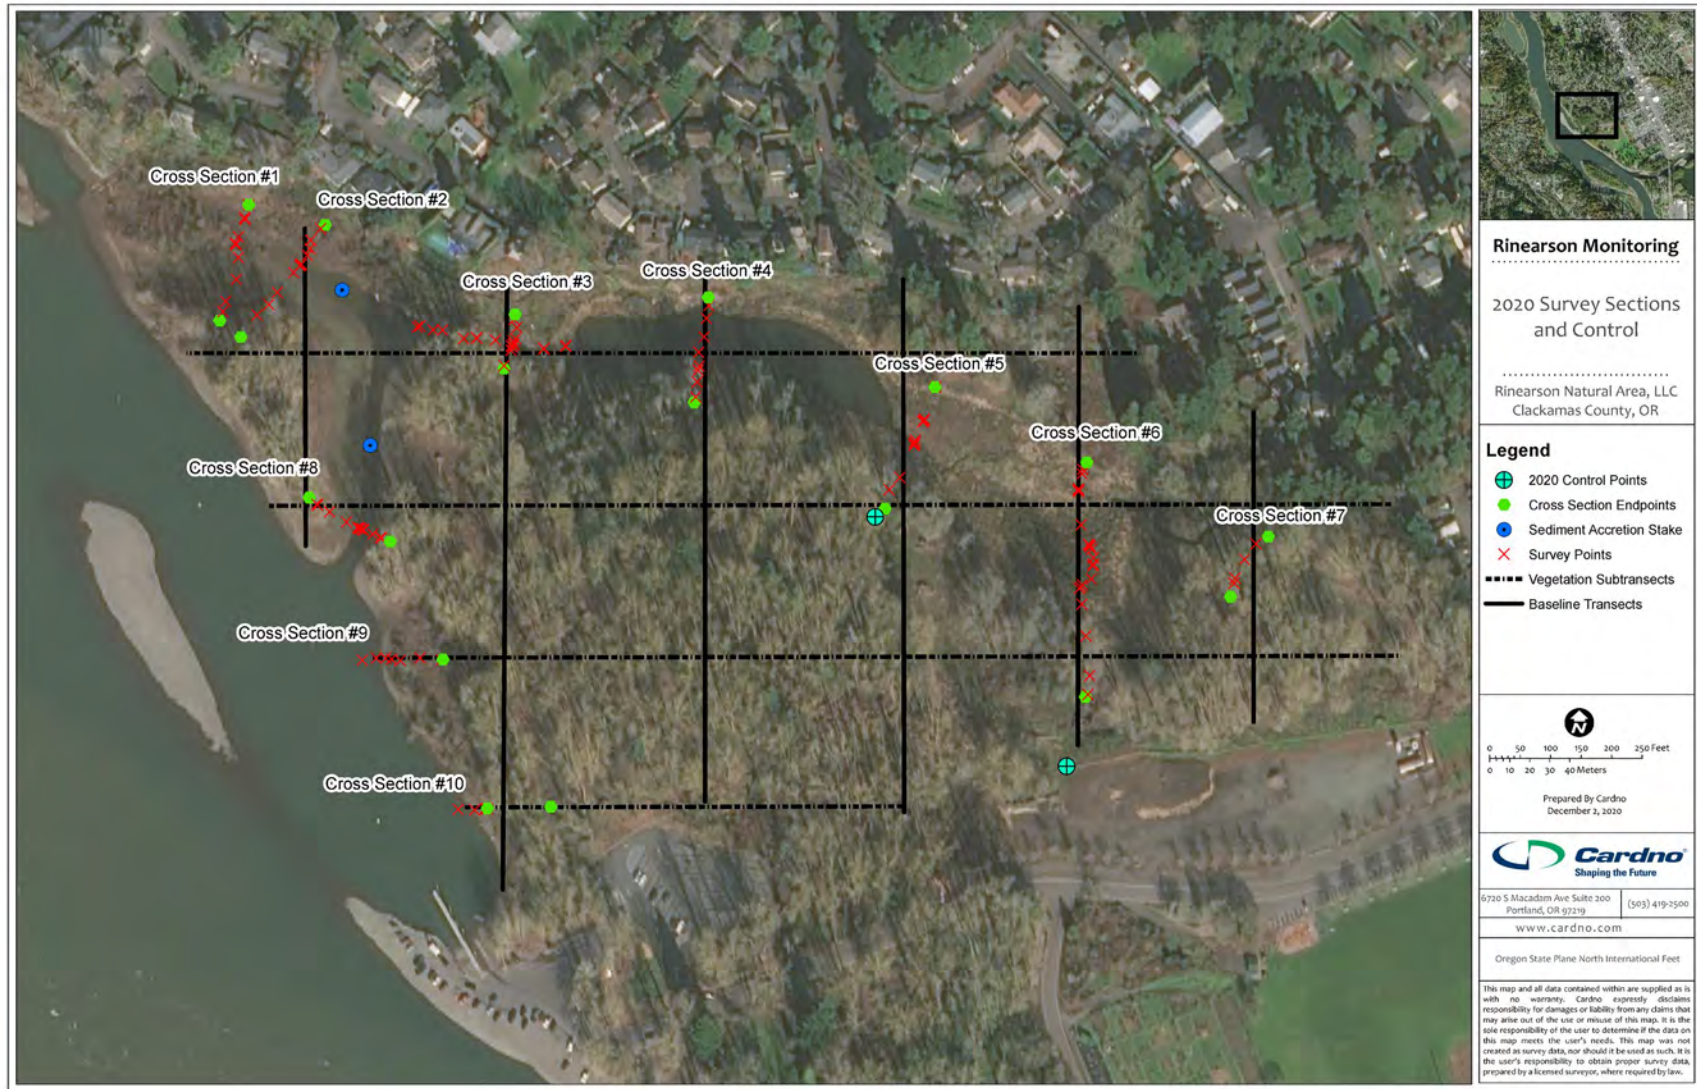
Figure 1-1 Transect and Cross Section Locations, Endpoints, and Survey Points

Cardno staff established two control points during the channel cross-section survey to ensure cross section endpoints could be found and re-occupied in subsequent sampling years (see Figure 1-1). These control points were established using survey-grade RTK GPS equipment that was post-processed using the National Oceanic and Atmospheric Administration’s online positioning user service. Control points were marked with capped rebar, stakes, and flags and positioned in open and easily accessible locations (Table 1-1).

As specified in the Rinearson HDP, sediment accretion stakes were installed in the historical Rinearson Creek and the Meldrum Bar channels (see Figure 1-1). The sediment accretion stakes were marked 2 feet above bed elevation to assist in monitoring future sediment accretion. Cardno staff observed some accretion, mostly fine sediment, in the historical Rinearson Creek channel while surveying cross sections 1 and 2. Approximately 3 inches of sand deposition was observed on river left of Meldrum Bar channel while surveying cross section 8. The roughened channel appeared to have 4 to 6 inches of fine sediment deposited at the connection to the Meldrum Bar channel (see Figure 2-1a), and an insubstantial amount of fine sediment deposition was observed during the survey of cross-section 3.

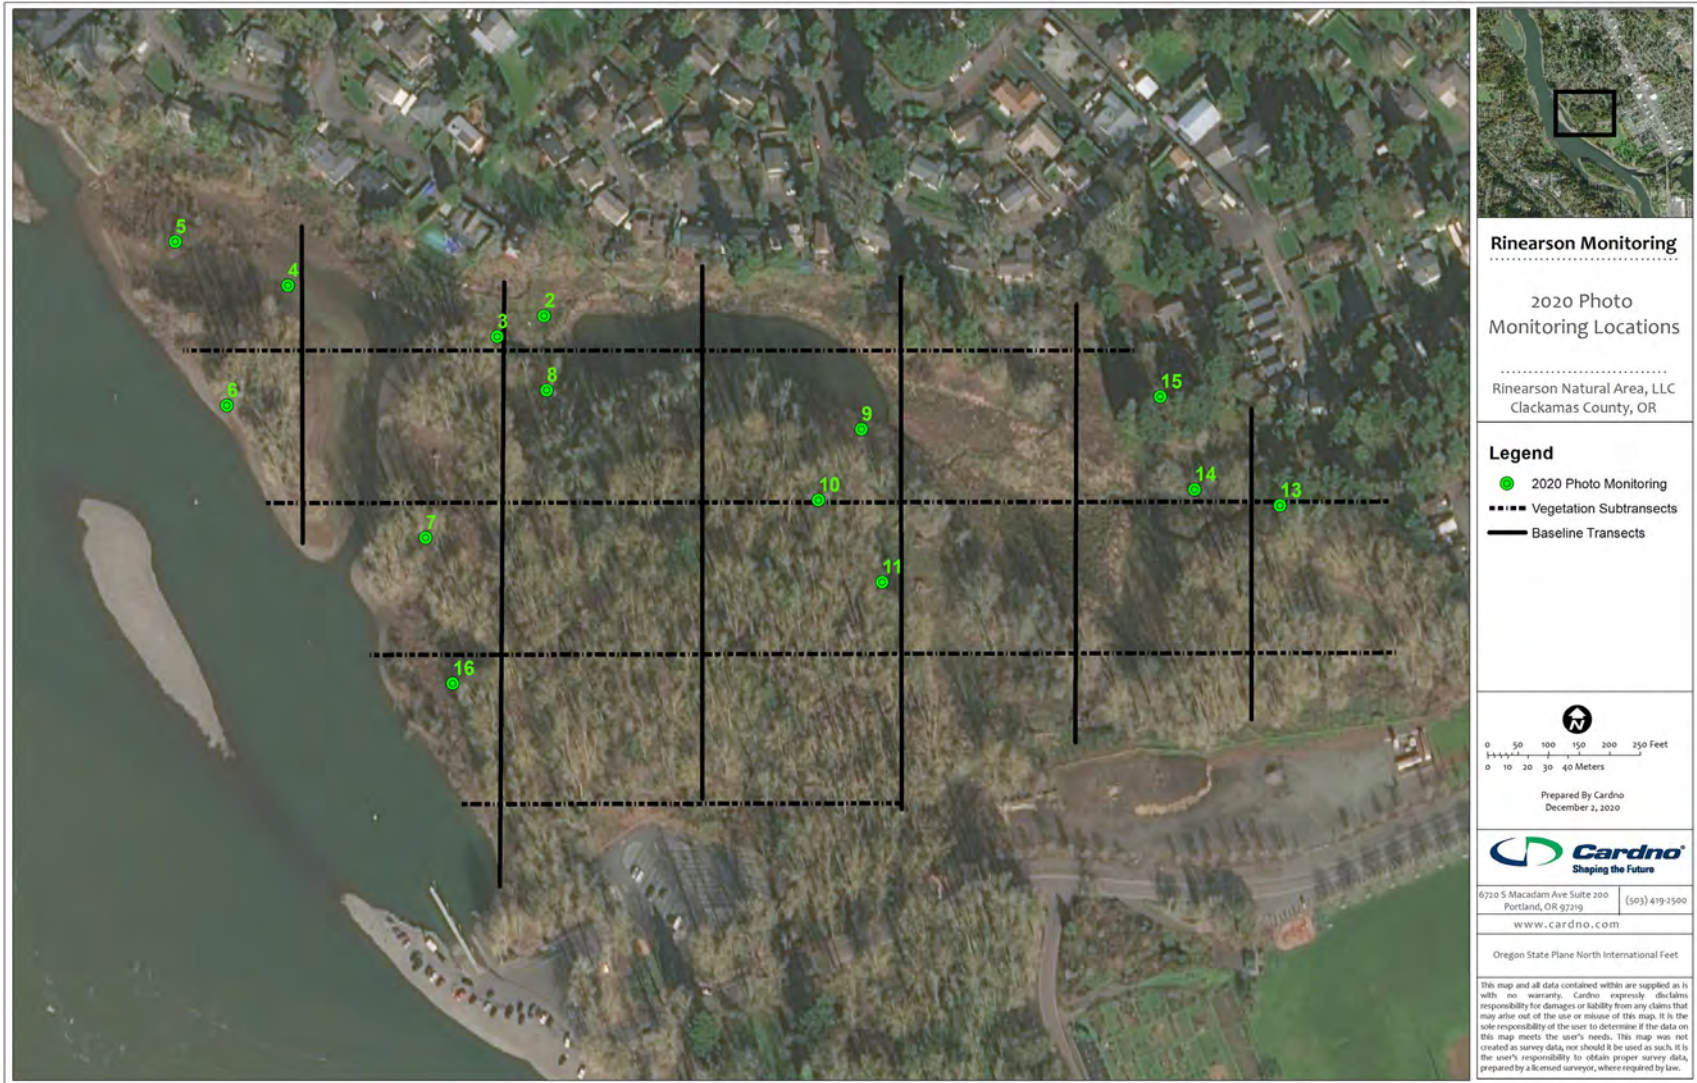
Figure 1-2 Photo Monitoring Locations

The Rinearson HDP required the establishment of permanent photo monitoring locations during the as-built survey using capped PVC pipe. However, like the transect endpoints, it seemed that no physical photo monitoring locations had been established prior to the 2020 field efforts. Consequently, Cardno reoccupied the approximate photo points used during baseline monitoring in 2016 (Runyon 2016) (Figure 1-2). These locations were occupied using recreation-grade GPS equipment, and photos were taken to monitor vegetation community development. Additional photos were taken at each vegetation quadrat sample location (Figure 3-1 below) and of relevant design elements during other field efforts (see Appendix A).

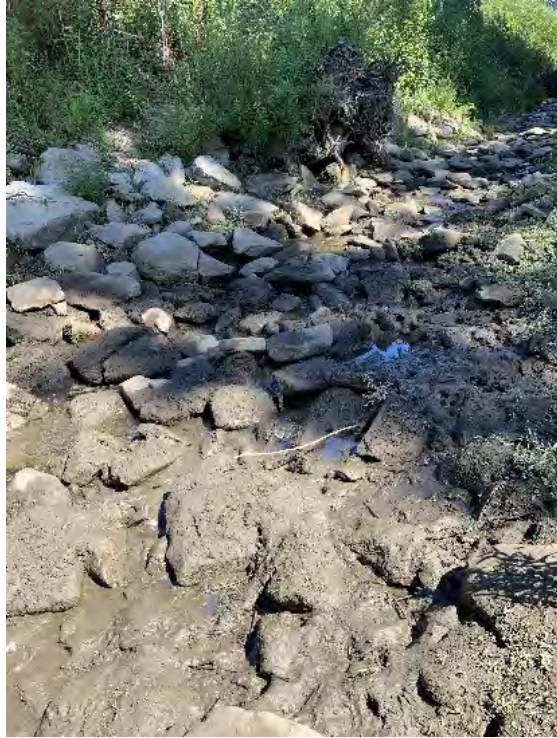
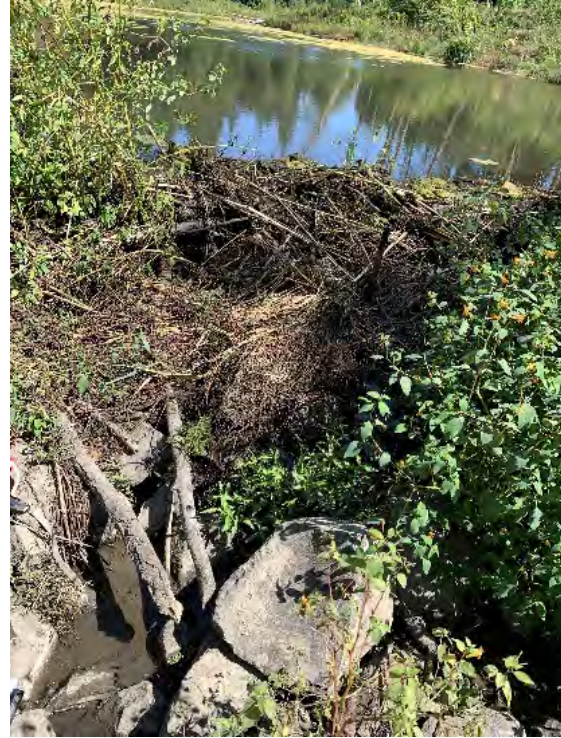
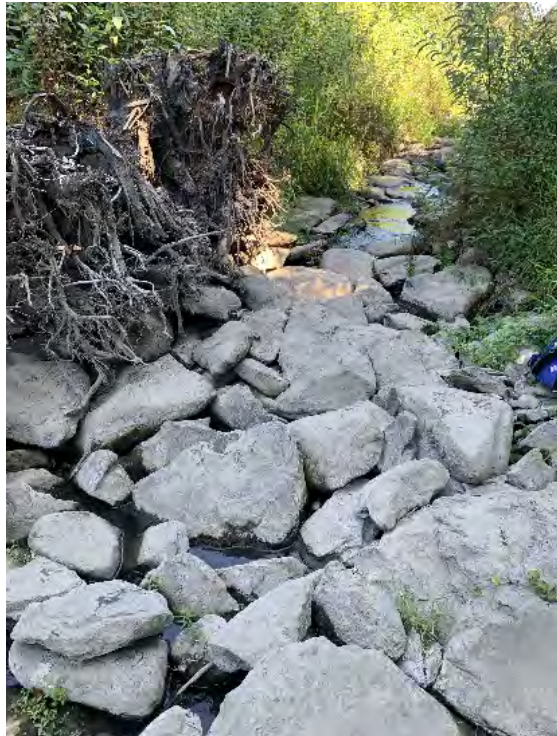
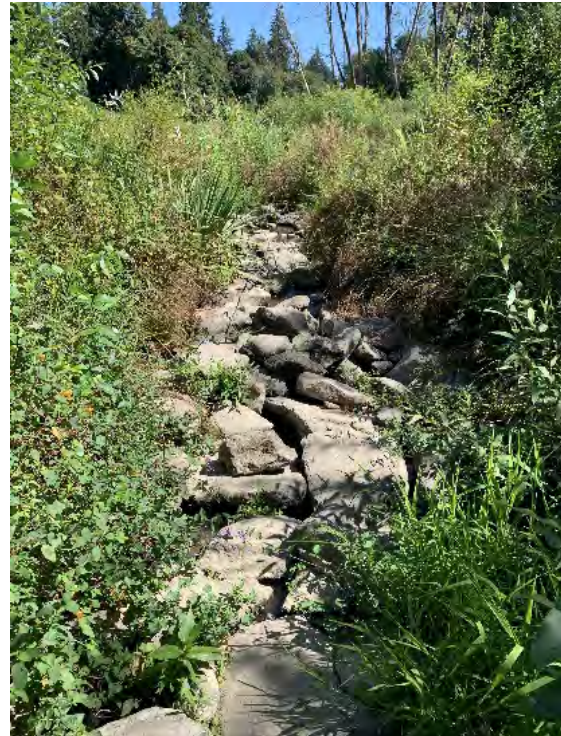
Figure 2-1 **Photos of Engineered Channel August 2020**

a. Connection to Meldrum Bar Channel

b. Pond Outlet

c. Impassable Section 1

d. Impassable Section 2

Cardno staff determined that the engineered channel was impassable for fish in August 2020 because (1) the fish jump height exceeded the limit by approximately 13 inches, (2) there was no clear jump pool at the pond outlet, and (3) the roughened channel had low water availability and was blocked by boulders in multiple locations. Cardno recommends adaptive management actions to address these fish passage limitations if and only if passage in late summer were deemed essential. High summer pond temperatures may be a factor, refer to subsequent water quality section.

As specified in the Rinearson HDP, survey-grade RTK GPS equipment was used to measure the water surface elevation (WSE) at the upstream and downstream ends of the engineered channel. During the 2020 survey, the engineered channel had an upstream WSE of 16.6 feet North American Vertical Datum of 1988 (NAVD88) and a downstream WSE of 9.3 feet NAVD88 (see Figure 2-2). The distance between these two WSE points was 242.9 feet; therefore, the WSE slope of the engineered channel was measured to be approximately 0.03 or 3 percent. The Rinearson HDP states that water availability would be assessed visually by observing the wetted area in the channel and the discharge over the pond outlet. During the 2020 survey, water discharge over the pond outlet was limited (see Figure 2-1b), and the wetted area within the engineered channel was inadequate for fish passage. Cardno staff observed that fish passage was obstructed by an excessive number of channel roughening boulders, which were stacked on top of one another in multiple sections of the engineered channel (see Figure 2-1c,d). This obstruction created a subsurface flow path for the creek where water went underneath and through the stacked rocks, eliminating the only viable pathway for fish ingress. Cardno staff believes this issue could be resolved if some of the roughening boulders were moved by hand to the outside extents of the channel and were re-configured to create a narrow low-flow thalweg that is not obstructed by stacked rocks.

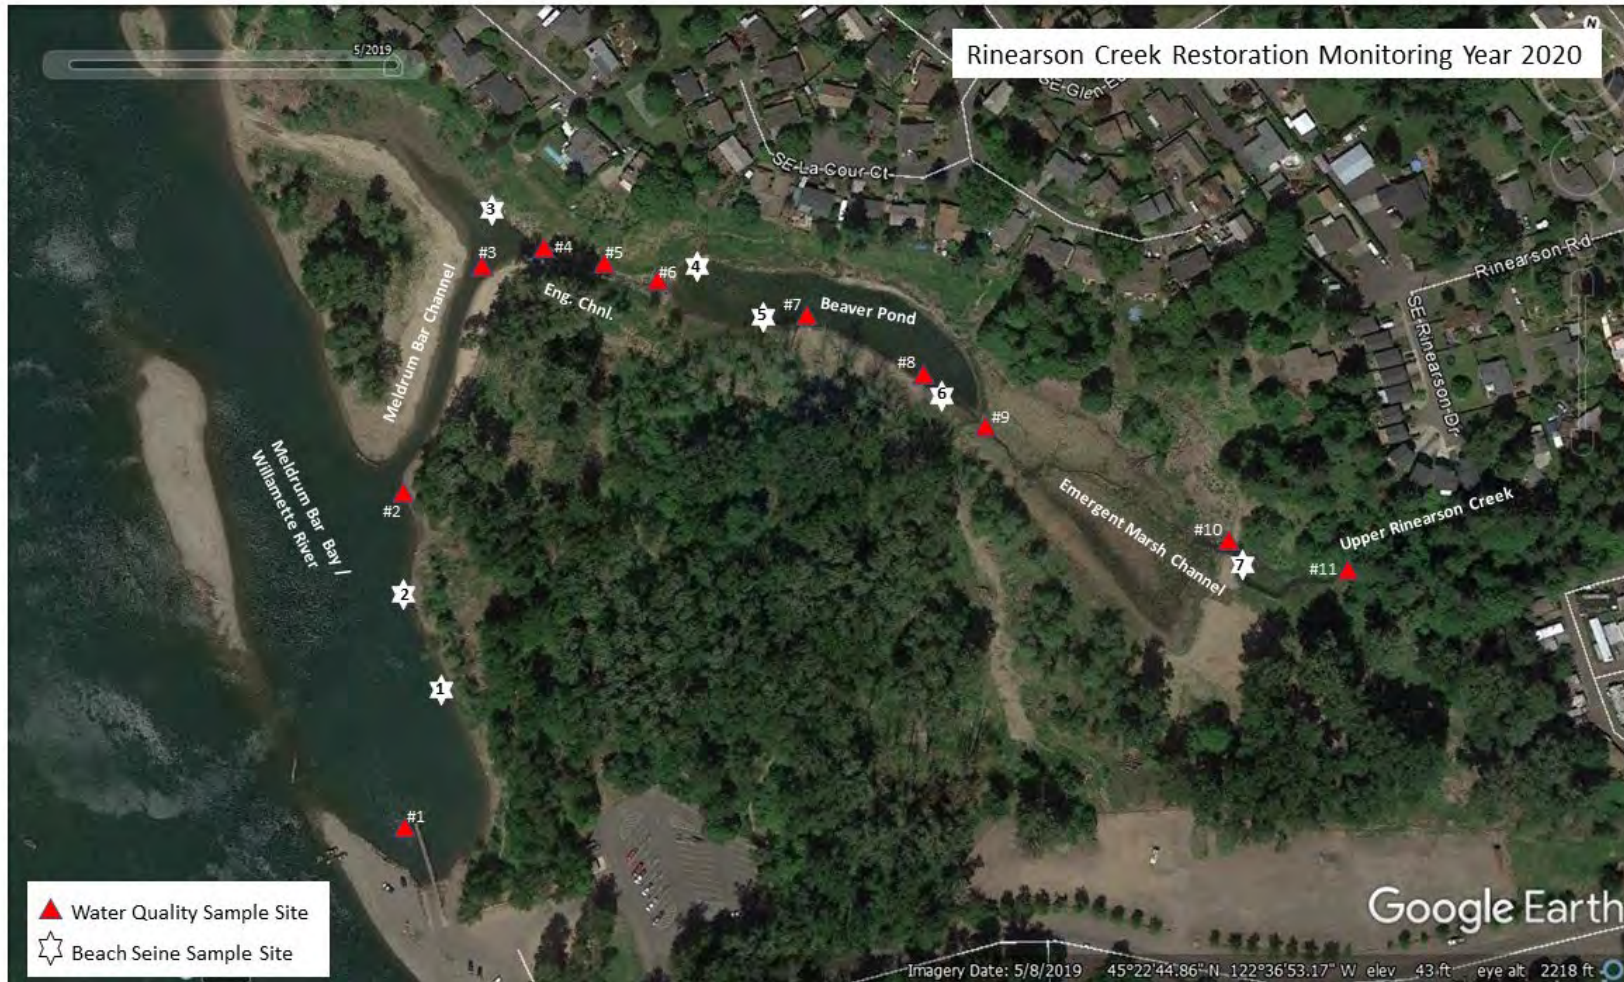
Figure 4-1 Approximate Sample Site Locations for Water Quality Monitoring and Fish Beach Seine Sampling for the Rinearson Creek Restoration Monitoring Plan, Year 2020

Over six sample-day events between February and May, a total of 27 beach seine hauls were conducted throughout the seven established seine sites (Table 4-1) (see Figure 4-1). In total, 14 different species of fish were captured, of which 10 fish species were native to the region and the remaining 4 fish species introduced, non-native species (Table 4-2). Besides fish species, signal crayfish and one non-native American bull frog were also identified in seine haul captures. A grand total of 366 fish were captured using beach seine methods with approximately half of all fish captured composed of juvenile Chinook salmon, an ESA-listed species (Table 4-3). Juvenile Chinook salmon were captured in the Meldrum Bar Channel (BSS 2) and in the beaver pond near the pond outlet (BSS 4) with approximately 95 percent of all Chinook captured during March and April sample days. Considering the additional ESA-listed species caught, 1 juvenile coho salmon was captured during February sampling in the beaver pond (BSS 4). In order of total abundance caught, following Chinook salmon, threespine stickleback, juvenile bluegill (non-native) and juvenile northern pikeminnow were the most abundant in total fish caught (Table 4-3). Summary statistics for size of fish captured are presented in Table 4-4 with common carp (non-native species) being the largest fish captured in all beach seine samples. While further examination of fish life history traits is warranted, captured species, such as salmonids, bluegill and northern pikeminnow, were all juveniles, whereas sculpin, speckled dace and threespine stickleback were likely a combination of both juveniles and adults.

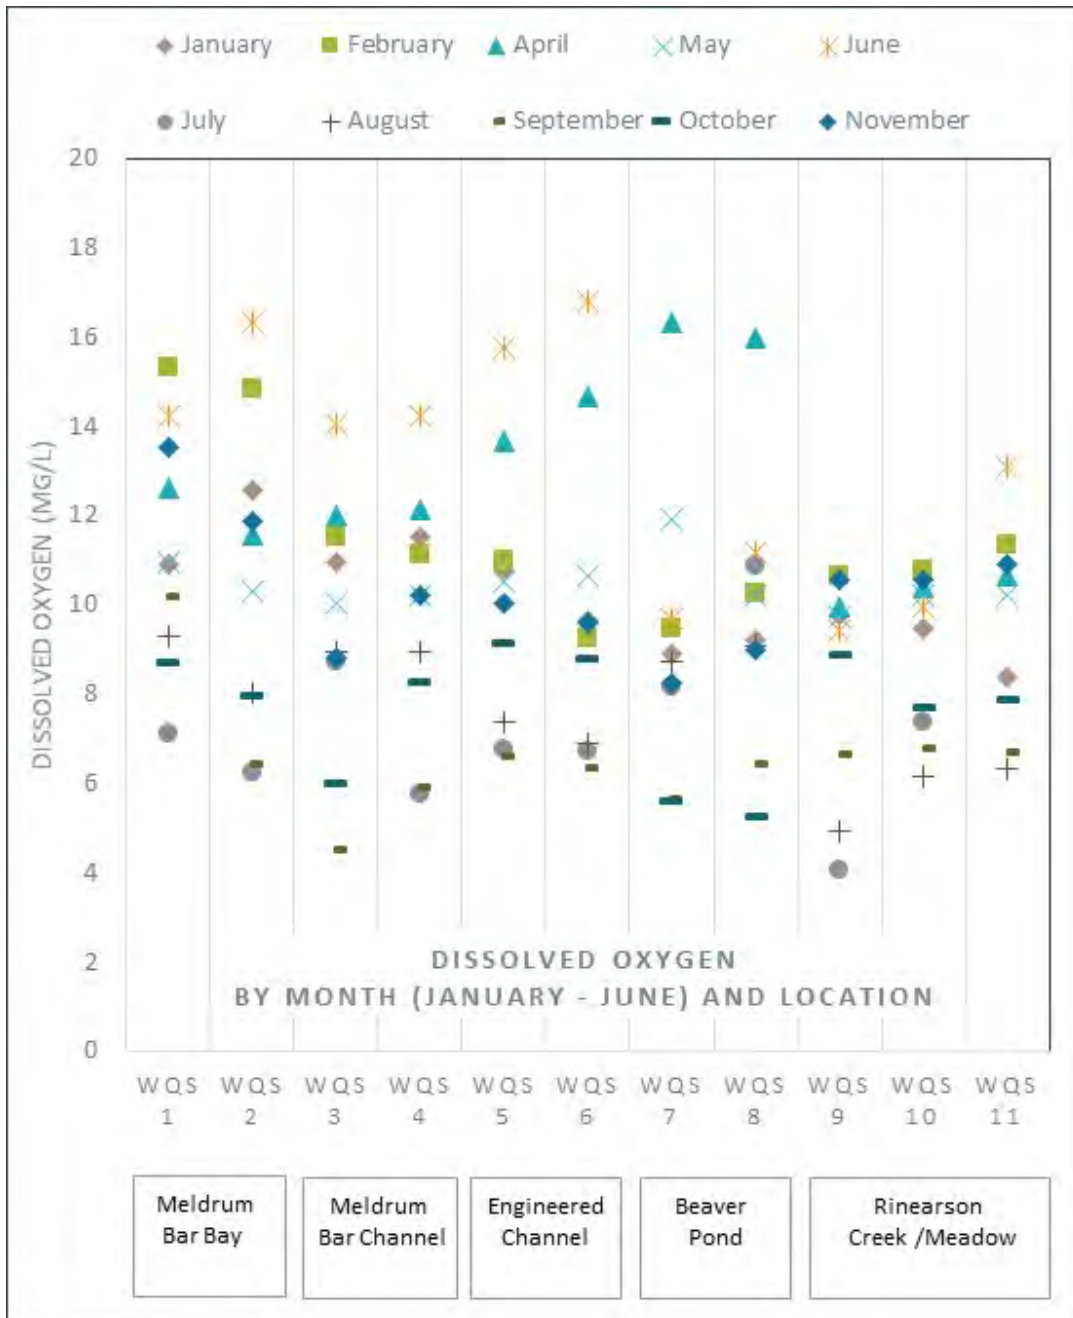
Figure 5-3 Field Meter Recordings for Water Dissolved Oxygen (DO mg/L) by Month and Water Quality Station, Year 2020

Monthly field readings for dissolved oxygen (DO milligrams per liter [mg/L]) show considerable variability between both months and sample sites (Figure 5-3). In general and overall, typical DO values ranged from 8 to 12 mg/L, although peak DO values were observed as high as ~17 mg/L in June and as low as 4 mg/L in July. General trends in low DO readings (typically less than 8 DO mg/L) occurred from July through October, whereas DO readings often exceeded 12 mg/L occurred in April and June. Collectively, DO readings across the year showed less variability (between sites) in the meadow wetland portion of the study area (WQS 9 through WQS 11).

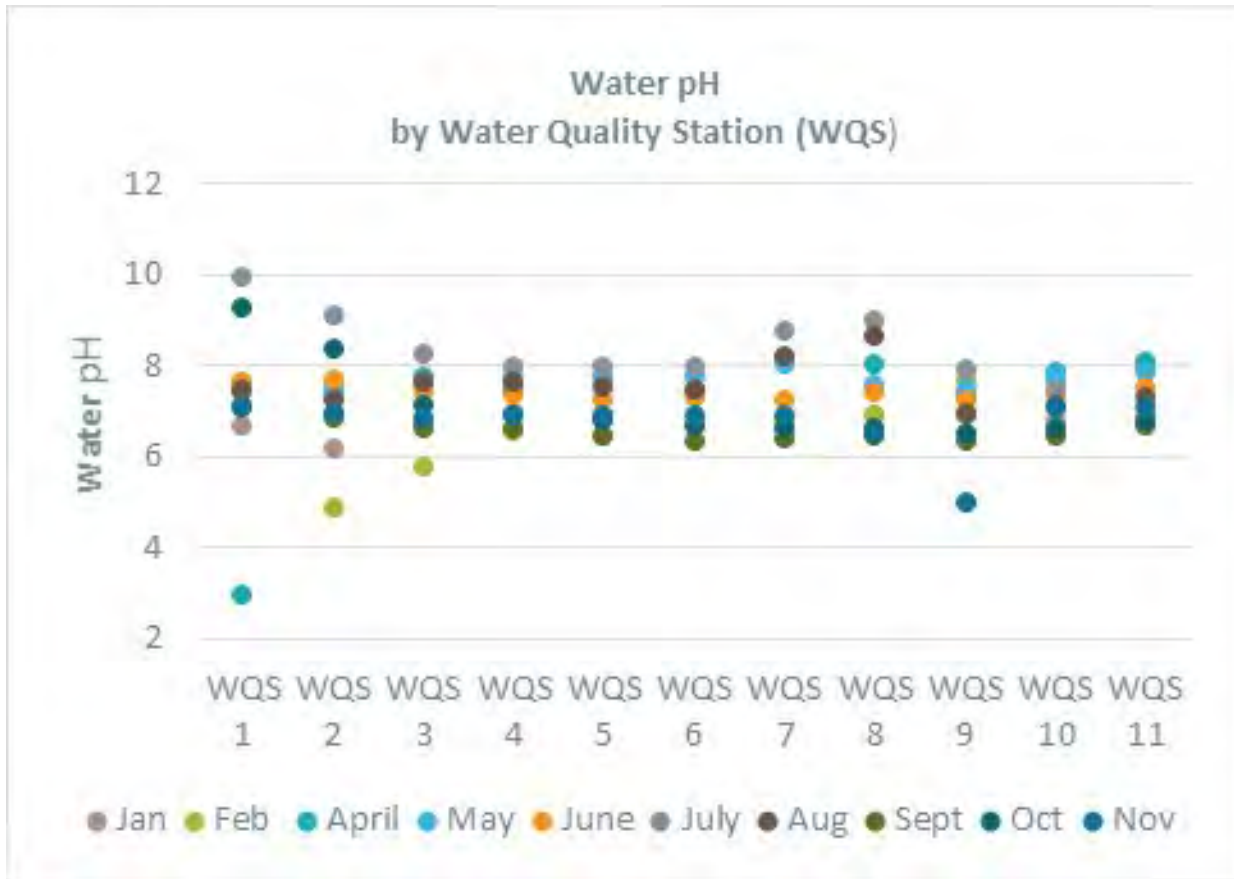
Figure 5-4 Field Meter Recordings for Water pH Respective of Month and Water Quality Station, Year 2020

Monthly field readings for water pH were relatively consistent between months and sample site. The majority of recorded water pH readings ranged between a pH of 6 to 8 (Figure 5-4) with the highest water pH of 10 and lowest pH of 3 both observed at WQS 1, the Meldrum Bar boat launch (i.e., Willamette River).. Water pH recordings at this site may be influenced by human waste and hydrocarbons associated with motorized watercraft use.

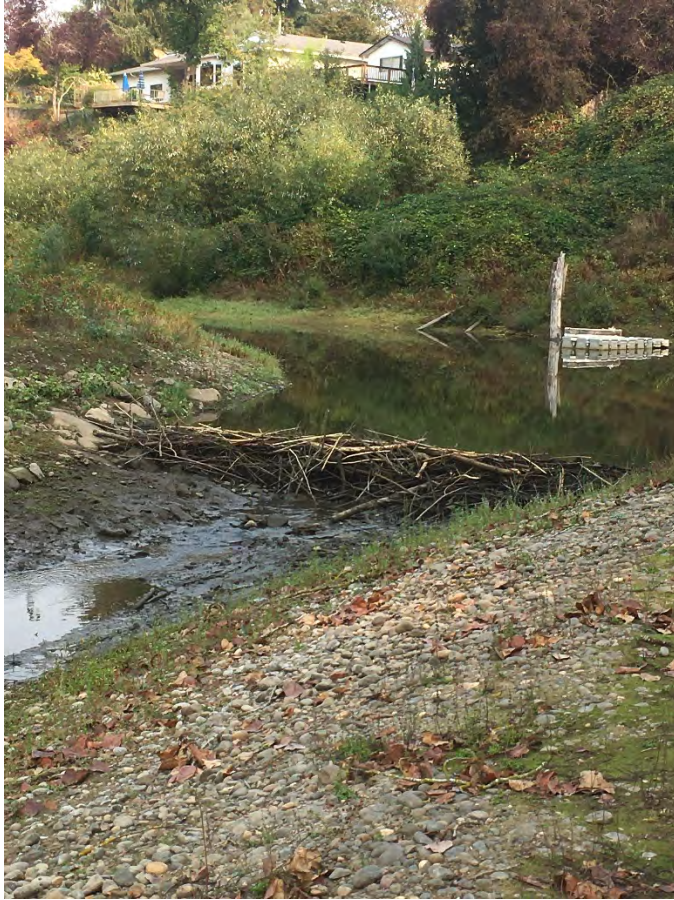
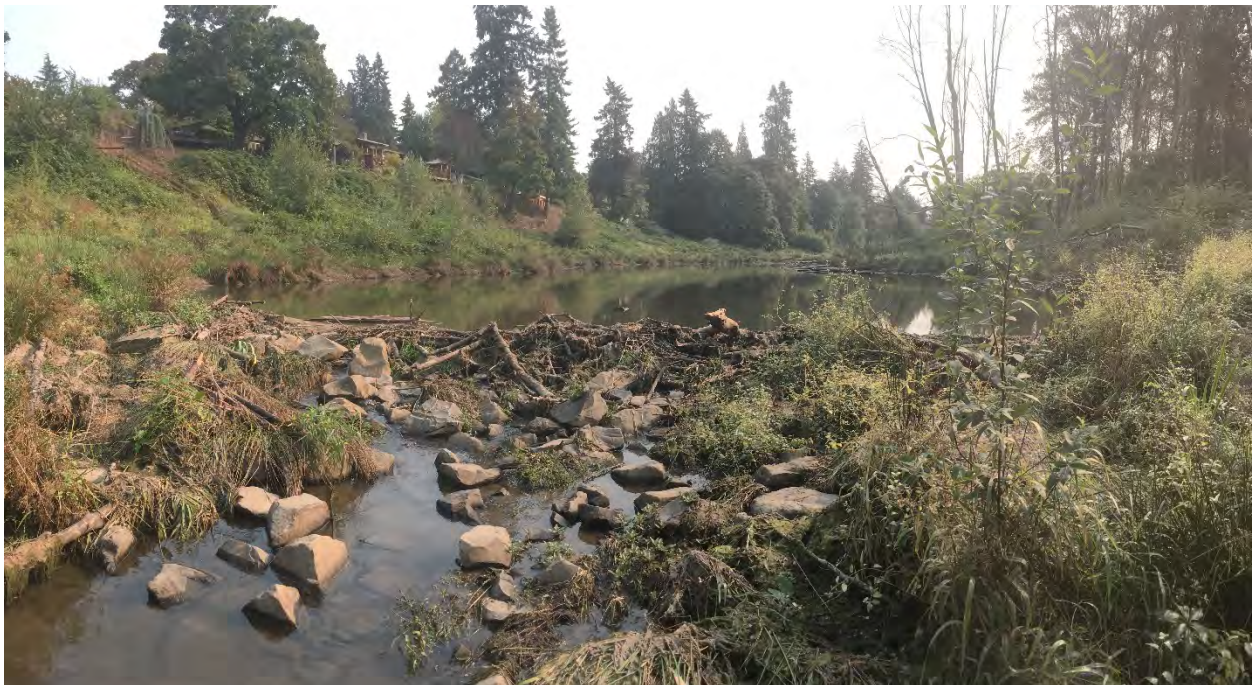
**Beaver Dam at Top of Meldrum Bar Channel and Beaver Dam as Part of the Large Pond Complex
in Rinearson Natural Area**

Photos taken October 1, 2020.
