# Alder Creek Restoration Project

## 2020 Monitoring Report Year 5

Wildlands PNW  
Portland Harbor Holdings II, LLC  
Contact: Julie Mentzer  
503-241-4895

February 2021  
Revised June 2021

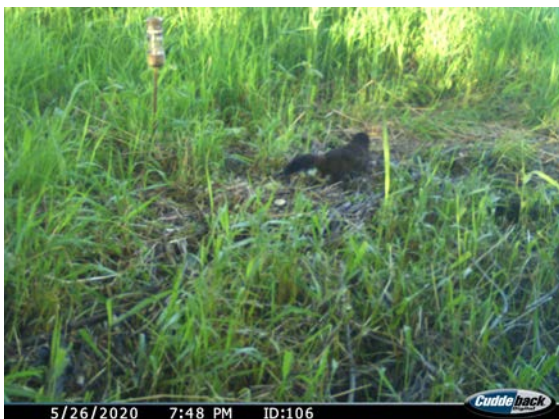
Mink surveys through camera trapping were conducted from April 26 through August 25, 2020. A photo of a mink was captured by Camera 1 on May 26 (see photo below). No mink were observed at the other two camera trapping locations during the survey period. Additionally, during an eagle survey on July 13, a biologist from Turnstone Environmental observed mink tracks along the shoreline. Other wildlife species included black-tailed deer (*Odocoileus hemionus*), racoon (*Procyon lotor*), brush rabbit (*Sylvilagus bachmani*), great egret (*Ardea alba*), Western Canada goose (*Branta canadensis*) and coyote (*Canis latrans*). Mink surveys will continue in Year 7 (2022).

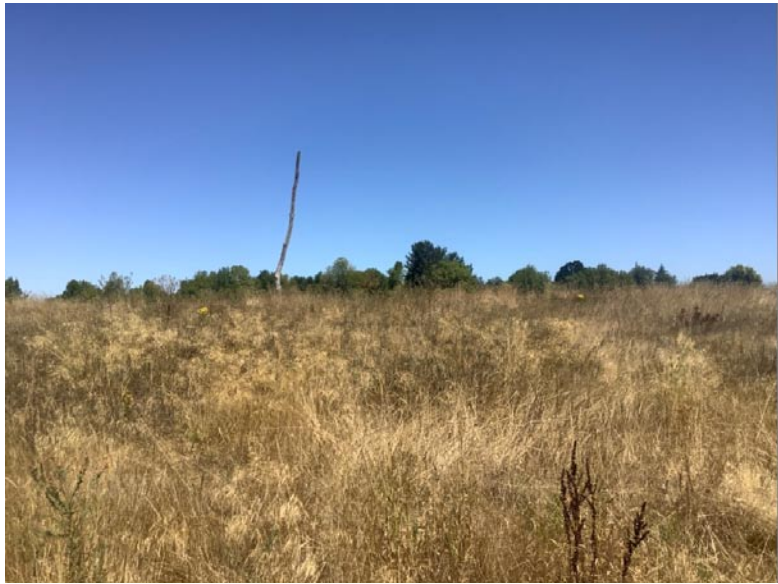
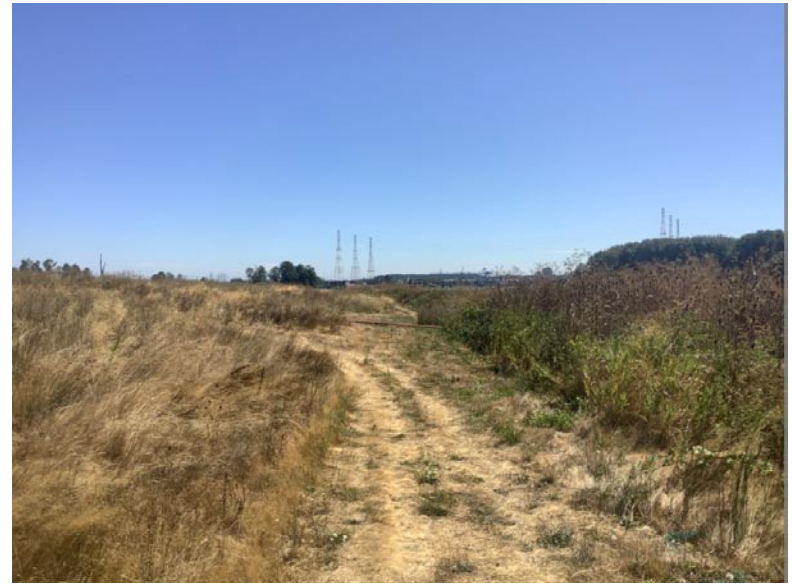
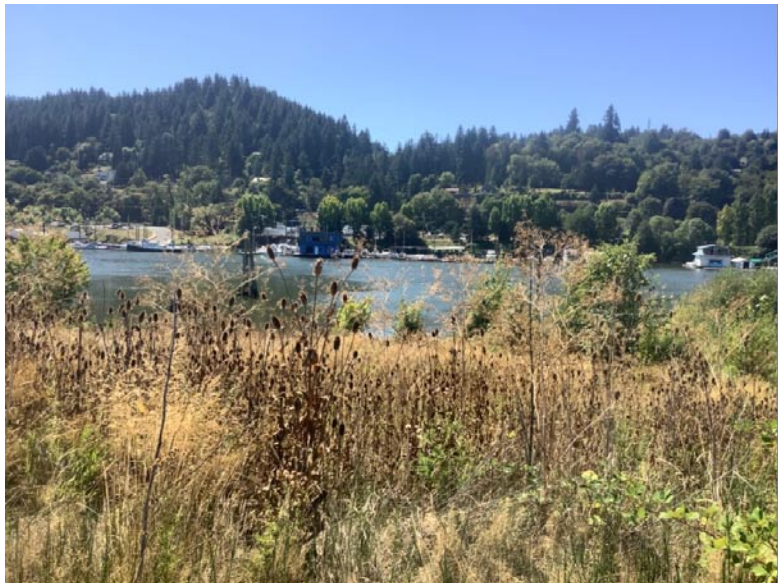
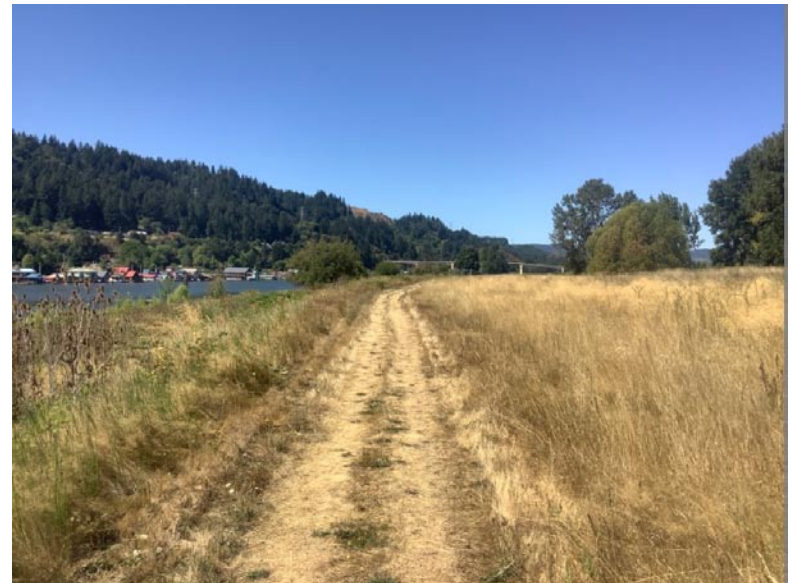
Figure 5a  
 Photo Location Map

A total of 10 permanent photo points was established for the Project to document overall site conditions and provide a basis for year-to-year comparisons. Multiple photos in different directions were taken on August 25, 2020 from each photo point. A map of the photo points and corresponding photos can be found in **Figures 5a-5b**. Photo-documentation will continue during Year 6 (2021).

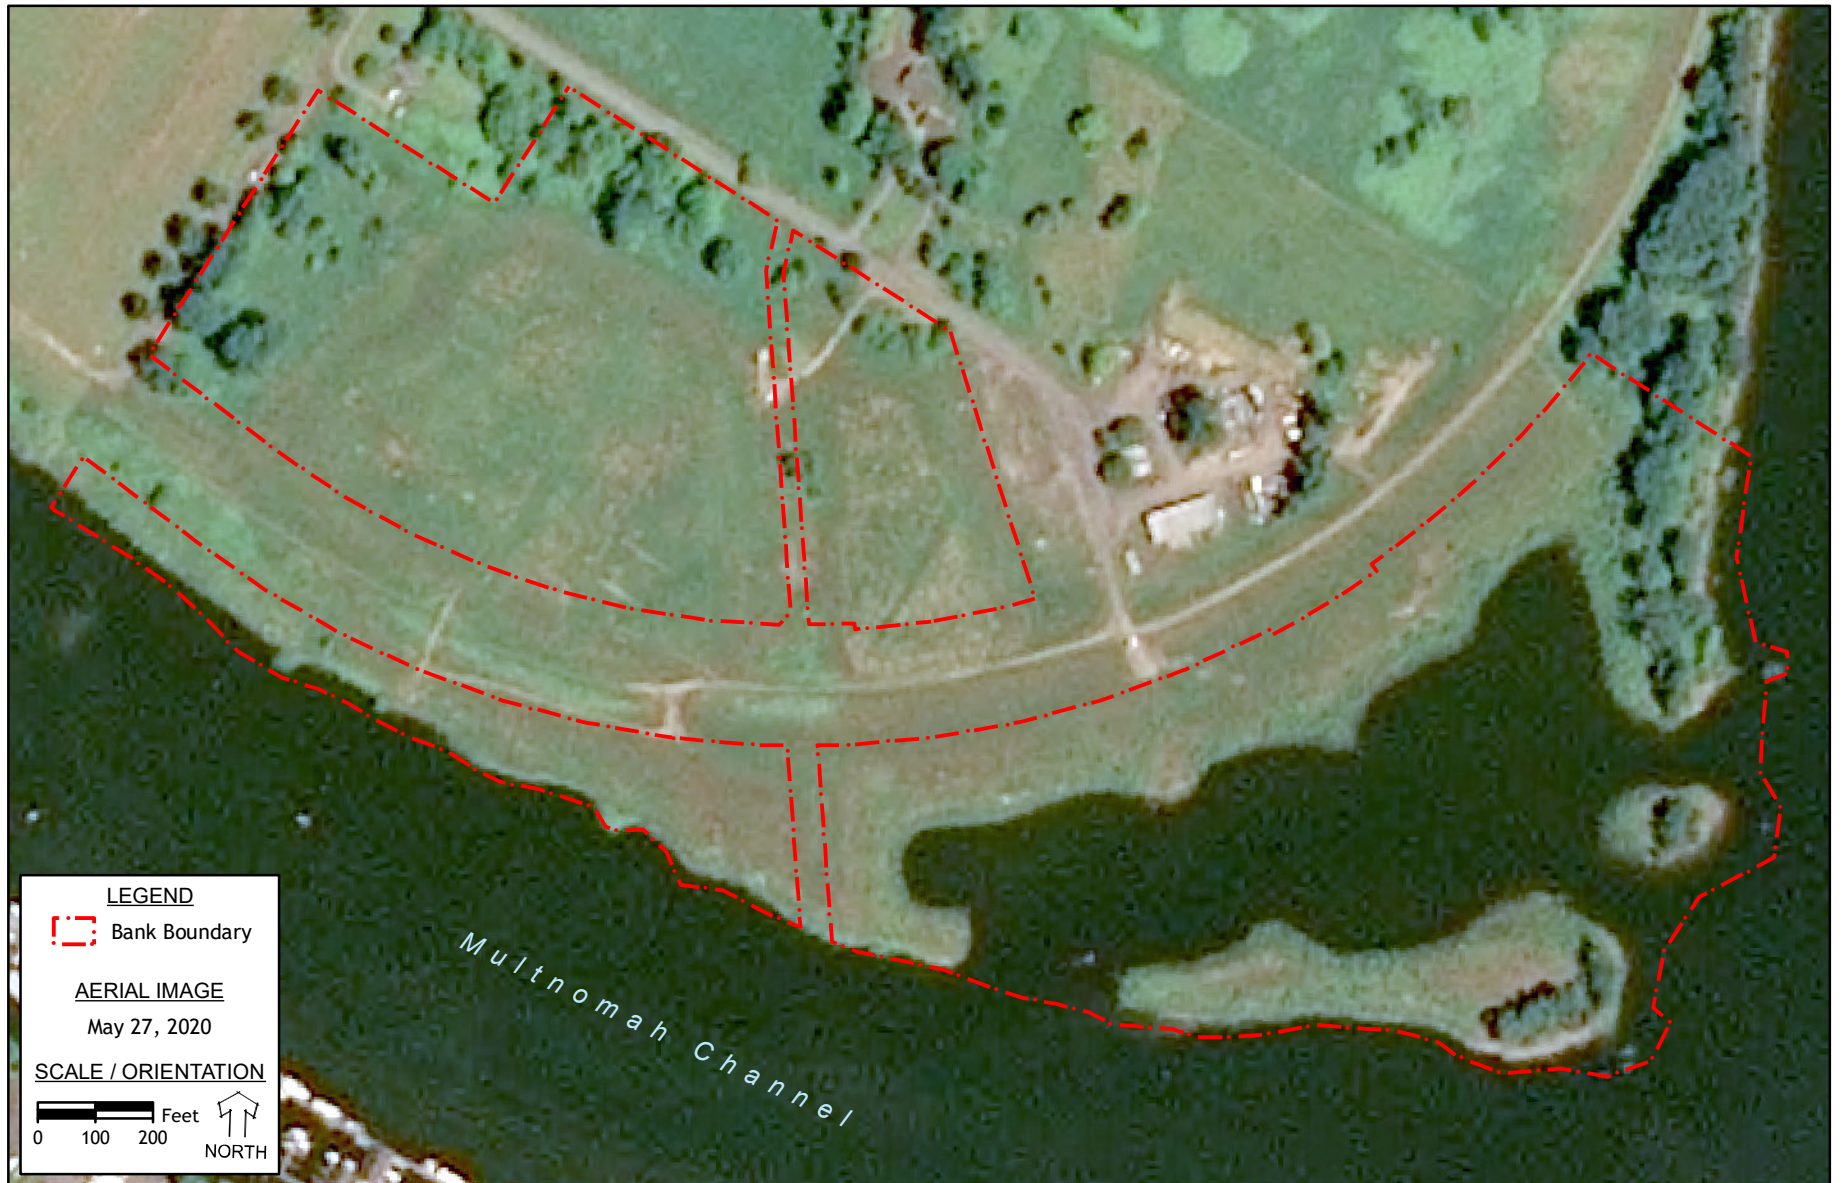
Figure 6m  
Aerial Photo Taken on 05/27/2020

Wildlands' staff again attempted to use a drone to take aerial photos of high water events during the 2020 monitoring period; however, staff was unable to obtain any useable images due to windy, rainy, and/or cloudy conditions. Satellite imagery was obtained for 10:45am on 5/27/2020 which was just a few days before the high water period of 2020 (**Figure 6c**). While Wildlands' GIS specialist was able to translate the approximate area of inundation captured by the satellite photo to GIS to calculate the approximate acreage of inundation shown on the photo (as requested by the Trustees), it should be noted that this method of using a low-resolution, non-georeferenced satellite aerial photo would yield only the approximate area of inundation for that particular moment in time and does not represent the extent of ACM on the site or the maximum level of inundation during a particular monitoring year. The information obtained from the satellite photo was compared to the Columbia Slough gauge data for accuracy. The aerial photo from 5/27/2020 was taken when water levels were shown at the Columbia Slough gauge to be approximately 14.0' NAVD and the GIS translation of the inundation shown on the aerial photo from 10:45am on 5/27/2020 was approximately 13.104 acres of ACM inundated. The highest water elevation of the 2019-2020 water year occurred on June 3 at 6:00am when the water reached an elevation of approximately 17.0' NAVD.

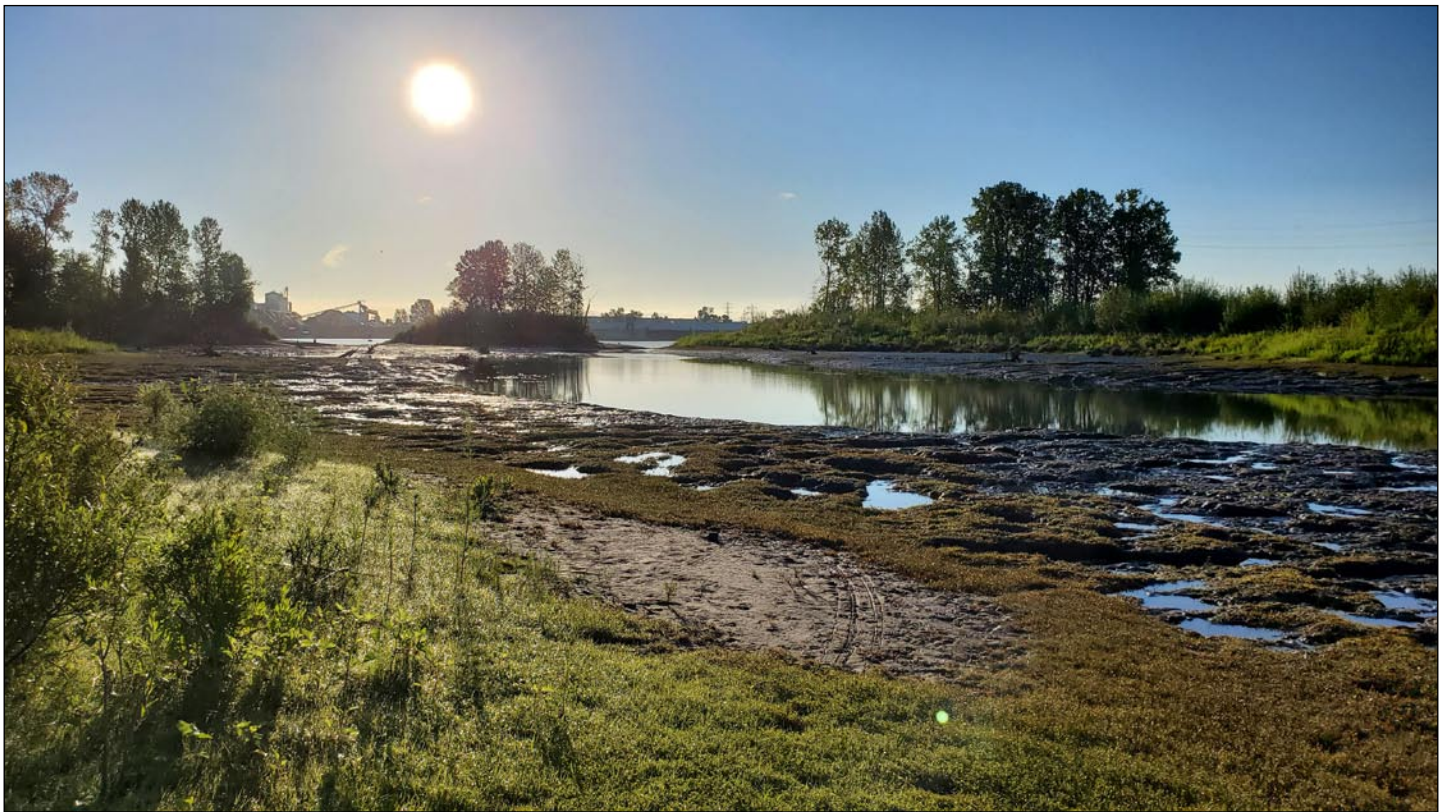
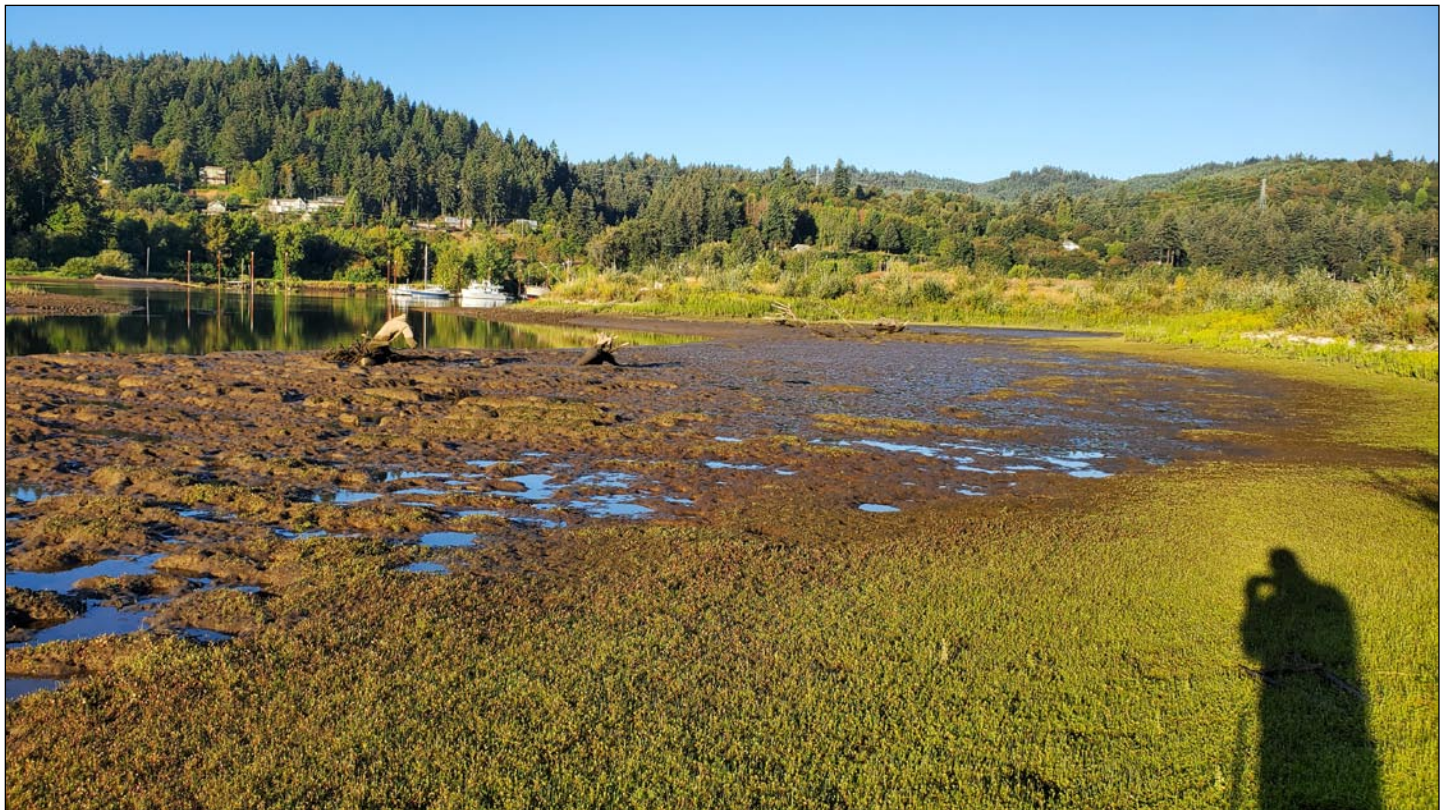
Figure 7  
Large Woody Debris

Large woody debris monitoring took place on September 18, 2020. A total of 65 pieces of large woody debris were observed on the project in 2020. Of those, 43 were identified as being originally installed LWD and the remaining 22 as being naturally recruited. Currently the Project is exceeding the 80% required LWD retention performance standard for Year 5. Photos of the LWD observed during surveys can be found in Figure 7. The remaining habitat complexity features of downed wood, debris piles, and rock piles all remain in good condition. Monitoring of the large woody debris and other habitat complexity features will continue in Year 7 (2022).

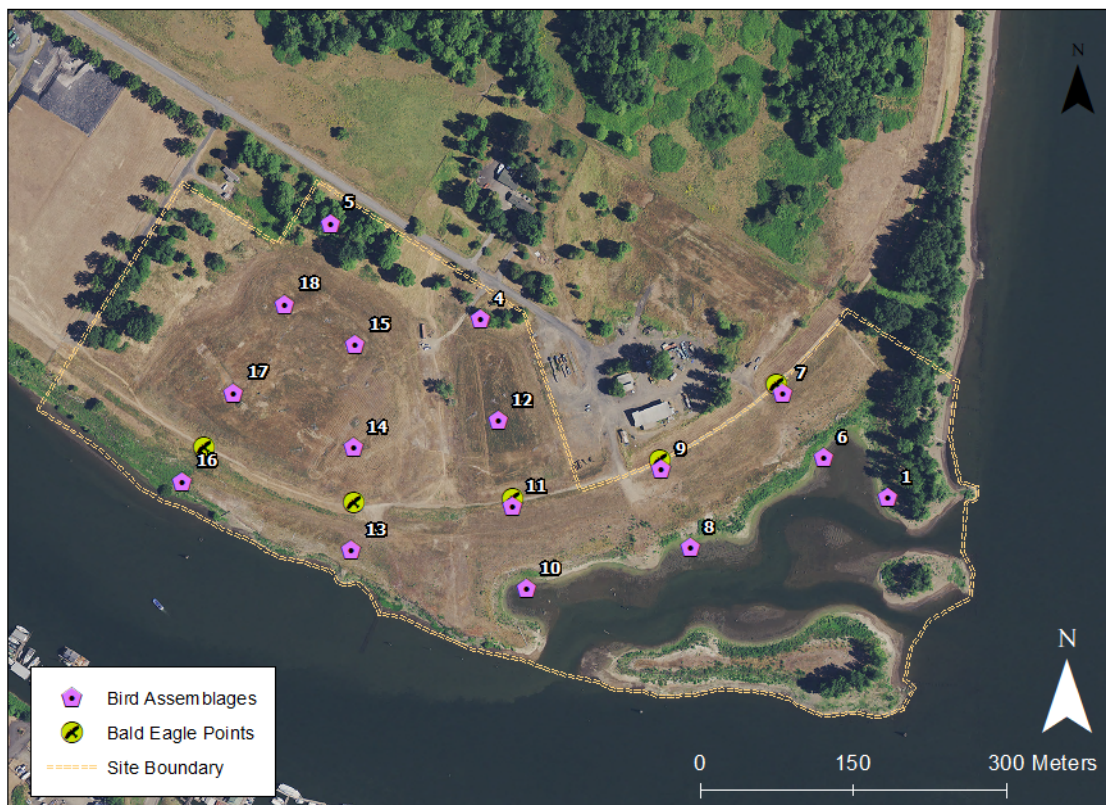
Figure 1. Survey Area, including eagle and point count locations

The survey area is located in the Portland Harbor, at the southernmost tip of Sauvie Island where the confluence of Multnomah Channel and the Willamette River occurs (Figure 1). Formerly a 64-acre sawmill complex before restoration activities took place, the area now includes restored side channels, roughly nine acres of improved beaches, mudflats, and marsh habitat, 27 acres of riparian habitat, and 13 acres of oak woodland habitat with several large snags.

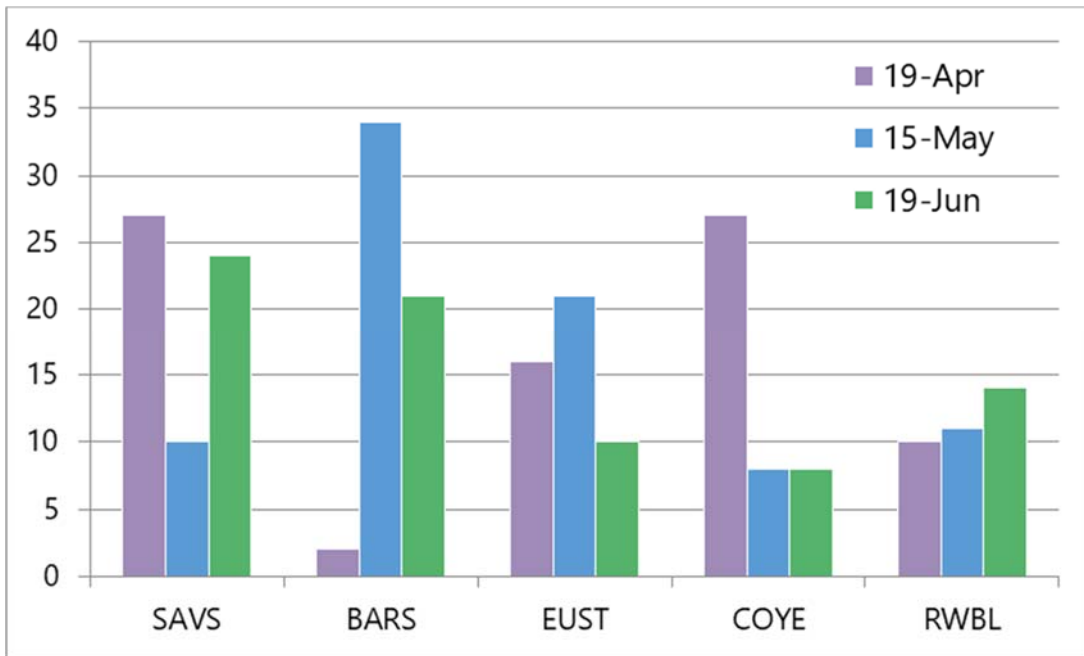
Figure 2. Top species counted in point count surveys, by total overall abundance

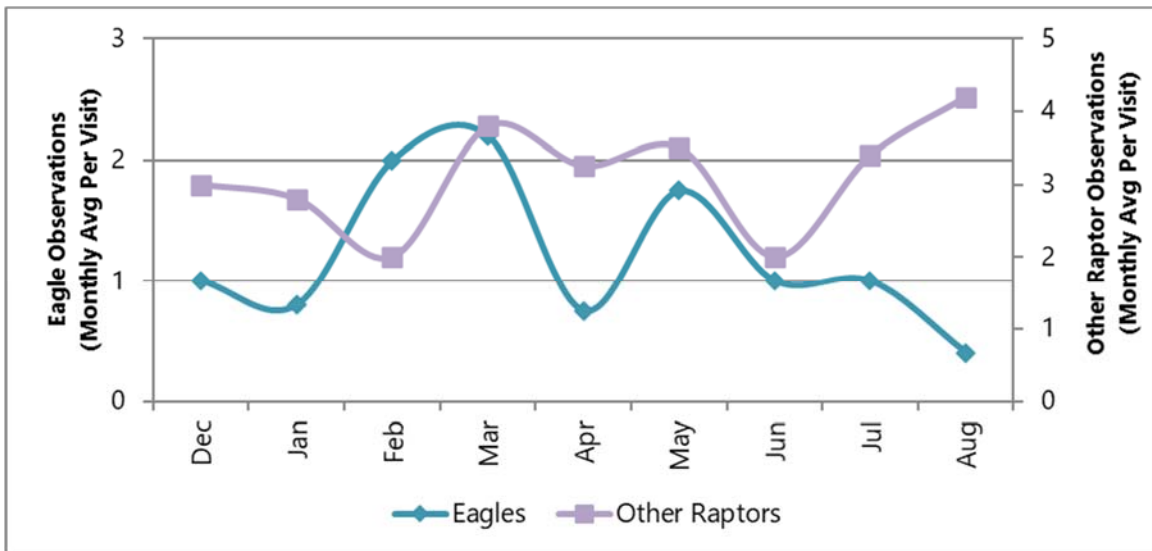
Figure 5. Mean bald eagle and other raptor observations, December 2019-August 2020, by month<sup>2</sup>

During the 2019-2020 survey period, 38 total eagle surveys were conducted. A total of 46 bald eagle sightings and 120 raptor sightings were recorded over the 38 visits. Other raptor species observed included osprey (*Pandion haliaetus*), red-tailed hawk (*Buteo jamaicensis*), American kestrel (*Falco sparverius*), merlin (*Falco columbarius*), and rough-legged hawk (*Buteo lagopus*). Turkey vultures (*Cathartes aura*) were also observed during many of the visits, but are not included in the official raptor counts. The spatial distribution of eagle observations recorded throughout the season is displayed in Figure 4. During a single survey, the highest number of eagle individuals observed was three – two adults and one juvenile. Eagles were observed on site, either flying over or perched, for 52 percent of all observations. Eagles were generally observed flying over the site or channel, but were occasionally observed perching in the cottonwood trees near the shore. Raptors were regularly observed perching and hunting throughout the site and the restored channels. No active raptor nests were observed on or near the site. Eagles were observed most often during the early nesting period of January through March, while raptor activity levels varied throughout the entire survey season (Figures 5, 6).

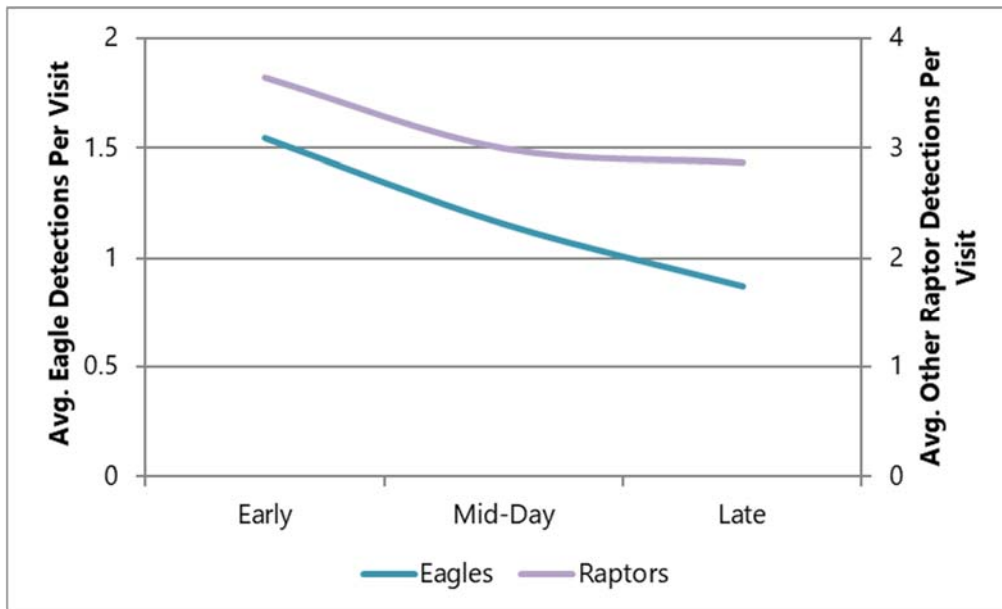
Figure 6. Mean bald eagle and other raptor observations December 2019-August 2020, by time of day<sup>2,3</sup>

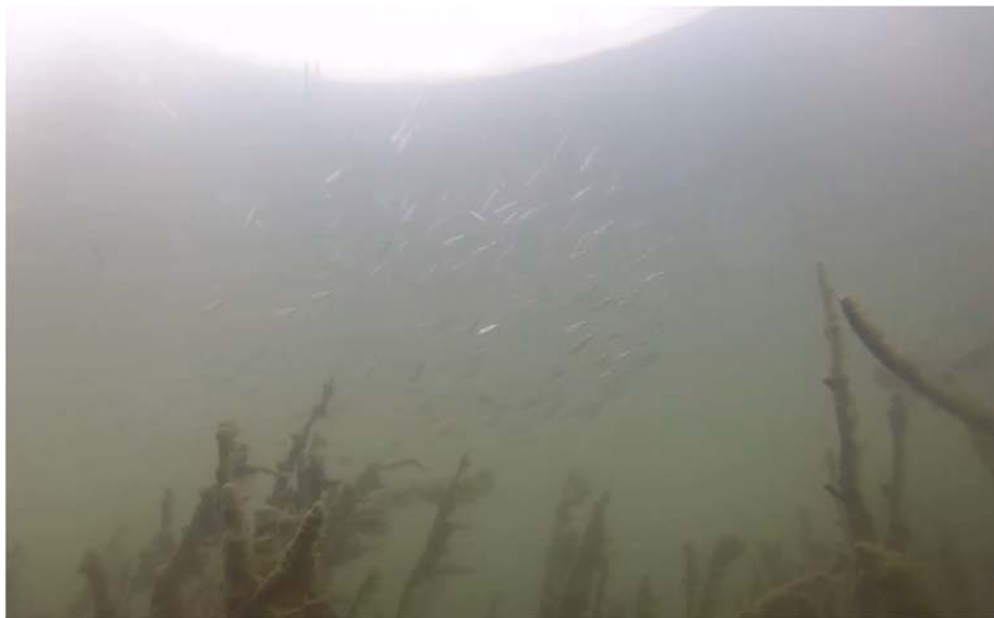
Figure 7. Screen Capture of Underwater Video Depicting Juvenile Salmonids on May 19, 2020

Biologists from Turnstone Environmental Consultants (Turnstone) conducted fish monitoring on eight occasions between February and May 2020. Juvenile salmonids were observed on several occasions along with minnows and other unidentified species. Less than ideal visibility during visual surveys yielded low levels of fish observation and hindered species identification, though the number of observations has increased since adopting stationary GoPro video stations rather than roving shoreline camera surveys. Details on the eight fish monitoring visits can be found in the Alder Creek Wildlife Monitoring Report by Turnstone in Appendix 7.

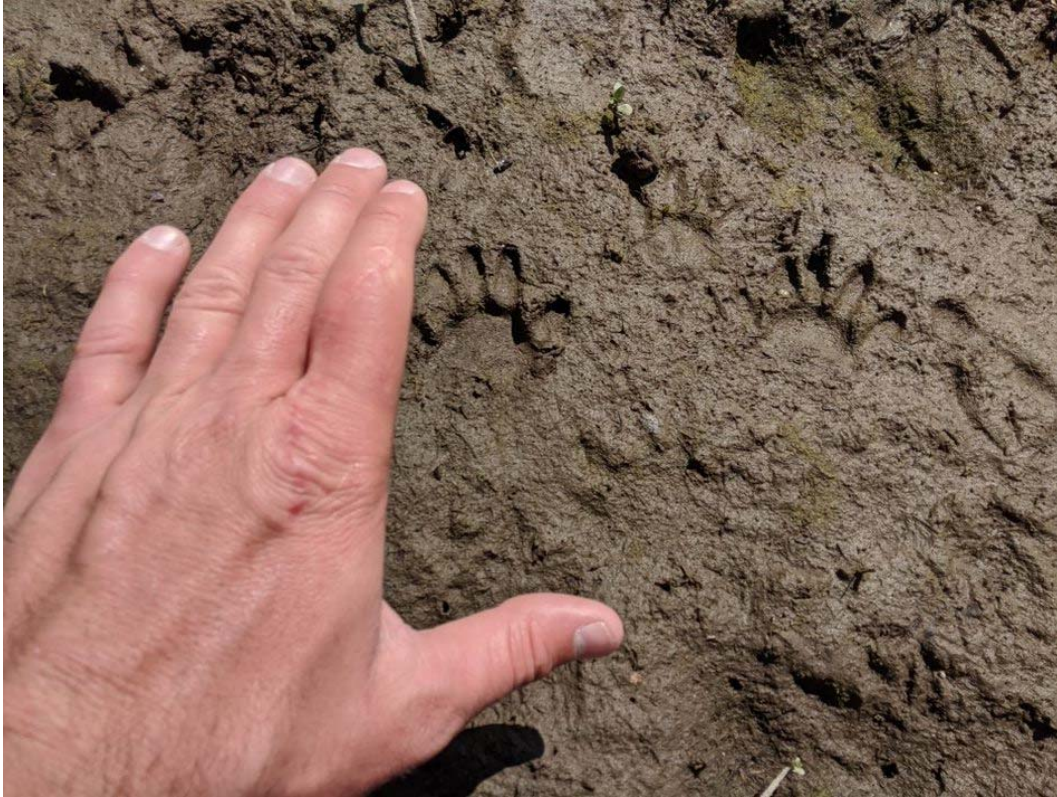
Figure 8. Mink Tracks Observed Along Shoreline on July 13, 2020

Although Turnstone was not contracted to conduct the mink camera and sign surveys outlined in the monitoring plan, a Turnstone biologist did observe mink tracks along the shore during an eagle monitoring visit on July 13, 2020 (Figures 8, 9).

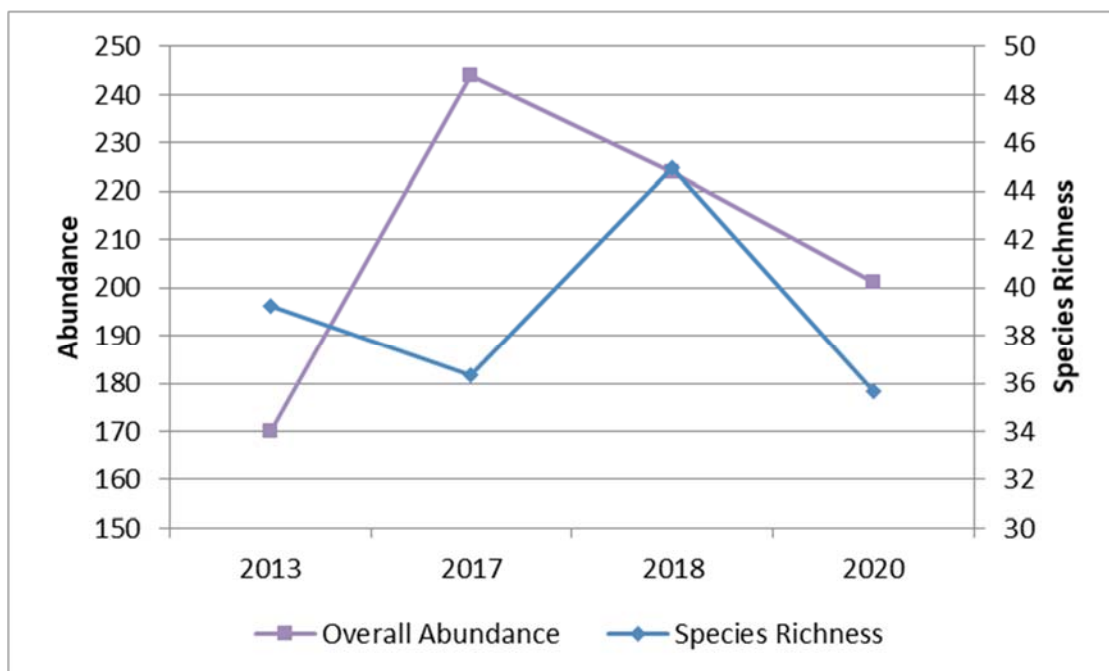
Figure 10. Species Abundance and Species Richness, by visit

Overall abundance of bird assemblages has increased since restoration activities took place, averaging 223 individuals over the three years of post-restoration monitoring, compared to 170 individuals during the baseline surveys (Figure 10). Species richness has stayed relatively the same, averaging 39 different species across the years of post-restoration monitoring which is similar to the baseline surveys. However, the composition of these species has changed over the years. As of 2020, the most common species was the Savannah sparrow, which prefers open meadows and similar habitats; prior to restoration, this species was recorded just four times over two visits in 2013. Two sensitive species, purple martin and willow flycatcher, have been recorded both pre- and post-restoration monitoring. Proportions of non-native species, including European starling, Eurasian collared-dove, California quail, house finch, and house sparrow, dropped initially after restoration occurred but have increased in the last monitoring season (Figure 11). This is largely attributable to European starlings which frequent the area.
