Alder Creek Restoration Project

2021 Monitoring Report Year 6

Wildlands PNW
Portland Harbor Holdings II, LLC
Contact: Julie Mentzer
503-241-4895

February 2022
Revised April 2022

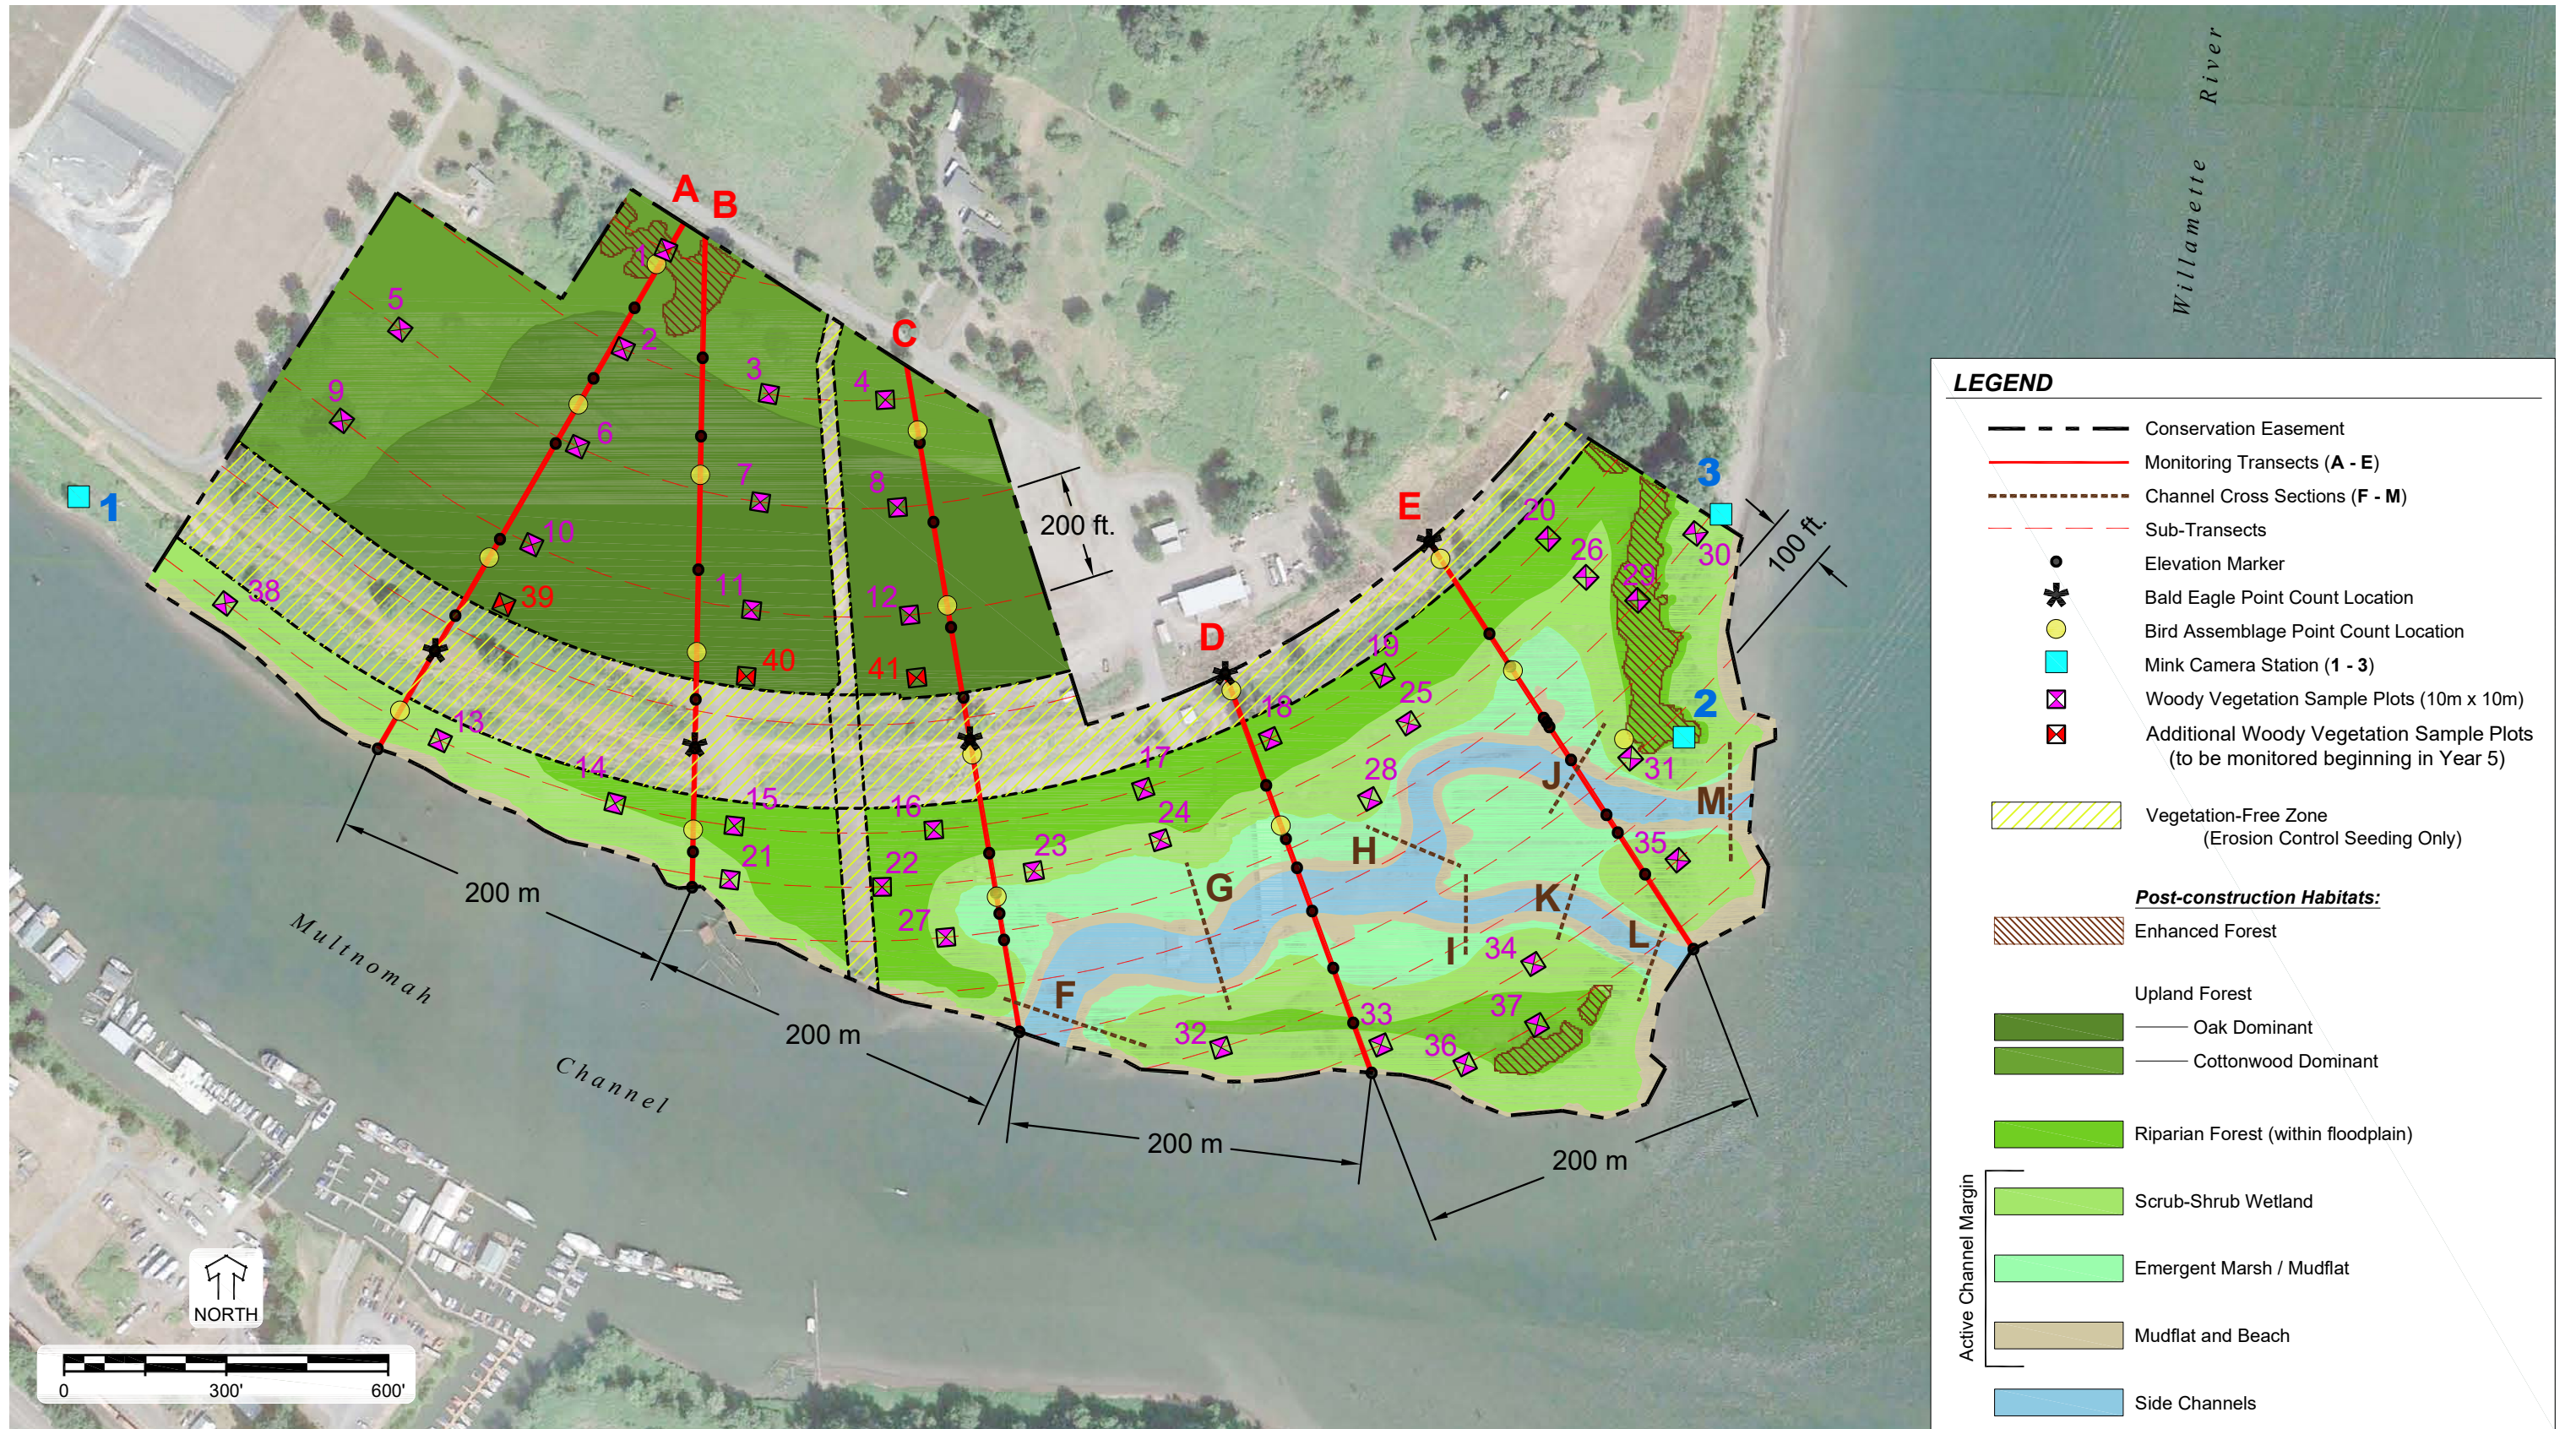
Quantitative monitoring data will be primarily collected using 10x10 meter sample plots along five main baseline transects running more or less north/south across the site (**Figure 3**). Beginning in Year 5, three additional sample plots within the upland forest will be monitored during the monitoring events within the upland forest. The locations of the three additional sample plots have been added to Figure 3.
