To: Portland Harbor Trustee Council  
From: Colin MacLaren  
RE: Final Harborton Year 1 Habitat Monitoring Report

# Portland General Electric Harborton Restoration: Year 1 Monitoring Report

**December 2021, Revised July 2022**

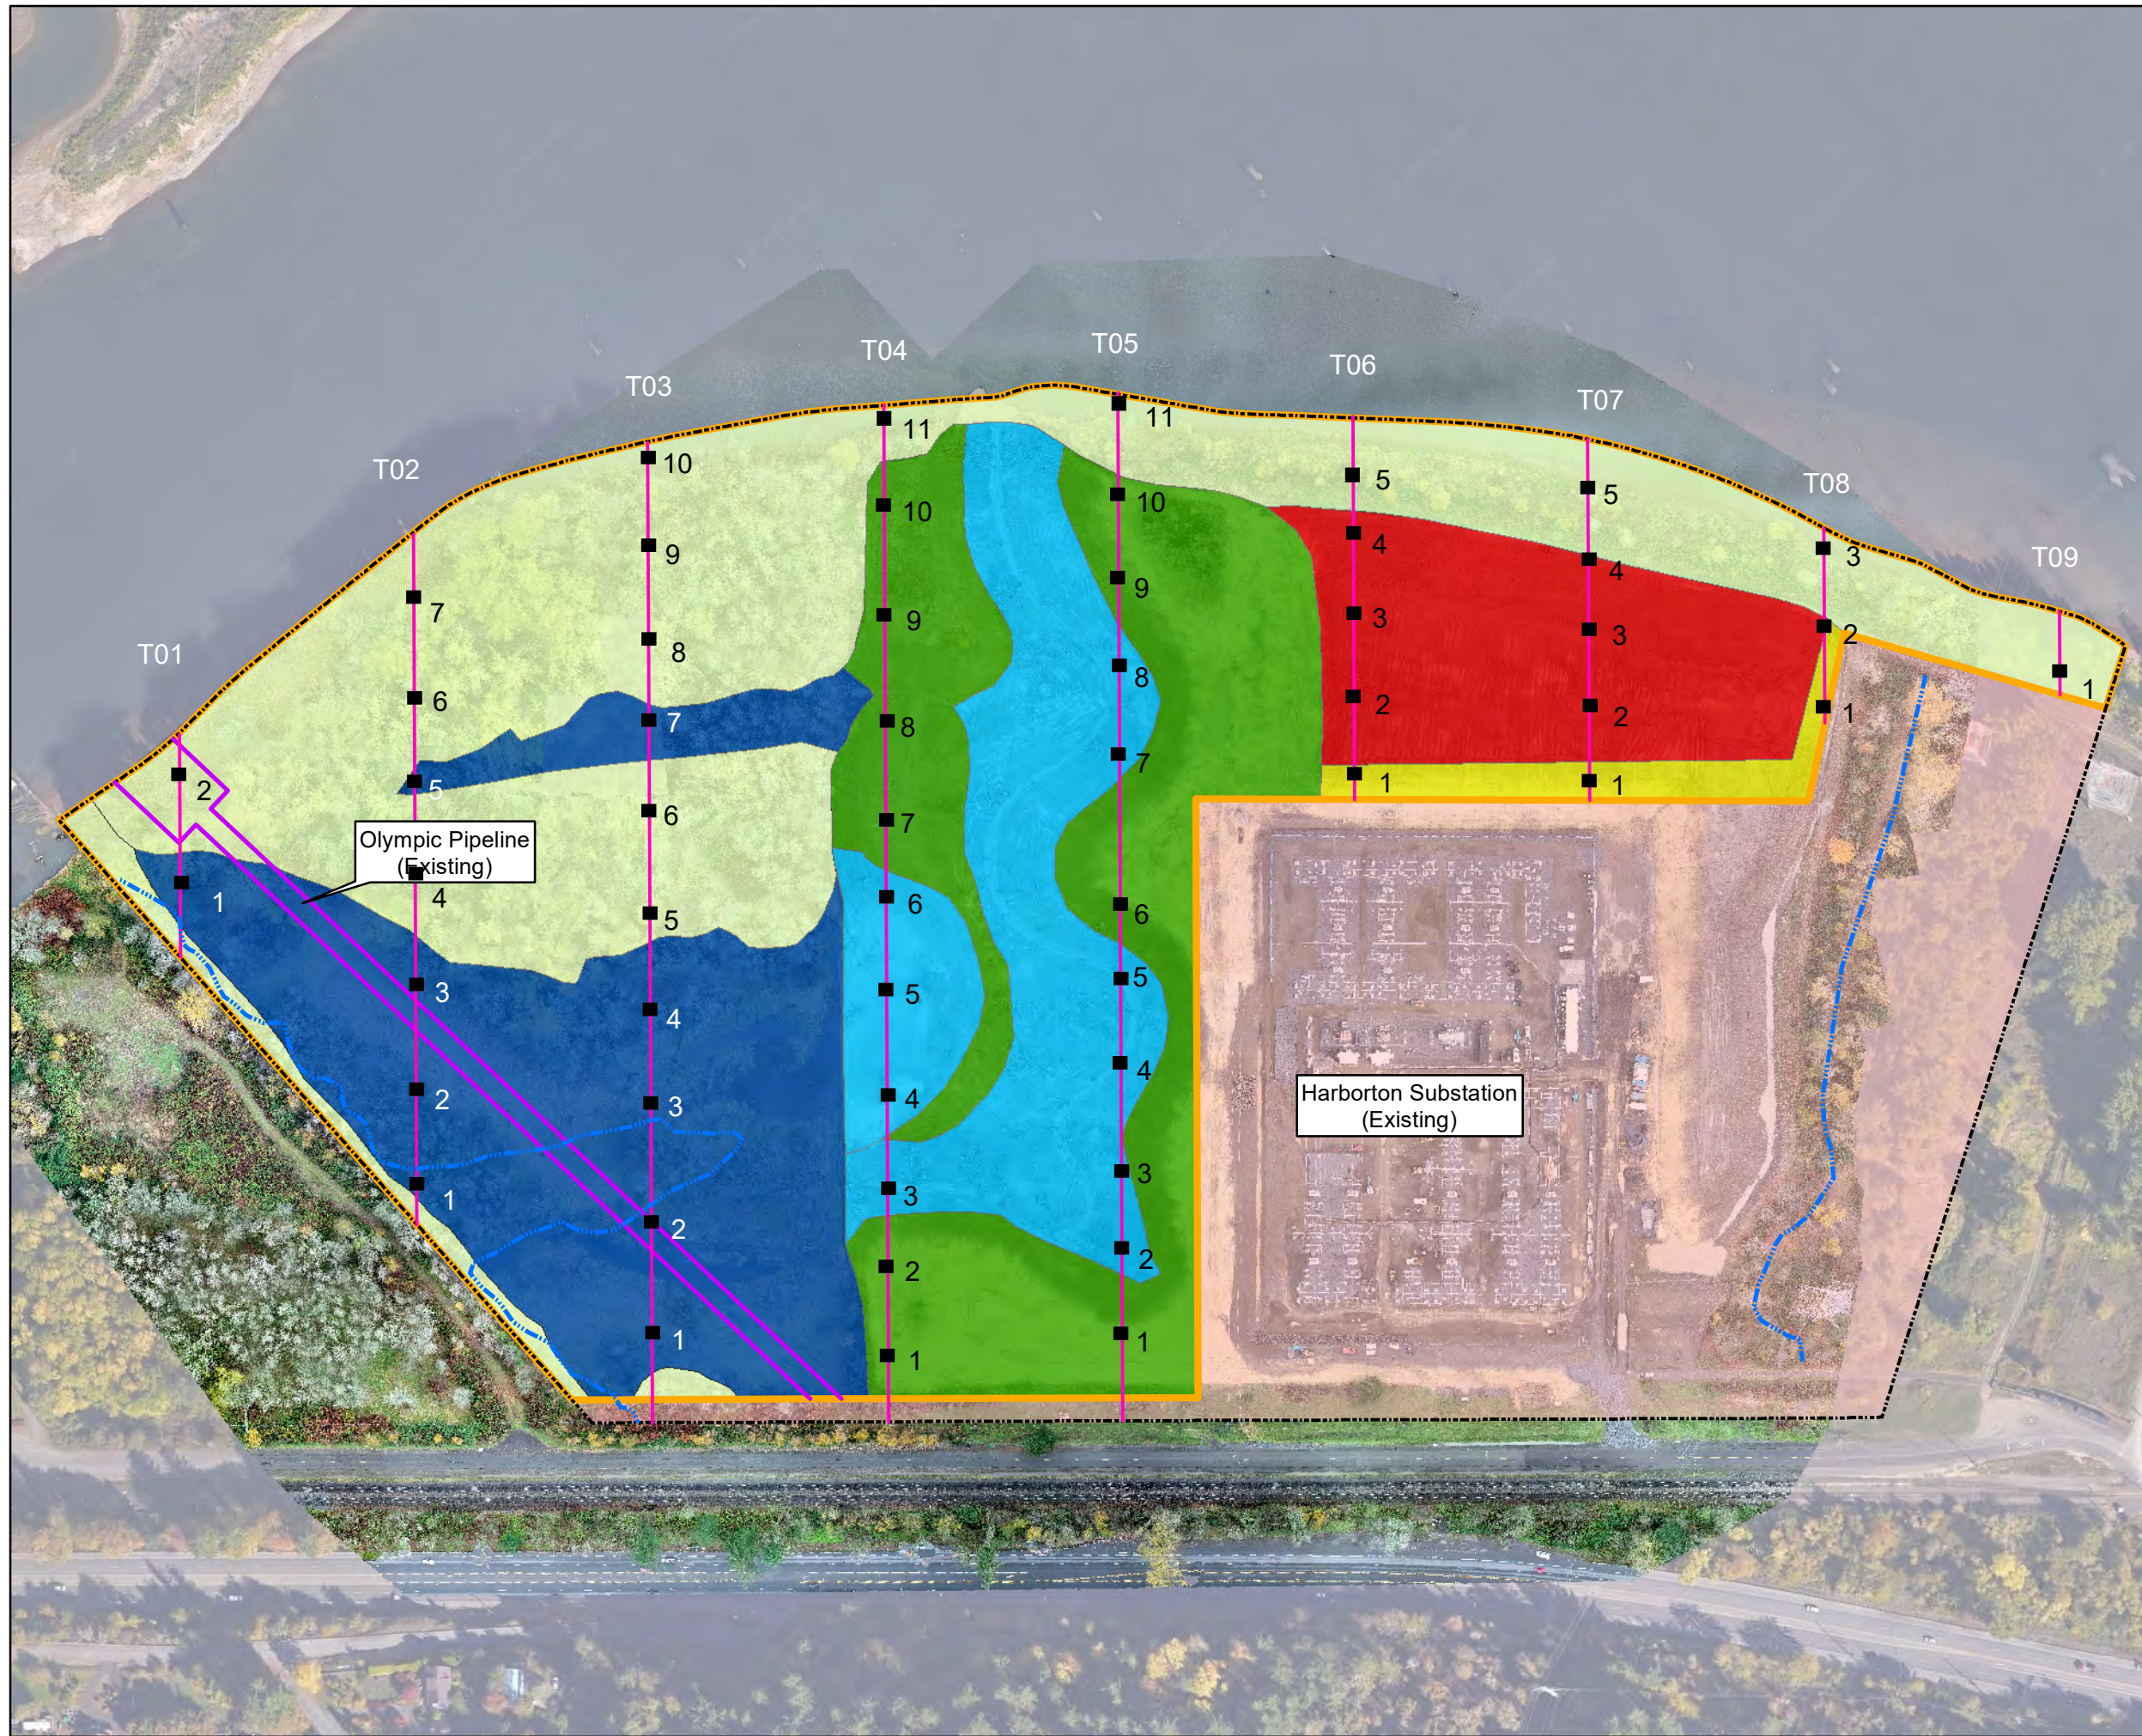
Figure 2  
Sample Line-intercept  
Vegetation Assessment Plots  
**PGE Environmental Services**

The second approach involved a line-intercept method to observe physical surface conditions within the riparian zone of the North Channel (Figures 2 and 3). General descriptions were collected for sediment erosion/deposition, channel conditions, and other pertinent observations of physical ACM habitat conditions. Lateral transects along the North Channel extended from the top of the floodplain valley wall to the opposite top of the valley wall.

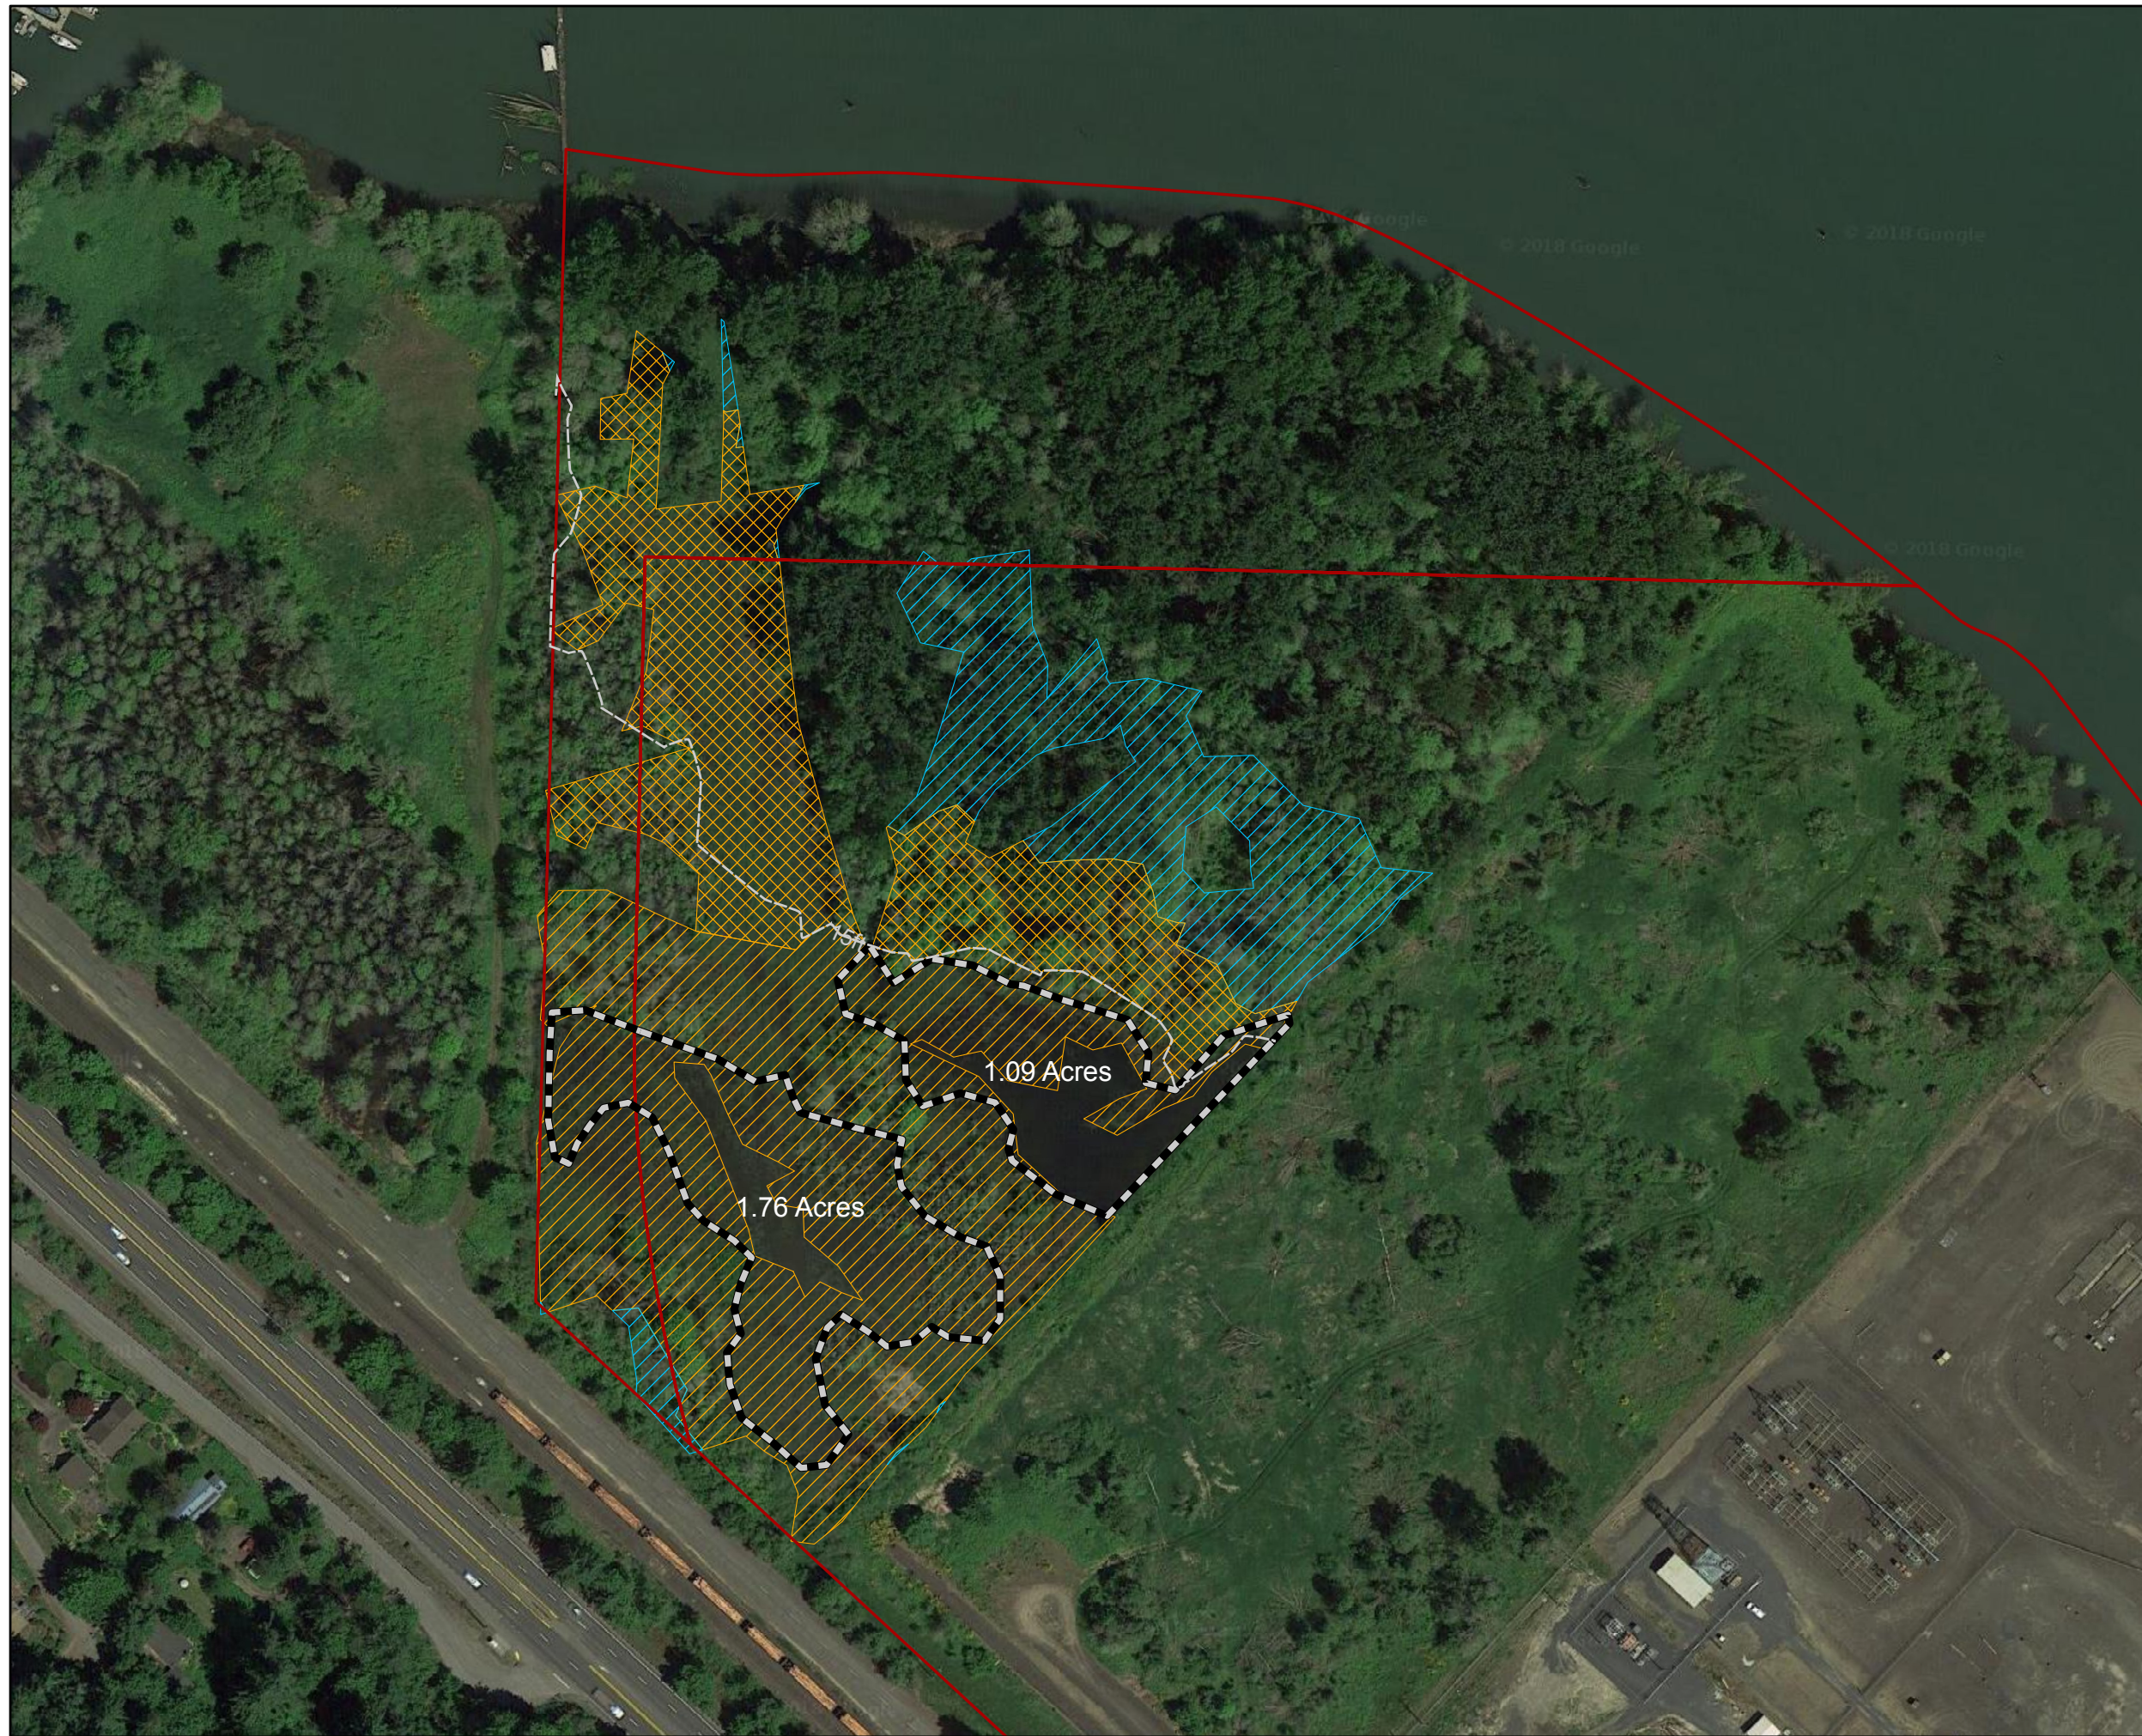
**Harborton Reed Canarygrass  
Treatment and Nontreatment Area  
Harborton**

RCG cover in wetlands is estimated to be 34 percent across managed areas of the Site. RCG is absent from the 6.62-acre wetland in Sub Area 3. RCG in Sub Area 4 wetlands includes a range of conditions from emergent areas with an estimated 90 percent RCG cover to shrub and forested areas with an estimated 46 percent RCG cover. Table 8 below describes cover in each habitat area and provides an overall estimate based on weighing the percent RCG cover by wetland type.

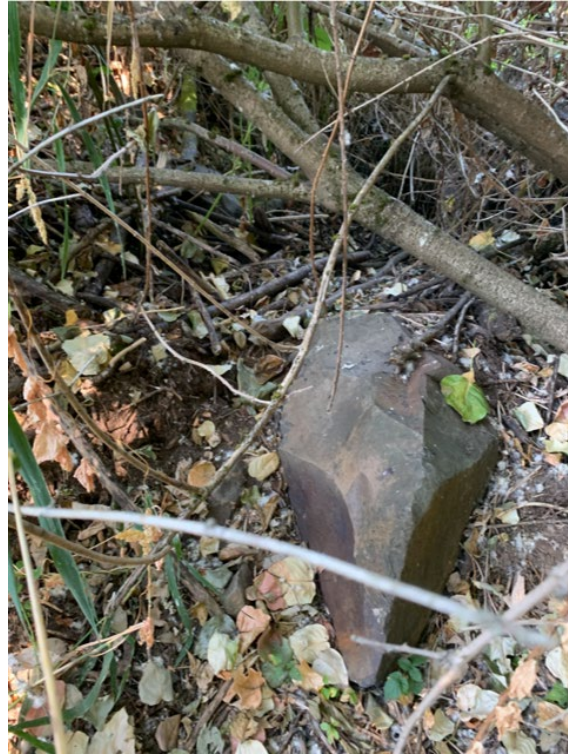
November 14, 2021 – closeup of SA 4 outlet
