Alder Creek Restoration Project

2022 Monitoring Report Year 7

Wildlands PNW
Portland Harbor Holdings II, LLC
Contact: Julie Mentzer
503-241-4895

February 2023

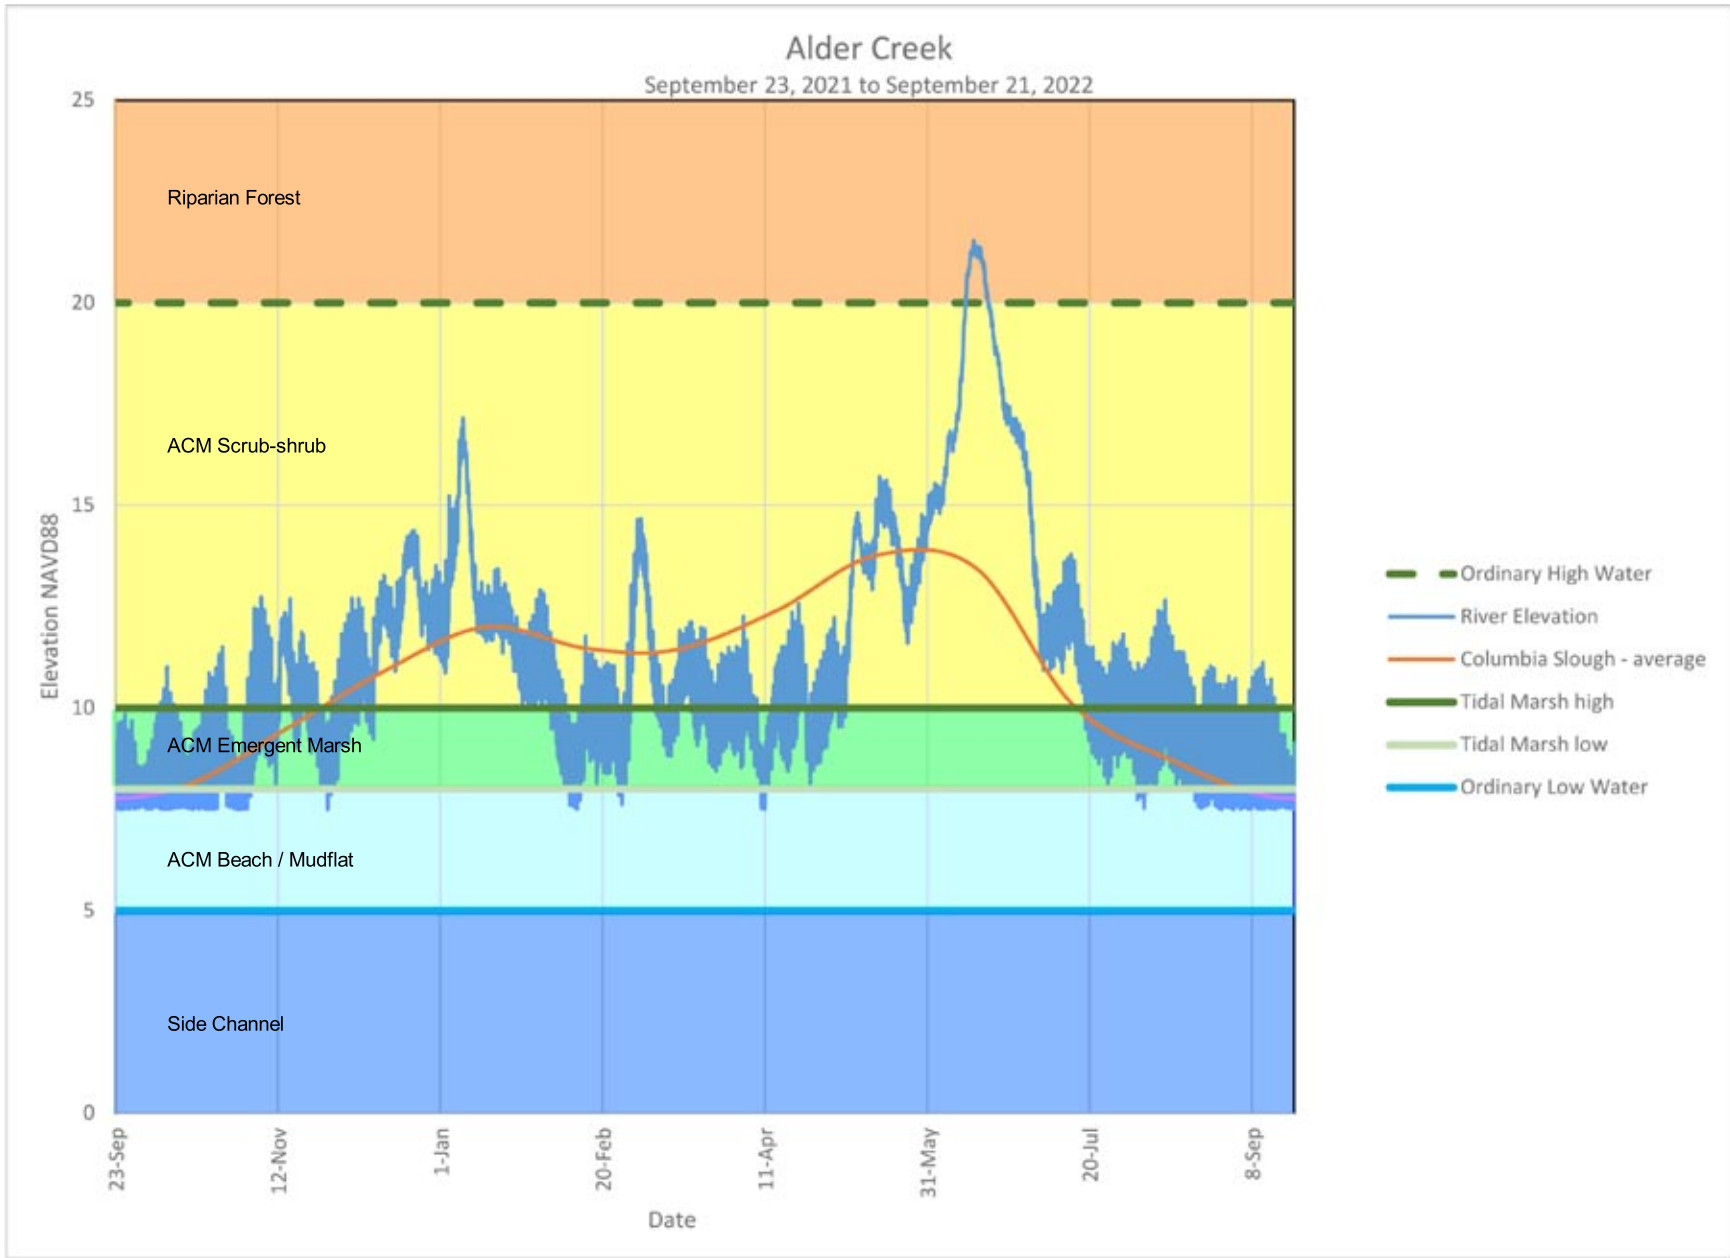
Figure 6b
Water Level Data

To determine the accuracy of the published data, the river elevation at the Project site has been surveyed on numerous occasions between 2010 and 2022 by both Wildlands' staff and by licensed surveyors from AKS Engineering and Forestry and has been compared to the data collected by the onsite data loggers. The surveyed river elevation data has been compared to the closest published 15-minute interval "gage height" at the USGS Columbia Slough station. It has been found to accurately match with the survey data, with an average difference of less than 0.02 feet. Historic water data from this station can be downloaded and a clear picture of the hydrology of the Project site can be determined. The Columbia Slough gauge provides an excellent representation of water elevations at Alder Creek. Continuous water level data from the USGS water data station at Columbia Slough and the two onsite data loggers was used to document the water levels on the Project site during the Reporting Period (See **Figure 6b**). The water level data for the Reporting Period shows that river elevations in early January, late-February/early March, and again in June were higher than average. While river levels were generally higher than average throughout much of the year, there were periods in February, March, and April which were lower than average.

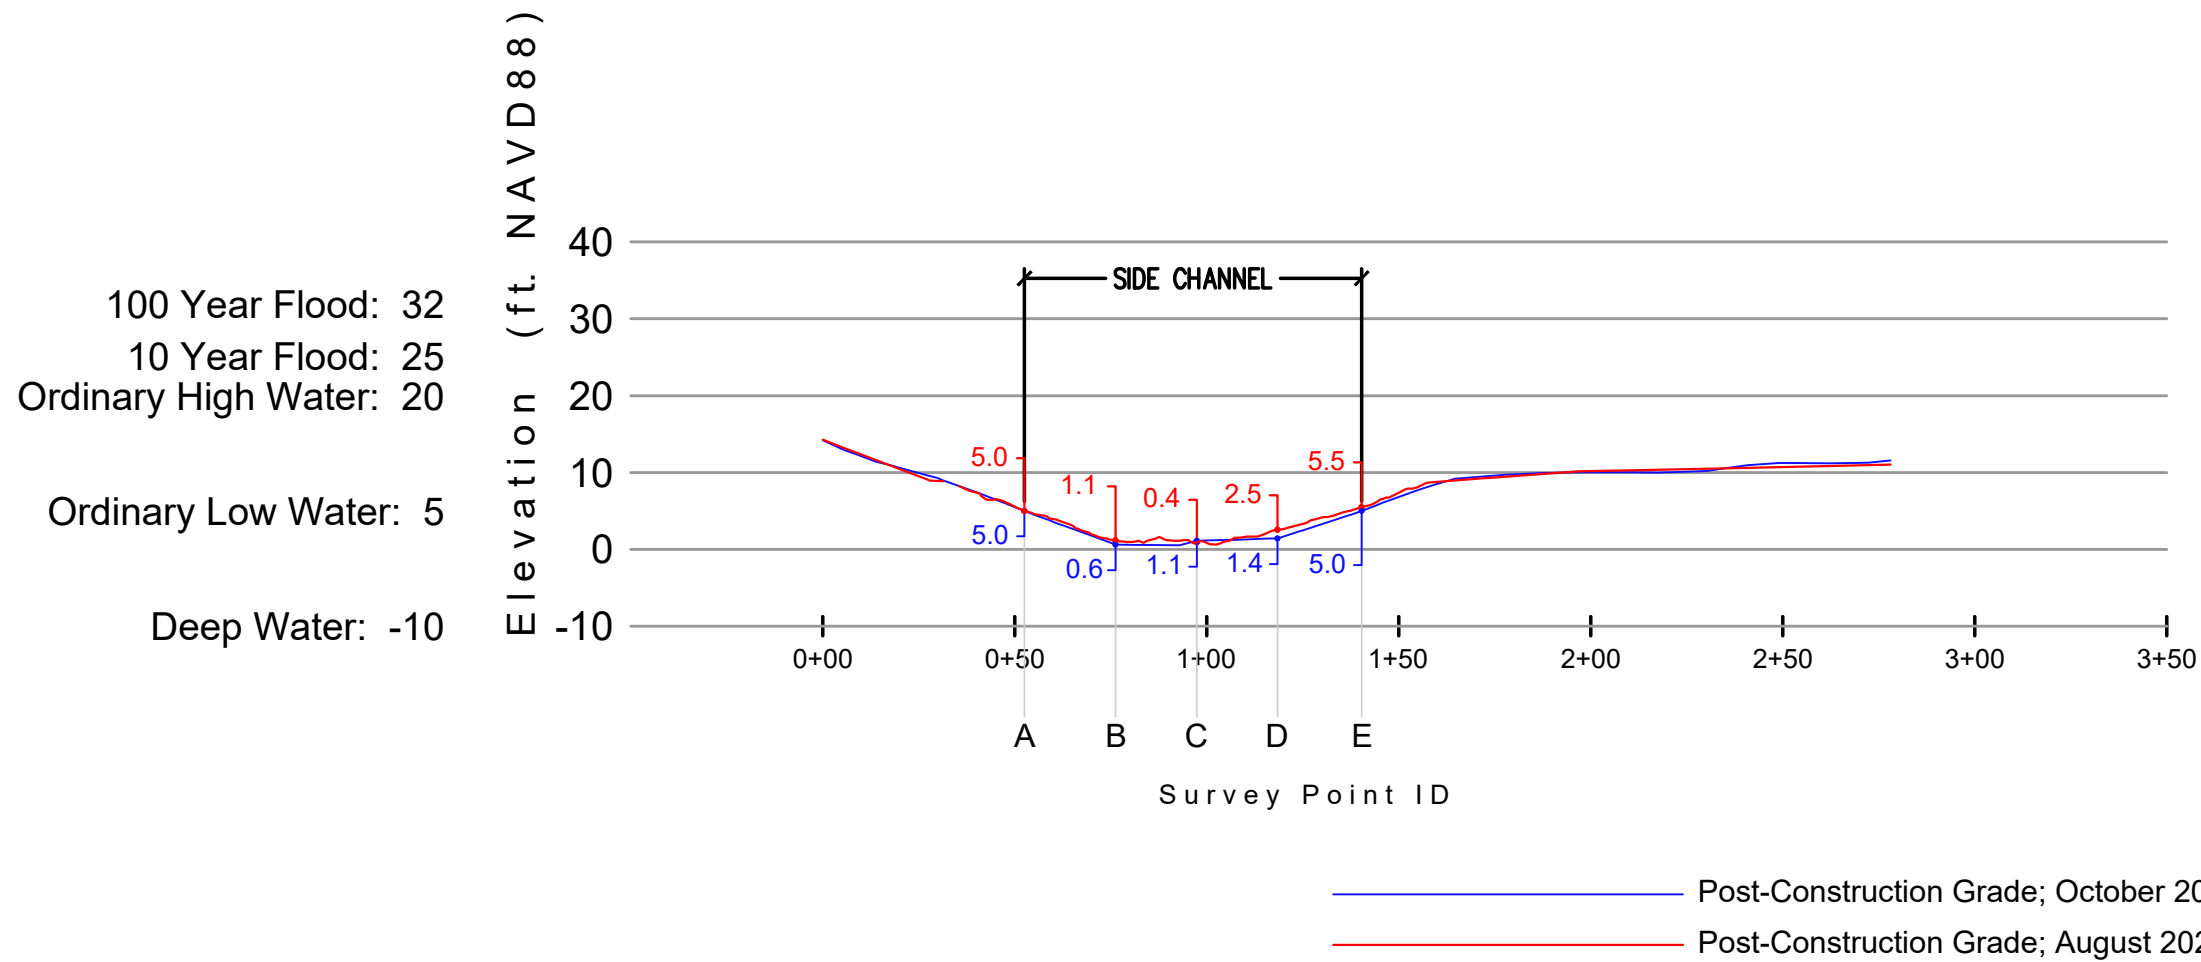
F Cross Section F

Cross Section F									
Survey Point ID	Elevation: October 2015	Elevation: August 2022	Elevation Change	Depth October 2015 relative to OHW (elevation 20.0)	Depth August 2022 relative to OHW (elevation 20.0)	Percent Change Relative to OHW 2015 to 2022		Absolute Percent Change Relative to OHW 2015 to 2022	
A	5.0	5.0	0.0	15.0	15.0	(15.0/15.0) =	100%	100 - 100 =	0%
B	0.6	1.1	+0.5	19.4	18.9	(18.9/19.4) =	97%	97 - 100 =	3%
C	1.1	0.4	-0.7	18.9	19.6	(19.6/18.9) =	103%	103 - 100 =	3%
D	1.4	2.5	+1.1	18.6	17.5	(17.5/18.6) =	94%	94 - 100 =	6%
E	5.0	5.5	+0.5	15.0	14.5	(14.5/15.0) =	97%	97 - 100 =	3%
Average Distance:			0.6					Average: 3%

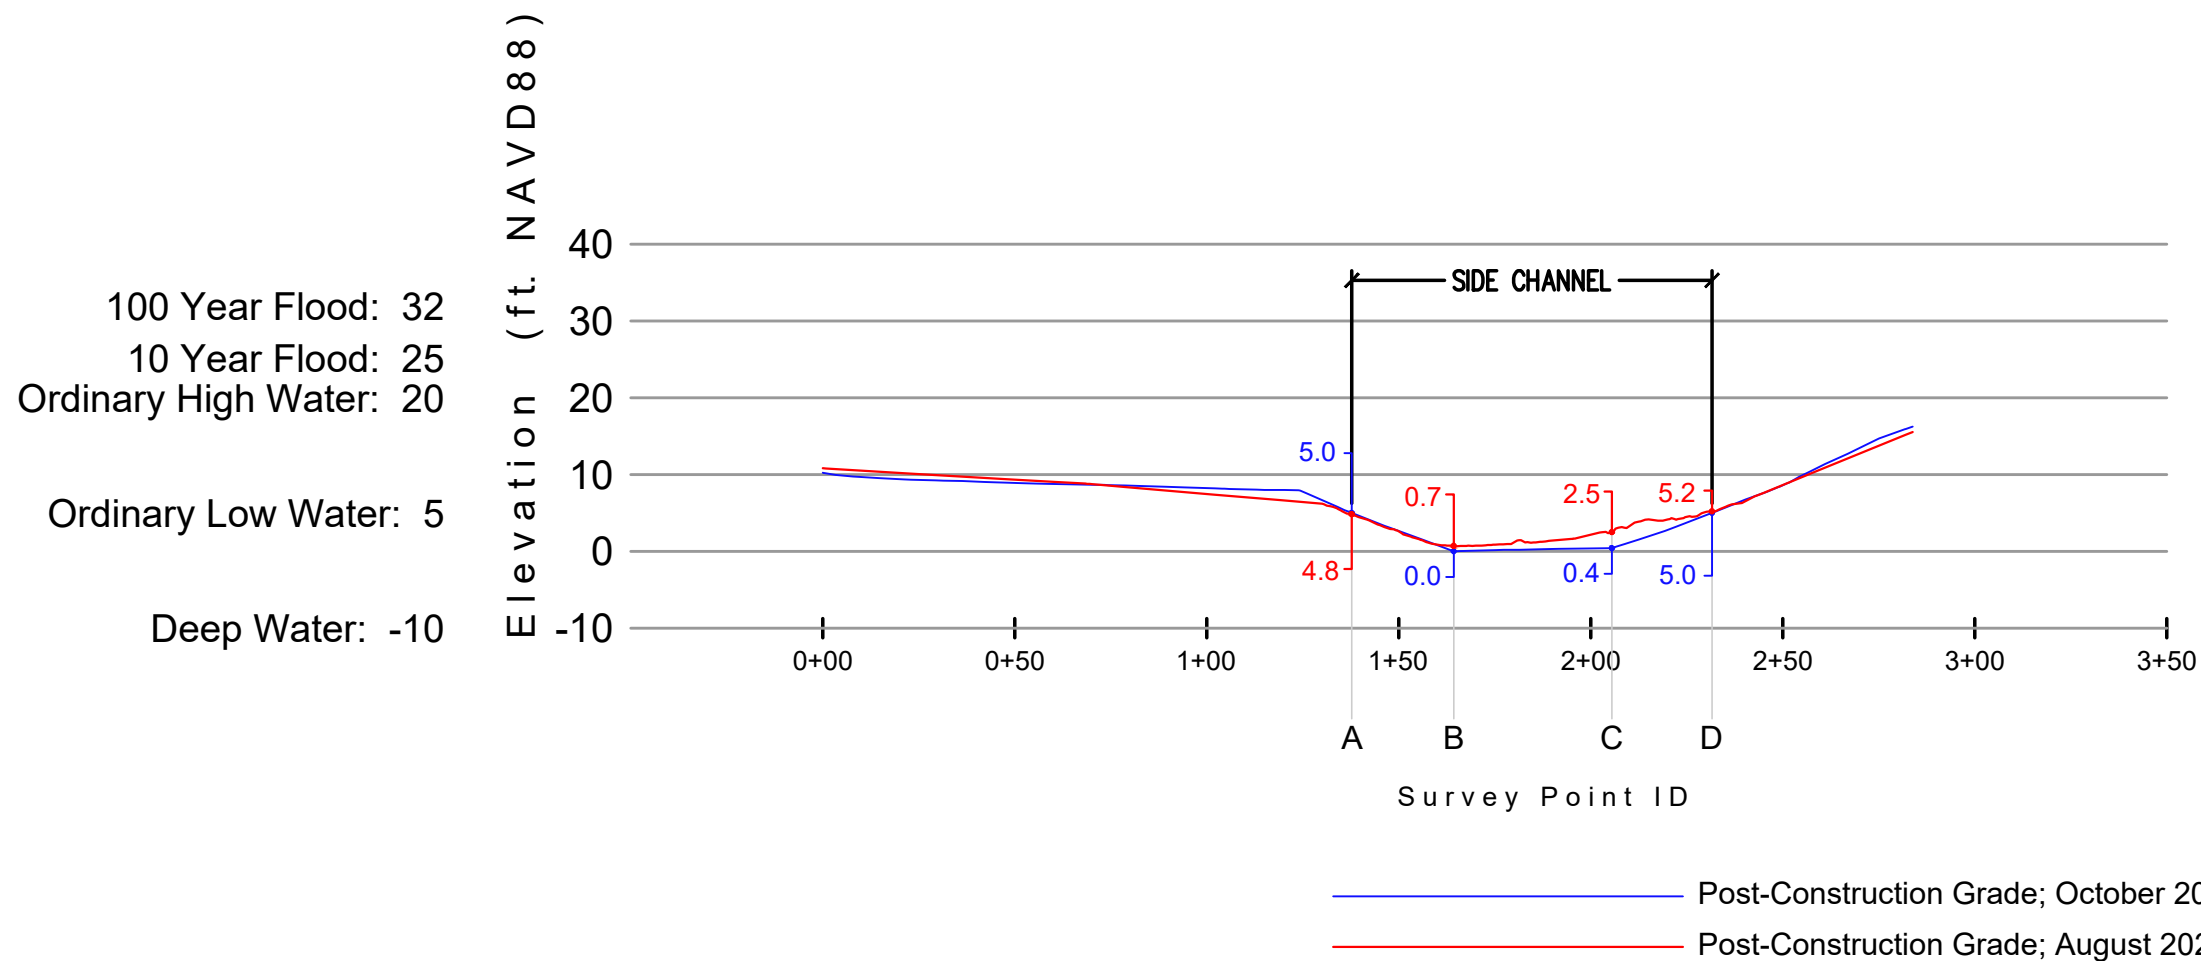
G Cross Section G

Cross Section G									
Survey Point ID	Elevation: October 2015	Elevation: August 2022	Elevation Change	Depth October 2015 relative to OHW (elevation 20.0)	Depth August 2022 relative to OHW (elevation 20.0)	Percent Change Relative to OHW 2015 to 2022		Absolute Percent Change Relative to OHW 2015 to 2022	
A	5.0	4.8	-0.2	15.0	15.2	(15.2/15.0) =	101%	101-100 =	1%
B	0.0	0.7	+0.7	20.0	19.3	(19.3/20.0) =	97%	97-100 =	3%
C	0.4	2.5	+2.1	19.6	17.5	(17.5/19.6) =	89%	89-100 =	11%
D	5.0	5.2	+0.2	15.0	14.8	(14.8/15.0) =	99%	99-100 =	1%
Average Distance:			0.8					Average: 4%

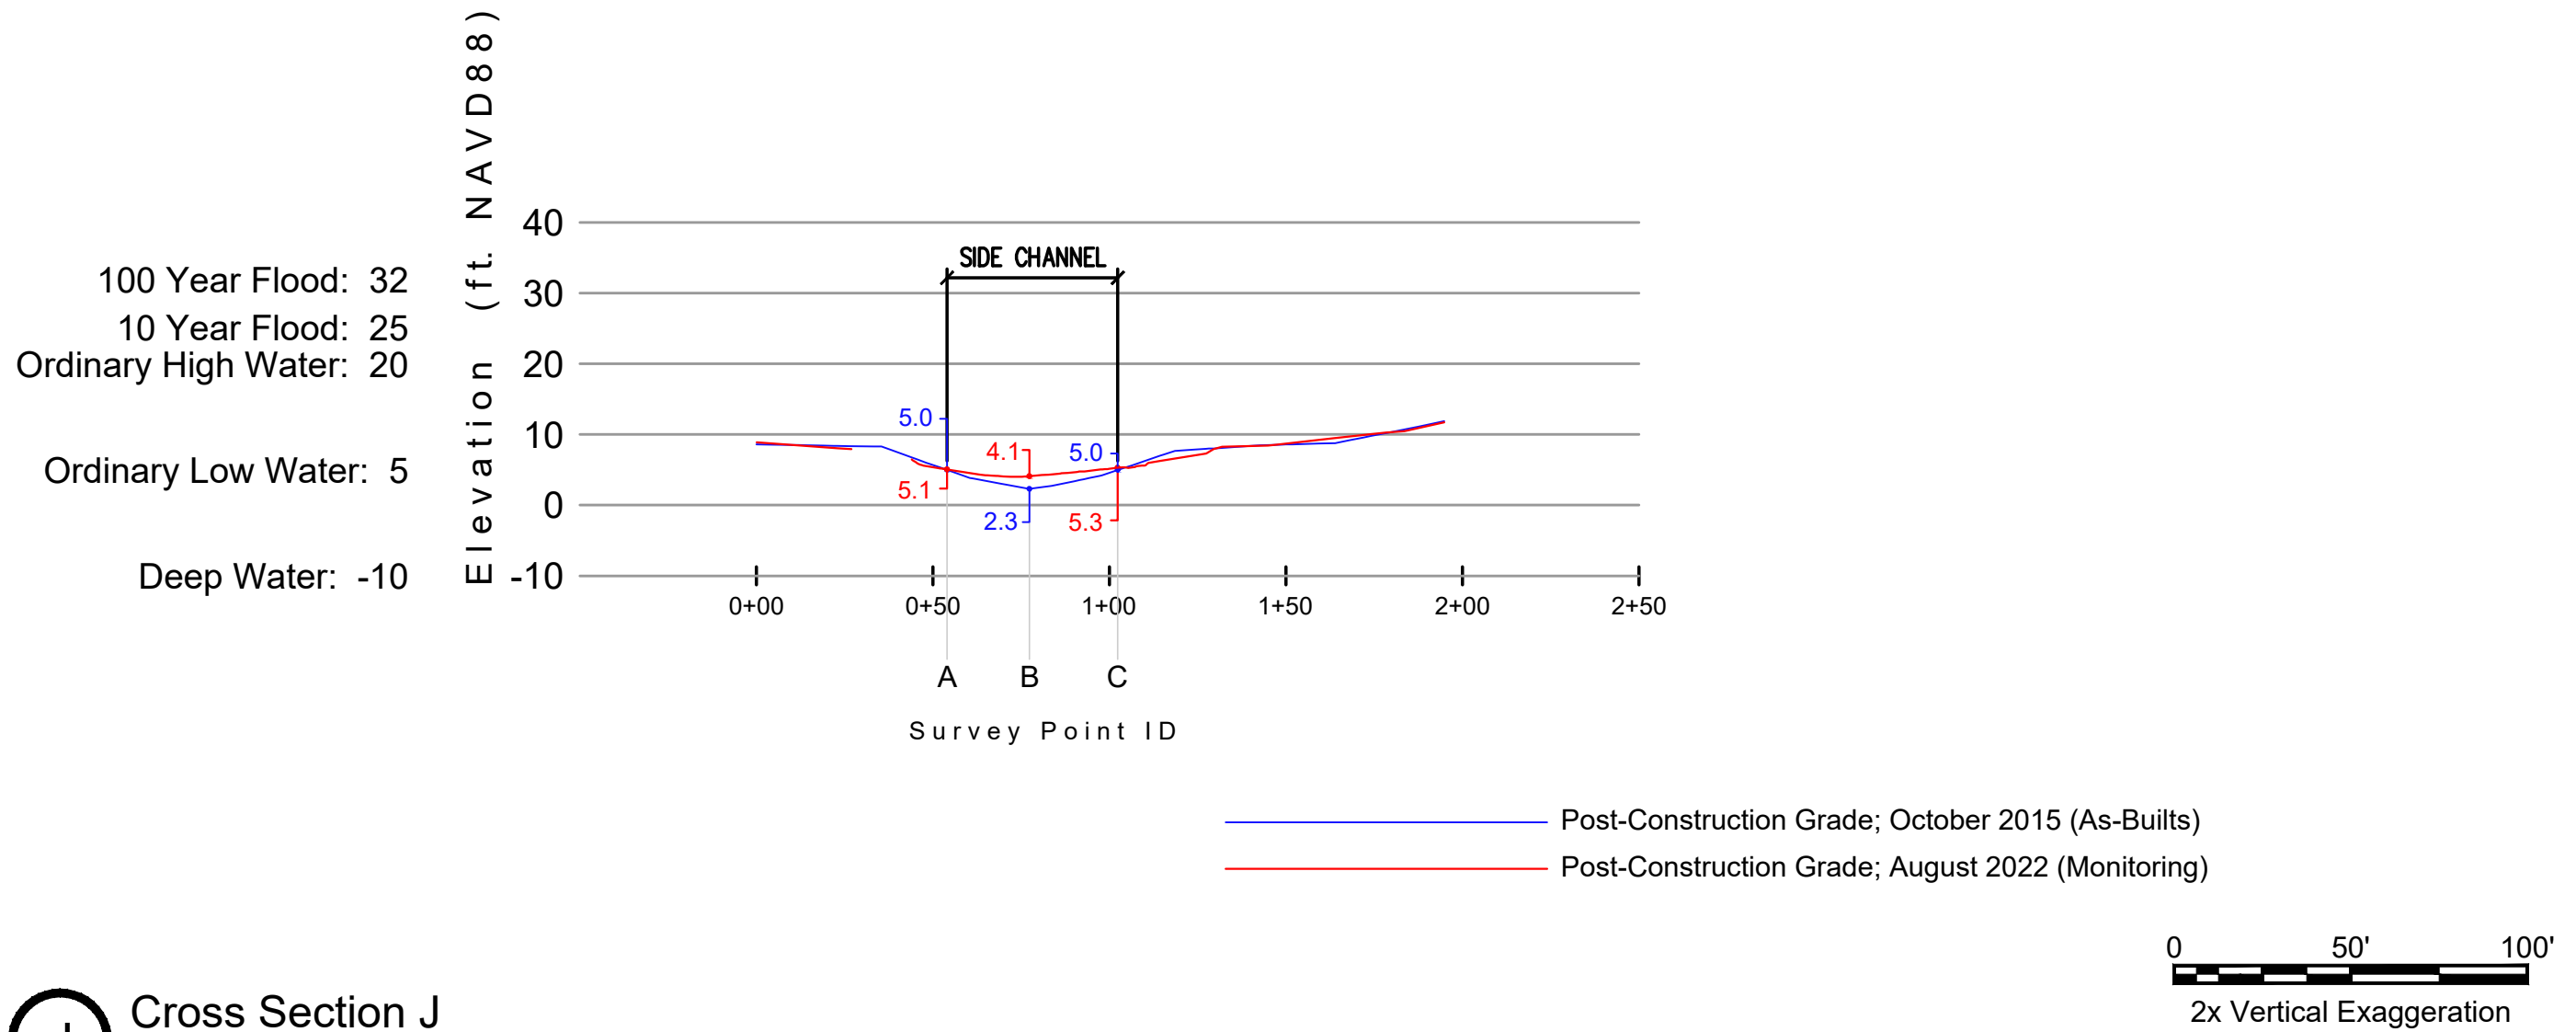
J Cross Section J

Cross Section J									
Survey Point ID	Elevation:		Elevation Change	Depth		Percent Change		Absolute Percent Change	
	October 2015	August 2022		relative to OHW (elevation 20.0)	relative to OHW (elevation 20.0)	Relative to OHW 2015 to 2022	Relative to OHW 2015 to 2022		
A	5.0	5.1	+0.1	15.0	14.9	(14.9/15.0) =	99%	99-100 =	1%
B	2.3	4.1	+1.8	17.7	15.9	(15.9/17.7) =	90%	90-100 =	10%
C	5.0	5.3	+0.3	15.0	14.7	(14.7/15.0) =	98%	98-100 =	2%
Average Distance:			0.7					Average: 4%

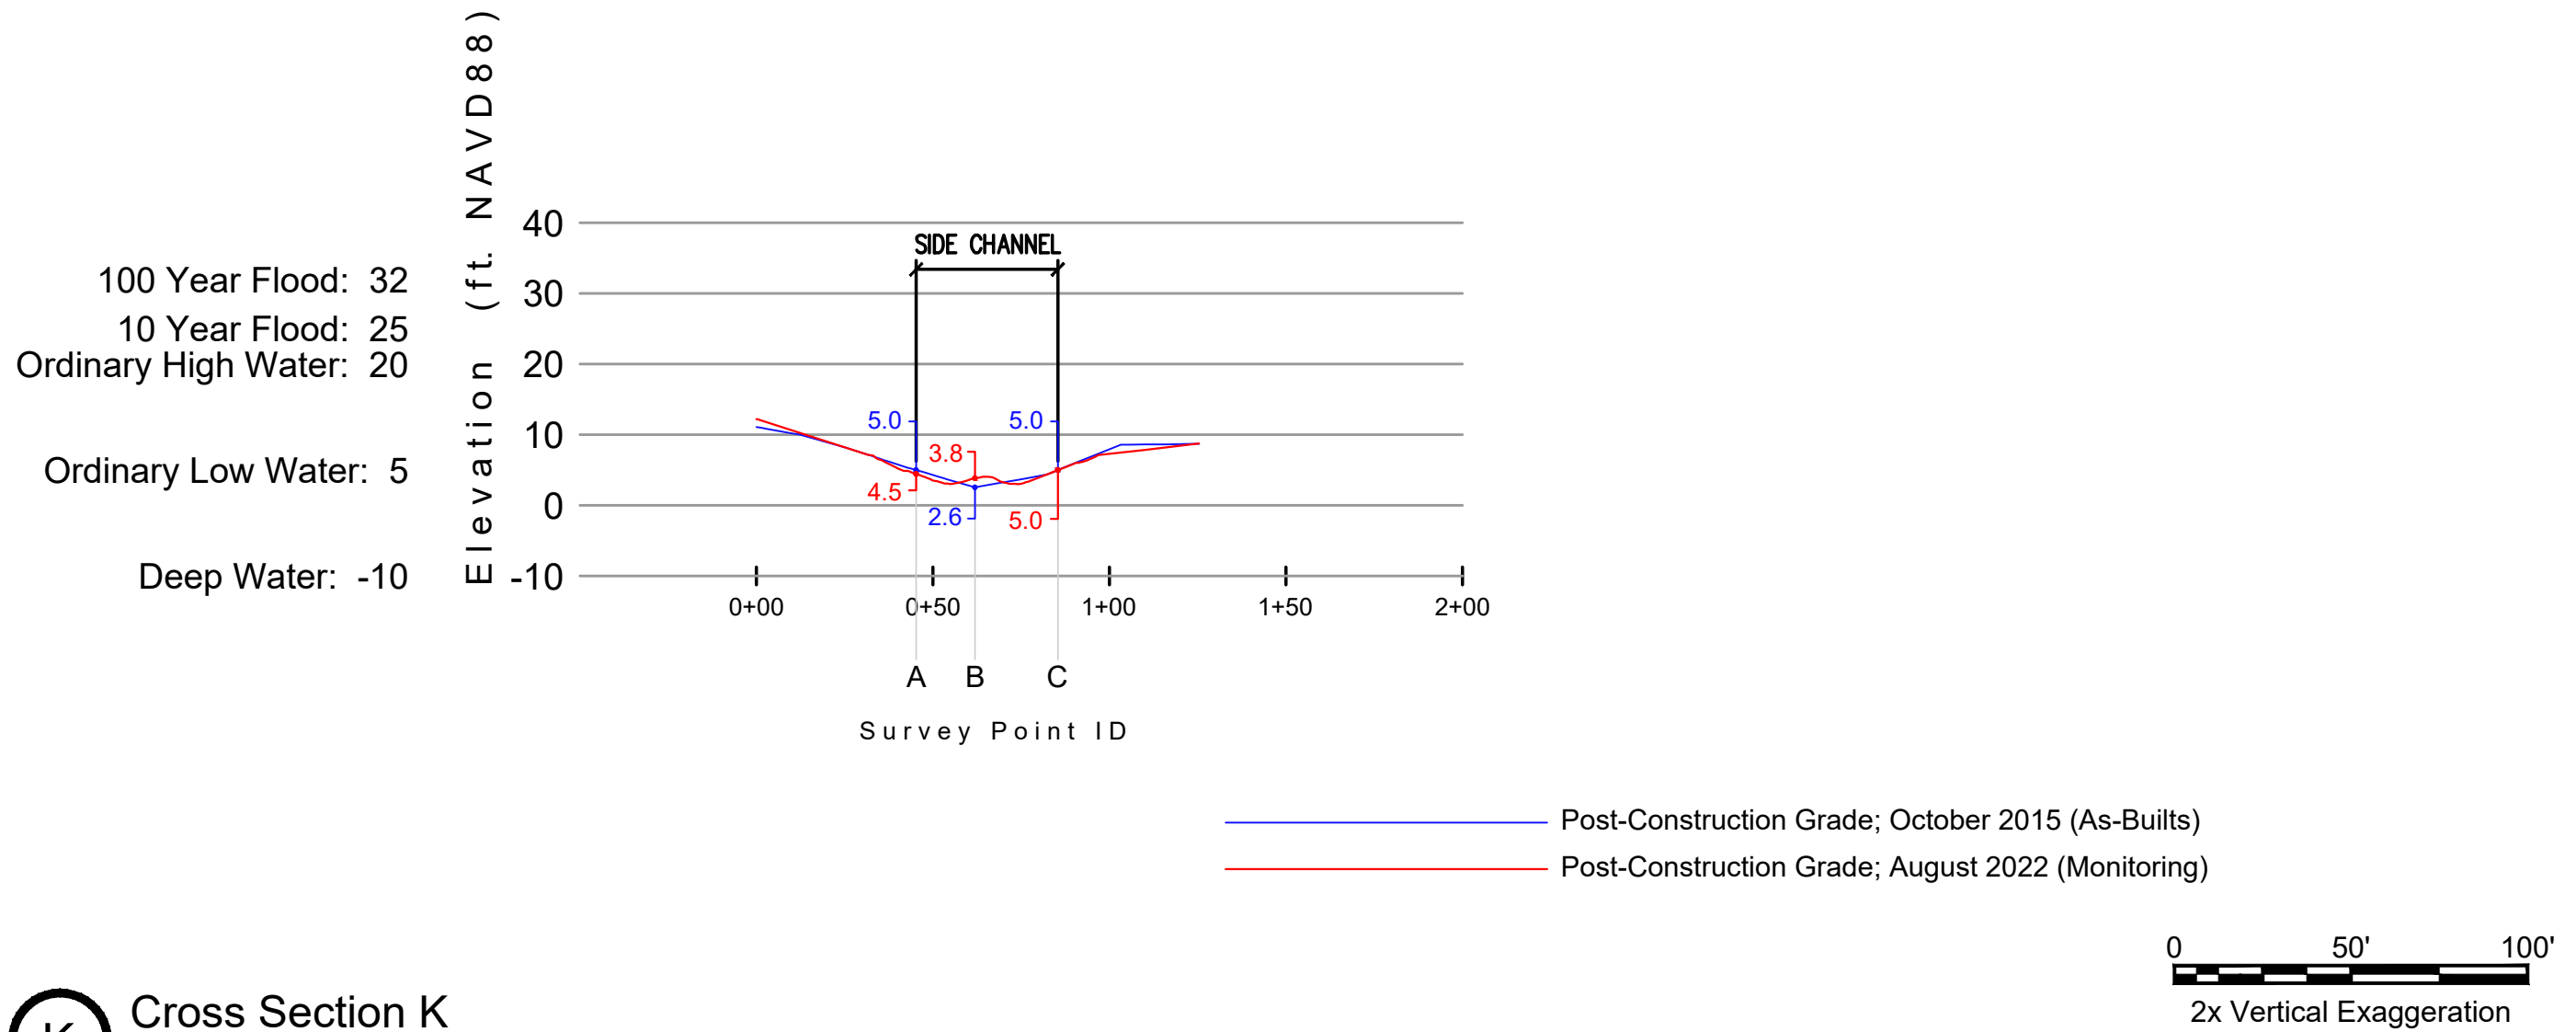
K Cross Section K

Cross Section K									
Survey Point ID	Elevation:		Elevation Change	Depth		Percent Change		Absolute Percent Change	
	October 2015	August 2022		relative to OHW (elevation 20.0)	relative to OHW (elevation 20.0)	Relative to OHW 2015 to 2022	Relative to OHW 2015 to 2022	Relative to OHW 2015 to 2022	Relative to OHW 2015 to 2022
A	5.0	4.5	-0.5	15.0	15.5	(15.5/15.0) =	103%	103 - 100 =	3%
B	2.6	3.8	+1.2	17.4	16.2	(16.2/17.4) =	93%	93 - 100 =	7%
C	5.0	5.0	0.0	15.0	15.0	(15.0/15.0) =	100%	100 - 100 =	0%
Average Distance:			0.6					Average: 3%

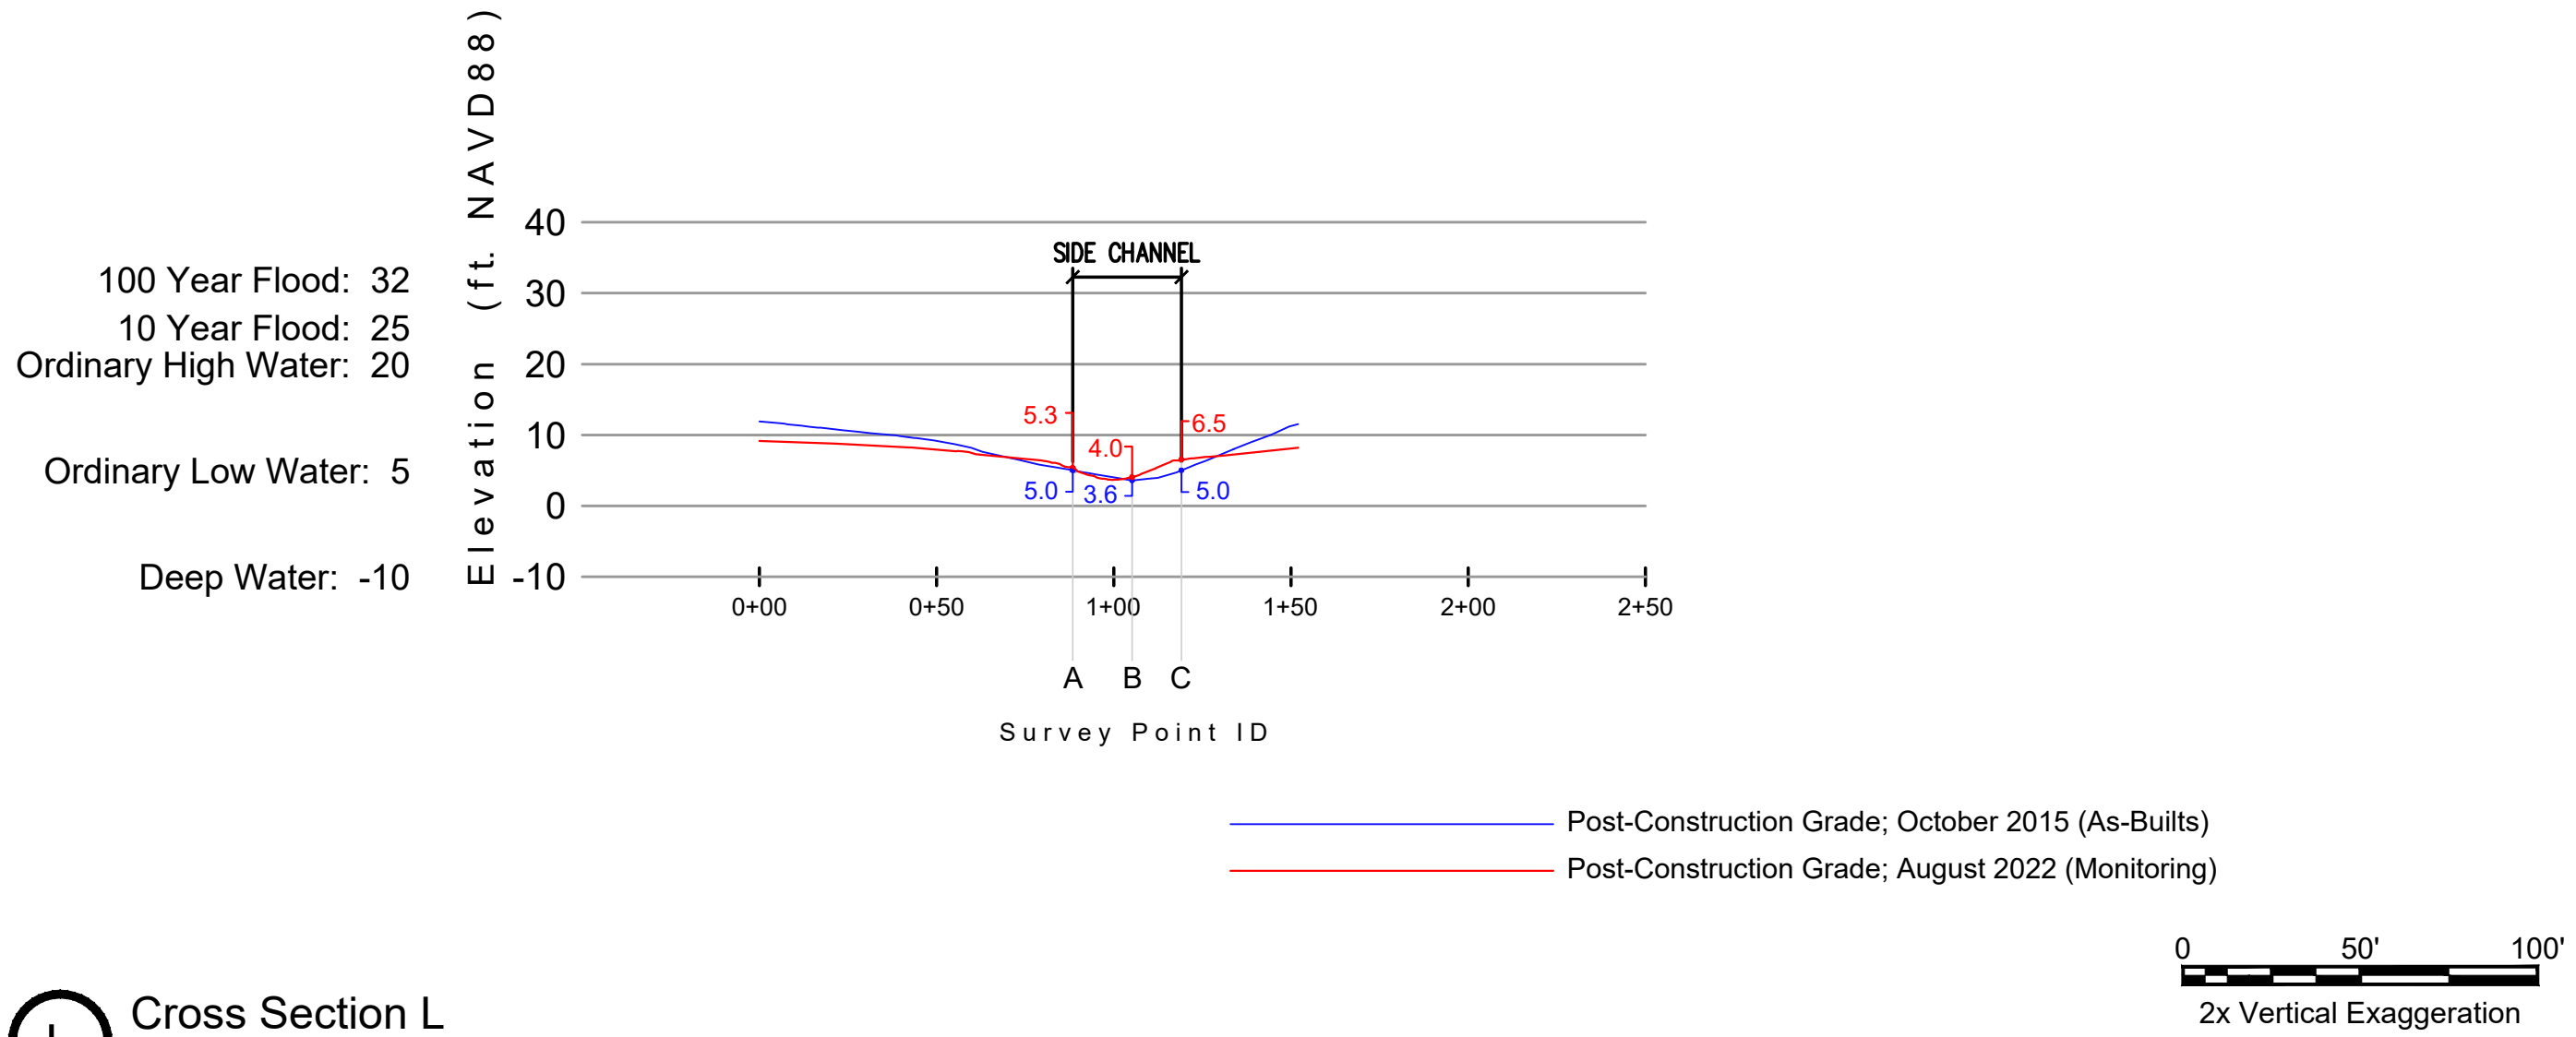
L Cross Section L

Cross Section L									
Survey Point ID	Elevation:		Elevation Change	Depth	Depth	Percent Change		Absolute Percent Change	
	October 2015	August 2022		October 2015 relative to OHW (elevation 20.0)	August 2022 relative to OHW (elevation 20.0)	Relative to OHW 2015 to 2022		Relative to OHW 2015 to 2022	
A	5.0	5.3	+0.3	15.0	14.7	(14.7/15.0) =	98%	98 - 100 =	2%
B	3.6	4.0	+0.4	16.4	16.0	(16.0/16.4) =	98%	98 - 100 =	2%
C	5.0	6.5	+1.5	15.0	13.5	(13.5/15.0) =	90%	90 - 100 =	10%
Average Distance:			0.7					Average: 5%

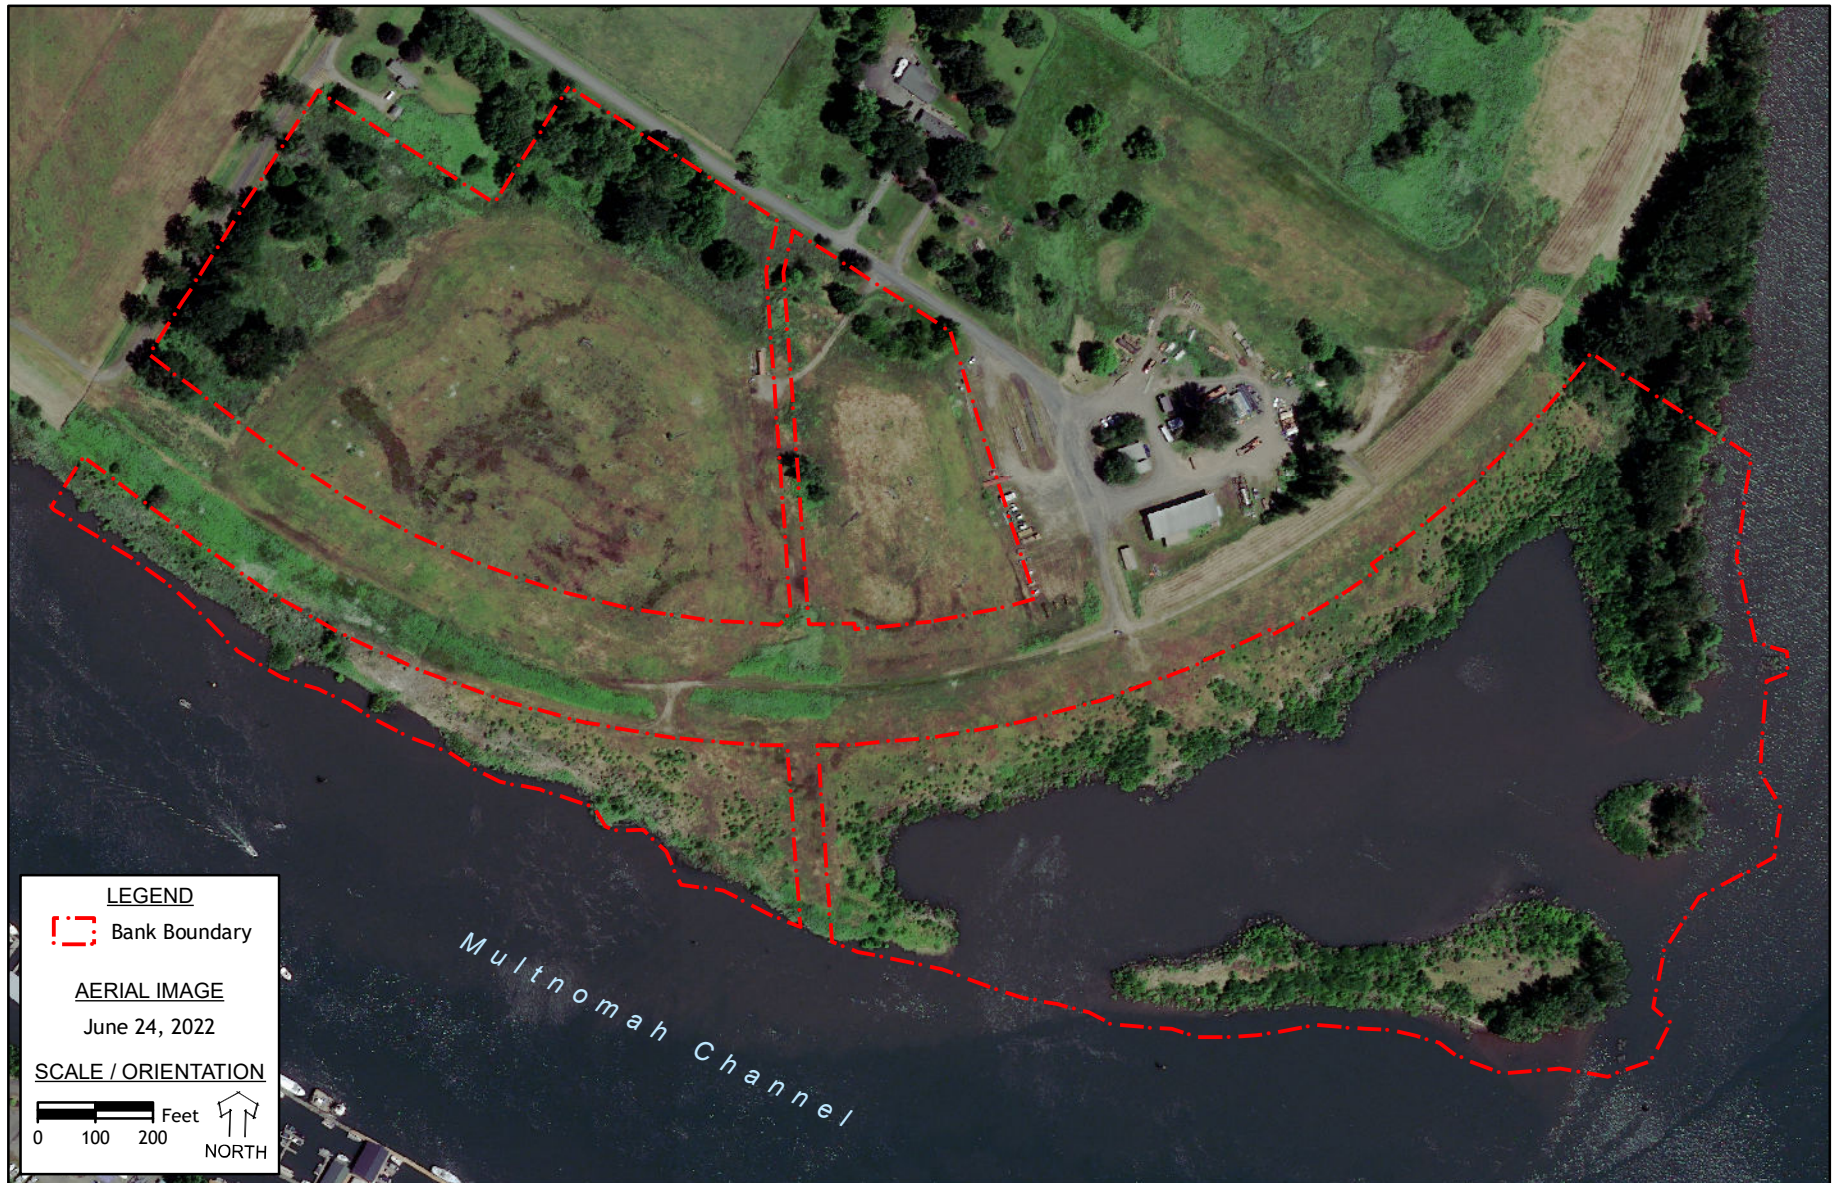
Figure 6q
Aerial Photo showing High Water - 06/24/2022

Wildlands' staff again attempted to use a drone to take aerial photos of high water events during the 2022 monitoring period; however, staff was unable to obtain any useable images due to windy, rainy, and/or cloudy conditions. Satellite imagery was obtained for 6/24/2022 which was just a few days after the high water period of 2022 (**Figure 6q**). While Wildlands' GIS specialist was able to translate the approximate area of inundation captured by the satellite photo to GIS to calculate the approximate acreage of inundation shown on the photo (as requested by the Trustees), it should be noted that this method of calculating site inundation would yield only the approximate area of inundation for that particular moment in time and does not represent the extent of ACM on the site or the maximum level of inundation during a particular monitoring year. The information obtained from the satellite photo was compared to data from the onsite data loggers and the Columbia Slough gauge for accuracy. The aerial photo from 6/24/2022 was taken when water levels were shown at the Columbia Slough gauge to be approximately 17.3' NAVD and the GIS translation of the inundation shown on the aerial photo from 6/24/2022 was approximately 16 acres of ACM inundated. The highest water elevation of the 2021-2022 water year occurred on June 14 when the water reached an elevation of approximately 21.5' NAVD. AKS collected a total of 203 assessment points along elevation 20 in order to measure the active channel margin onsite in Year 7 (2022). Due to thick vegetative conditions, some of the areas along elevation 20 were inaccessible. These areas are shown on **Figure 6d**. The ACM acreage from the as-built drawings was 20.351 acres. The 2022 ACM acreage is 20.259 acres. The difference between the two acreages is 0.092 which represents less than one half of 1% reduction in ACM area. This is well below the 10% threshold.

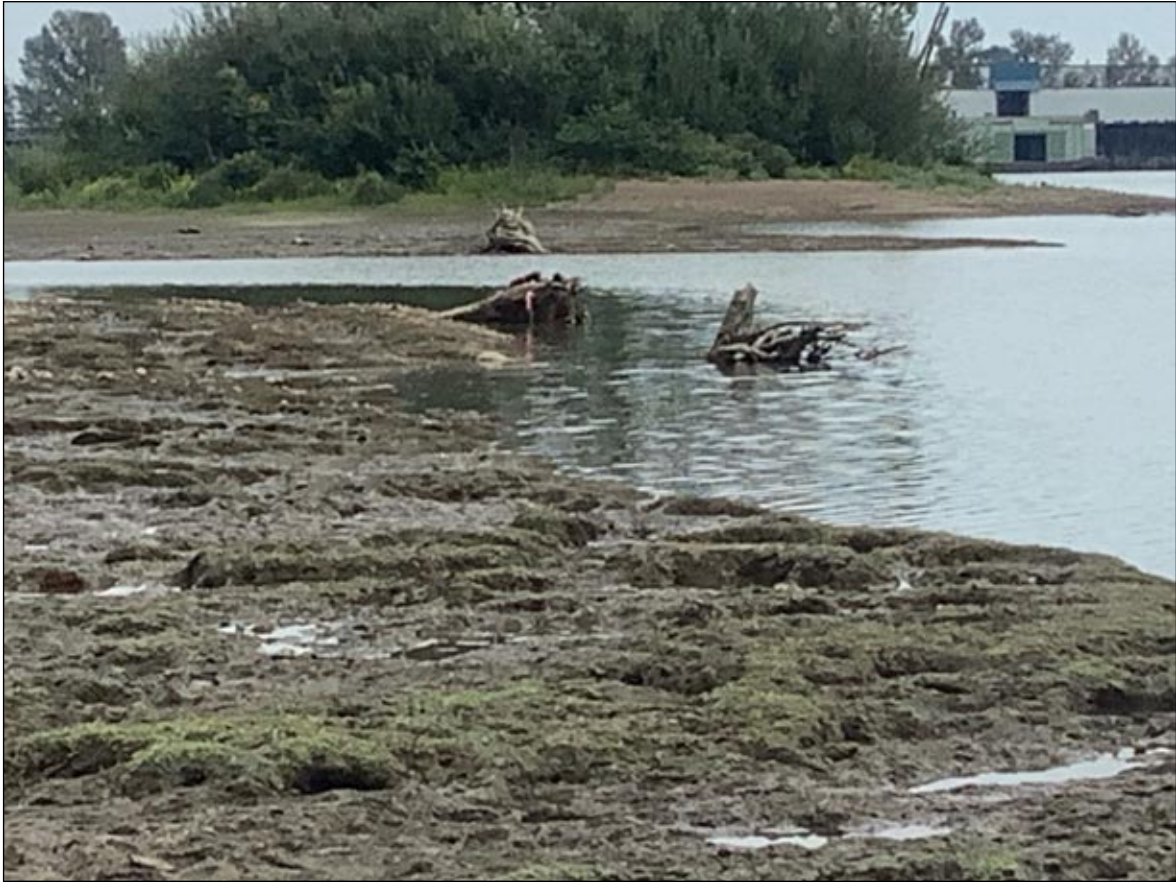
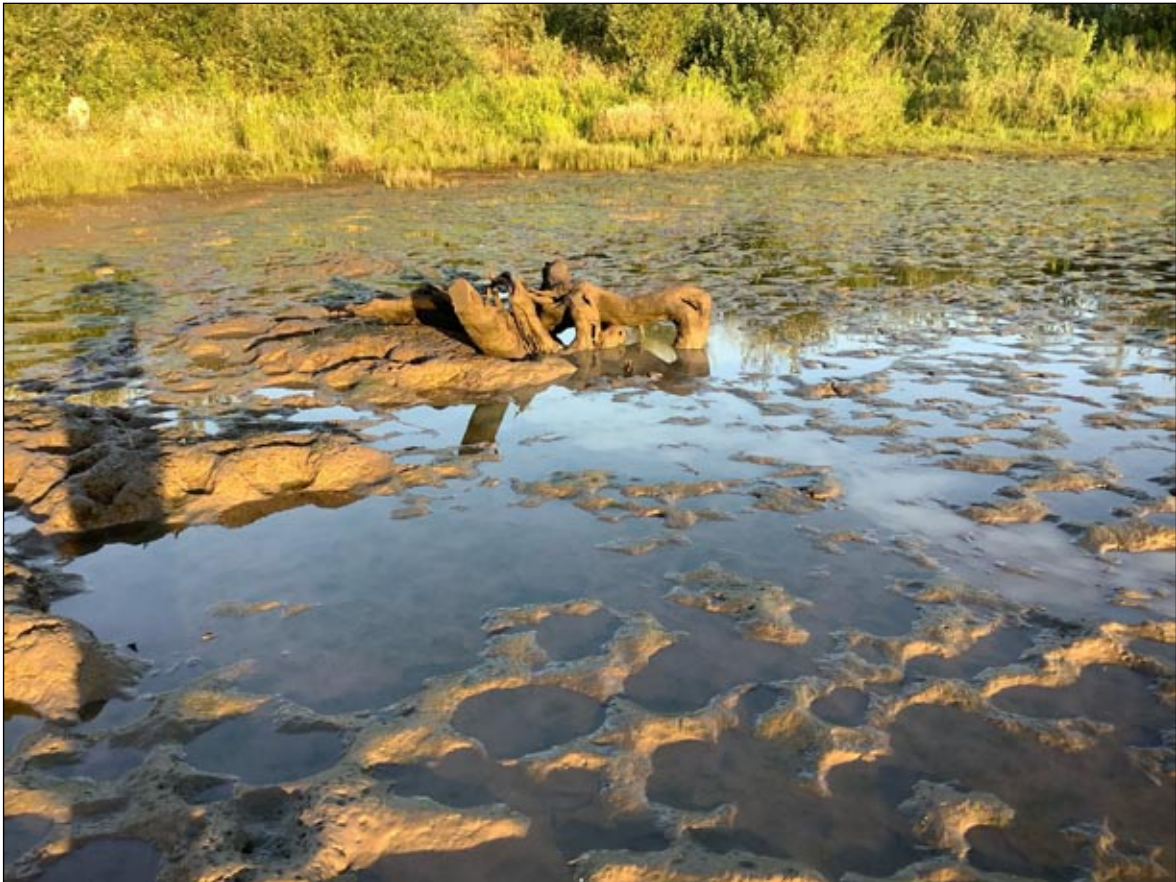
Figure 7
Large Woody Debris

Large woody debris (LWD) monitoring took place on August 16-18, 2022. A total of 65 pieces of LWD were documented onsite consisting of 43 pieces of LWD originally installed and 22 pieces of LWD naturally recruited, which is the same count as the last monitoring event in Year 5. Currently the Project is exceeding the 80% required LWD retention performance standard for Year 7. Representative photos of the LWD observed during surveys can be found in Figure 7. The remaining habitat complexity features of downed wood, debris piles, and rock piles all remain in good condition. Monitoring of the large woody debris and other habitat complexity features will continue in Year 10 (2025).

If the amount of large wood on-site fails to meet performance standards in Years 2, 3, 5, 7 or 10 and if existing conditions and hydraulics will allow the retention of replacement materials, LWD will be installed in the interior channels (and marsh/mudflat where appropriate) to achieve the targeted density.

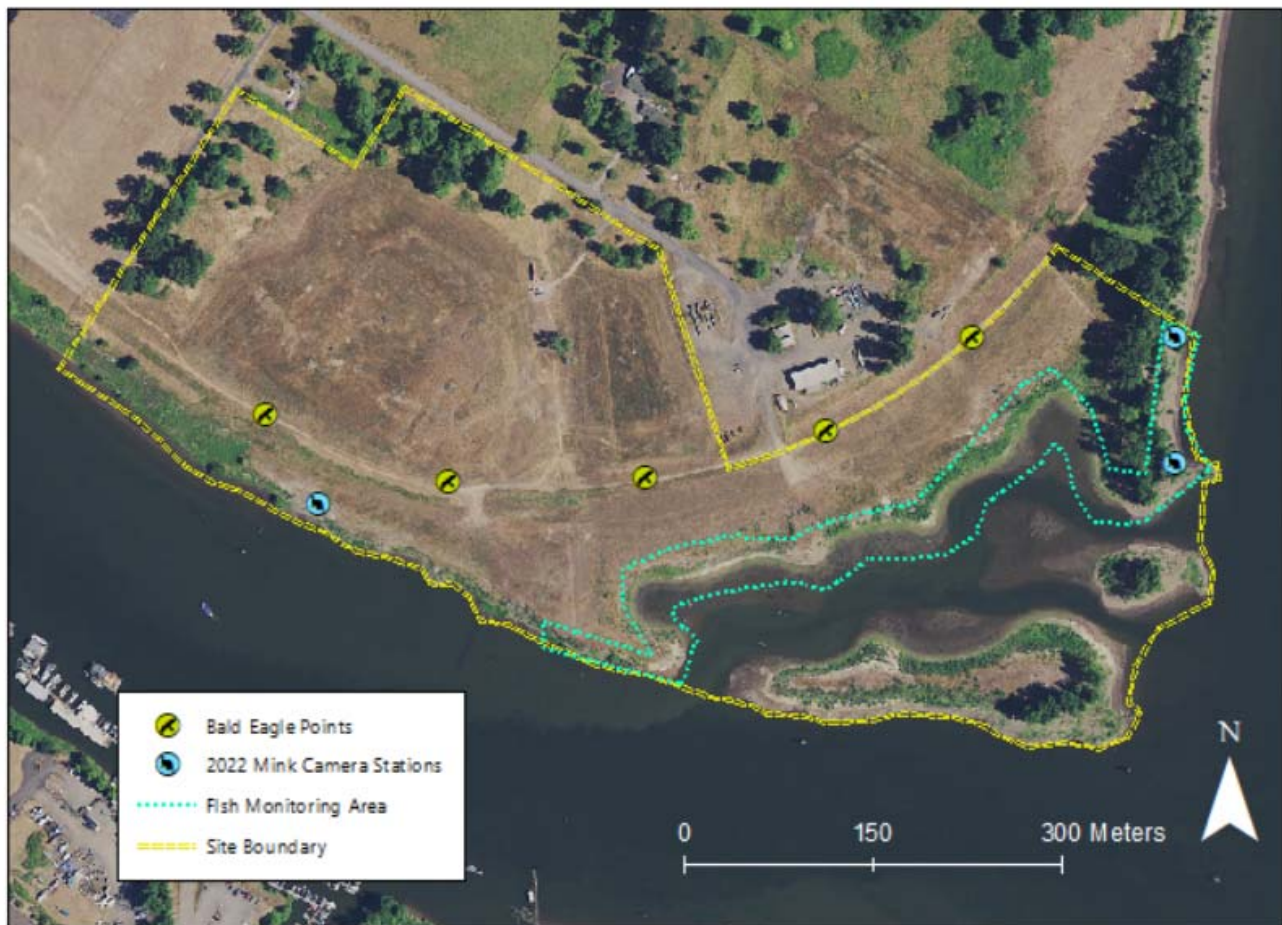
Figure 1. Survey area and monitoring locations

The survey area is located in the Portland Harbor, at the southernmost tip of Sauvie Island where the confluence of Multnomah Channel and the Willamette River occurs (Figure 1). Formerly a 64-acre sawmill complex before restoration activities took place, the area now includes restored side channels, roughly nine acres of improved beaches, mudflats, and marsh habitat, 27 acres of riparian habitat, and 13 acres of oak woodland habitat with several large snags.
