Alder Creek Restoration Project

2022 Monitoring Report Year 7

Wildlands PNW
Portland Harbor Holdings II, LLC
Contact: Julie Mentzer
503-241-4895

February 2023

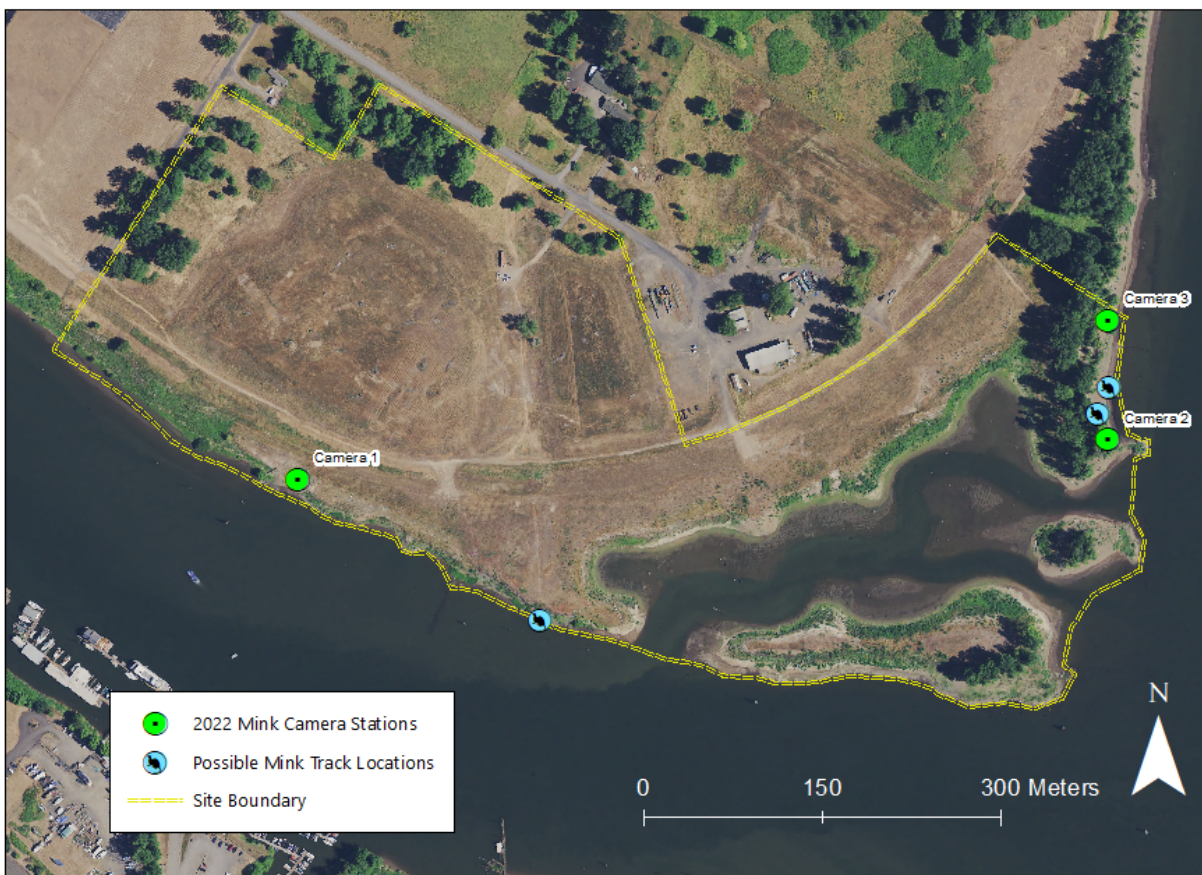
Figure 3. Locations of possible mink tracks in 2022

During the 2022 survey period, Turnstone conducted six mink sign surveys. Possible mink tracks were noted on May 21 along the Multnomah Channel shoreline, nearest to Camera 1. On September 2, possible mink tracks were noted just north of Camera 2. In addition, Wildlands personnel noted possible mink tracks on May 11 north of Camera 2. No individuals, scat, or den sites were found during field sign investigation surveys. Other wildlife signs noted included Canada goose, black-tailed deer, raccoon, nutria (*Myocastor coypus*), coyote, and river otter (*Lutra canadensis*).
