**YEAR 3 (2022)
MONITORING REPORT
Linnton Mill Restoration Site**

DECEMBER 2022 *UPDATED MARCH 2023*

RestorCap LLC
337 17th Street, Suite 200
Oakland, CA 94607

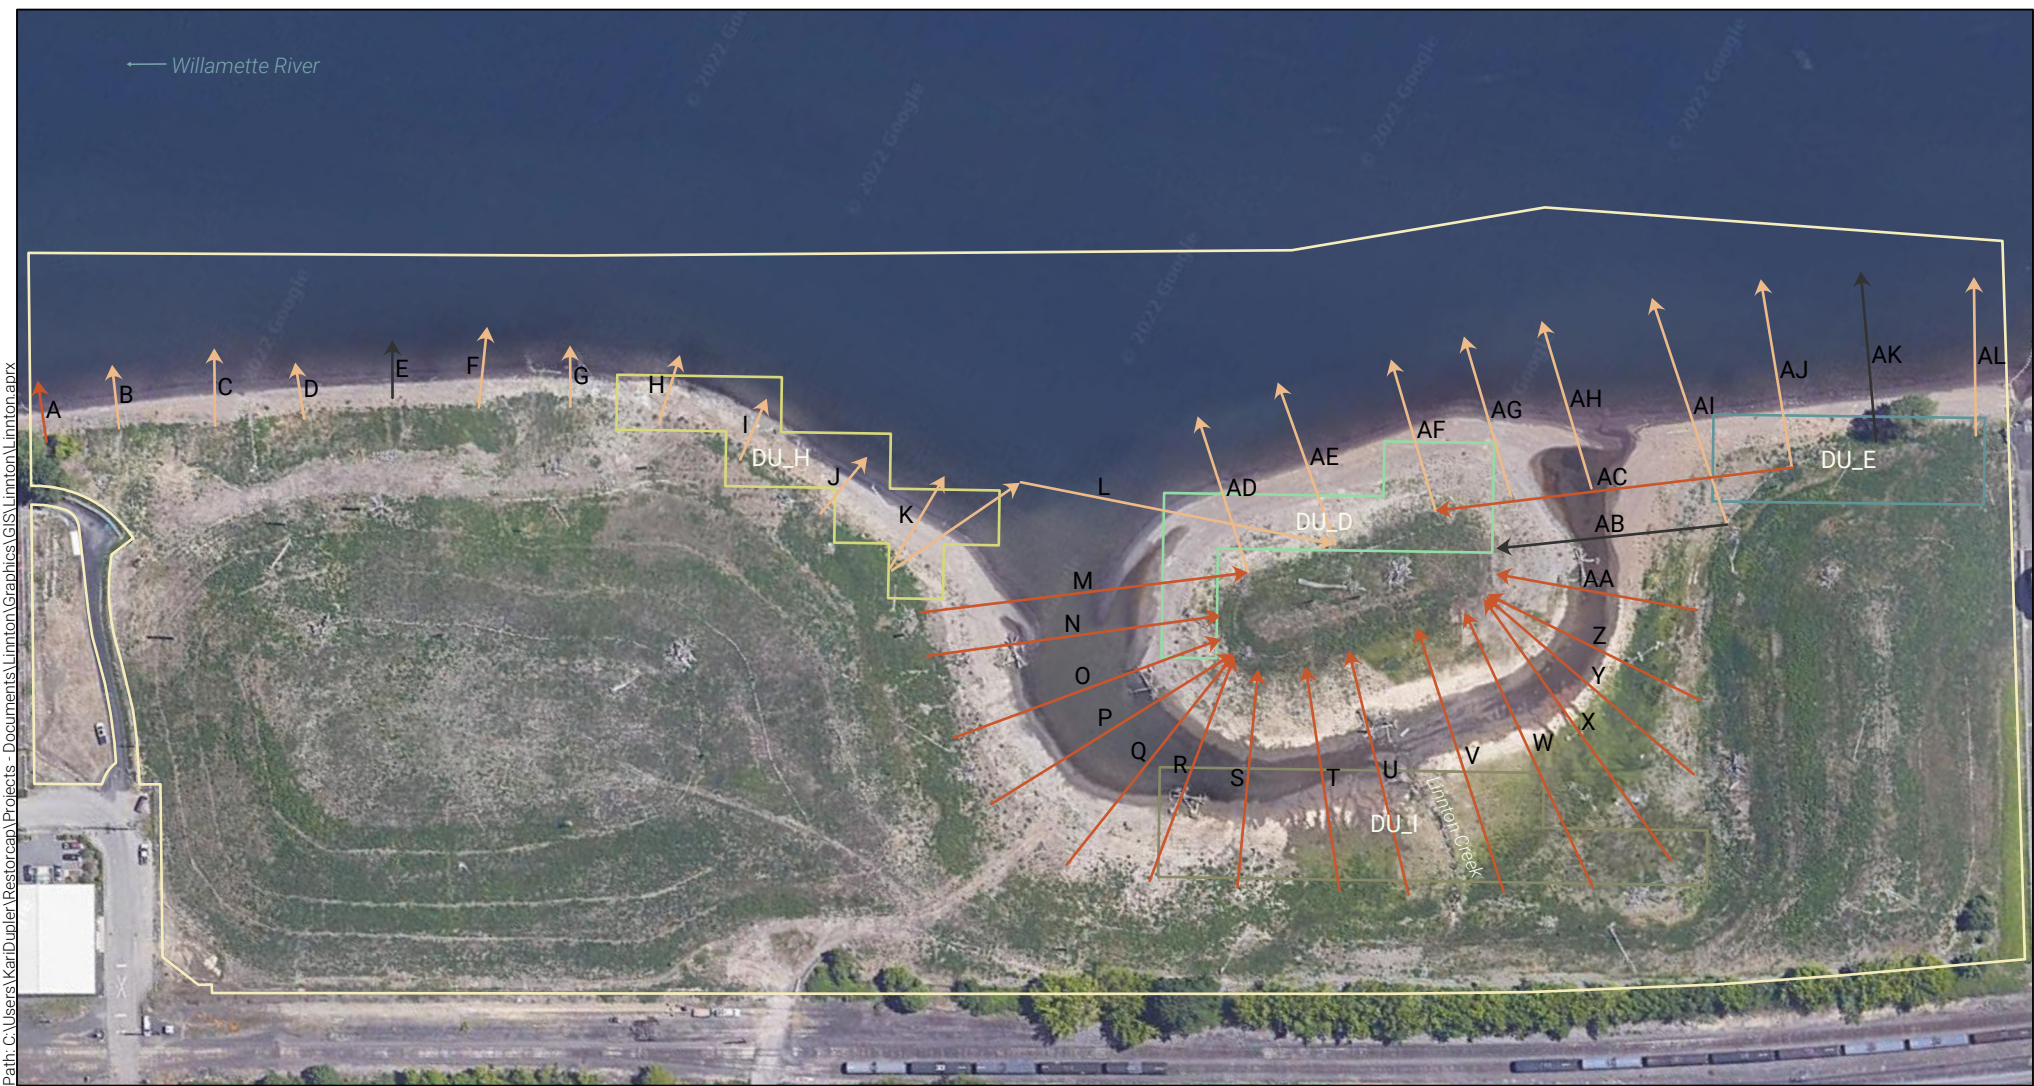
FIGURE 3

To assist in tracking elevation changes within the aquatic restoration area, those transects located within decision units D, E, H, and I are noted below and on Figure 3.

Topographic Monitoring Transects

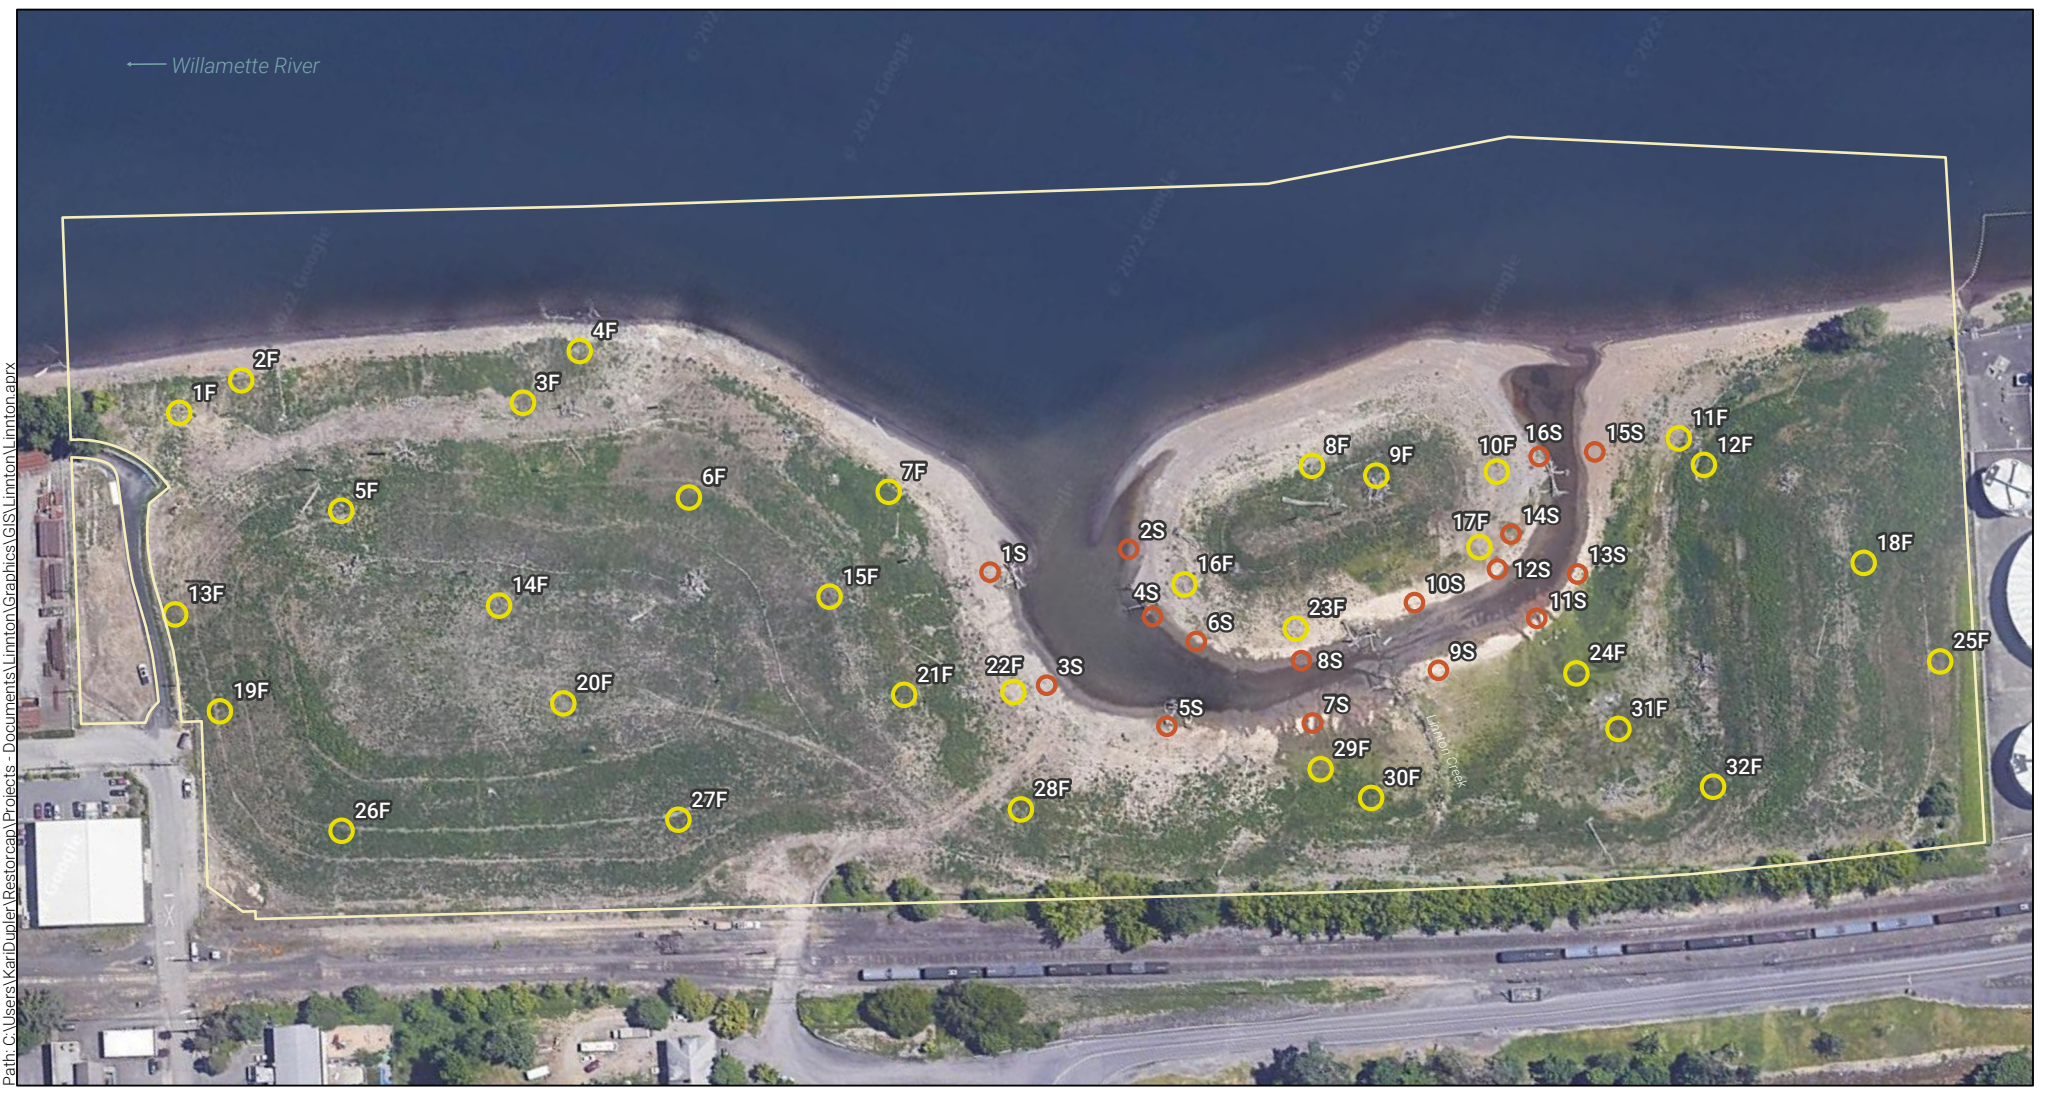
FIGURE 4

Vegetation Monitoring Plots

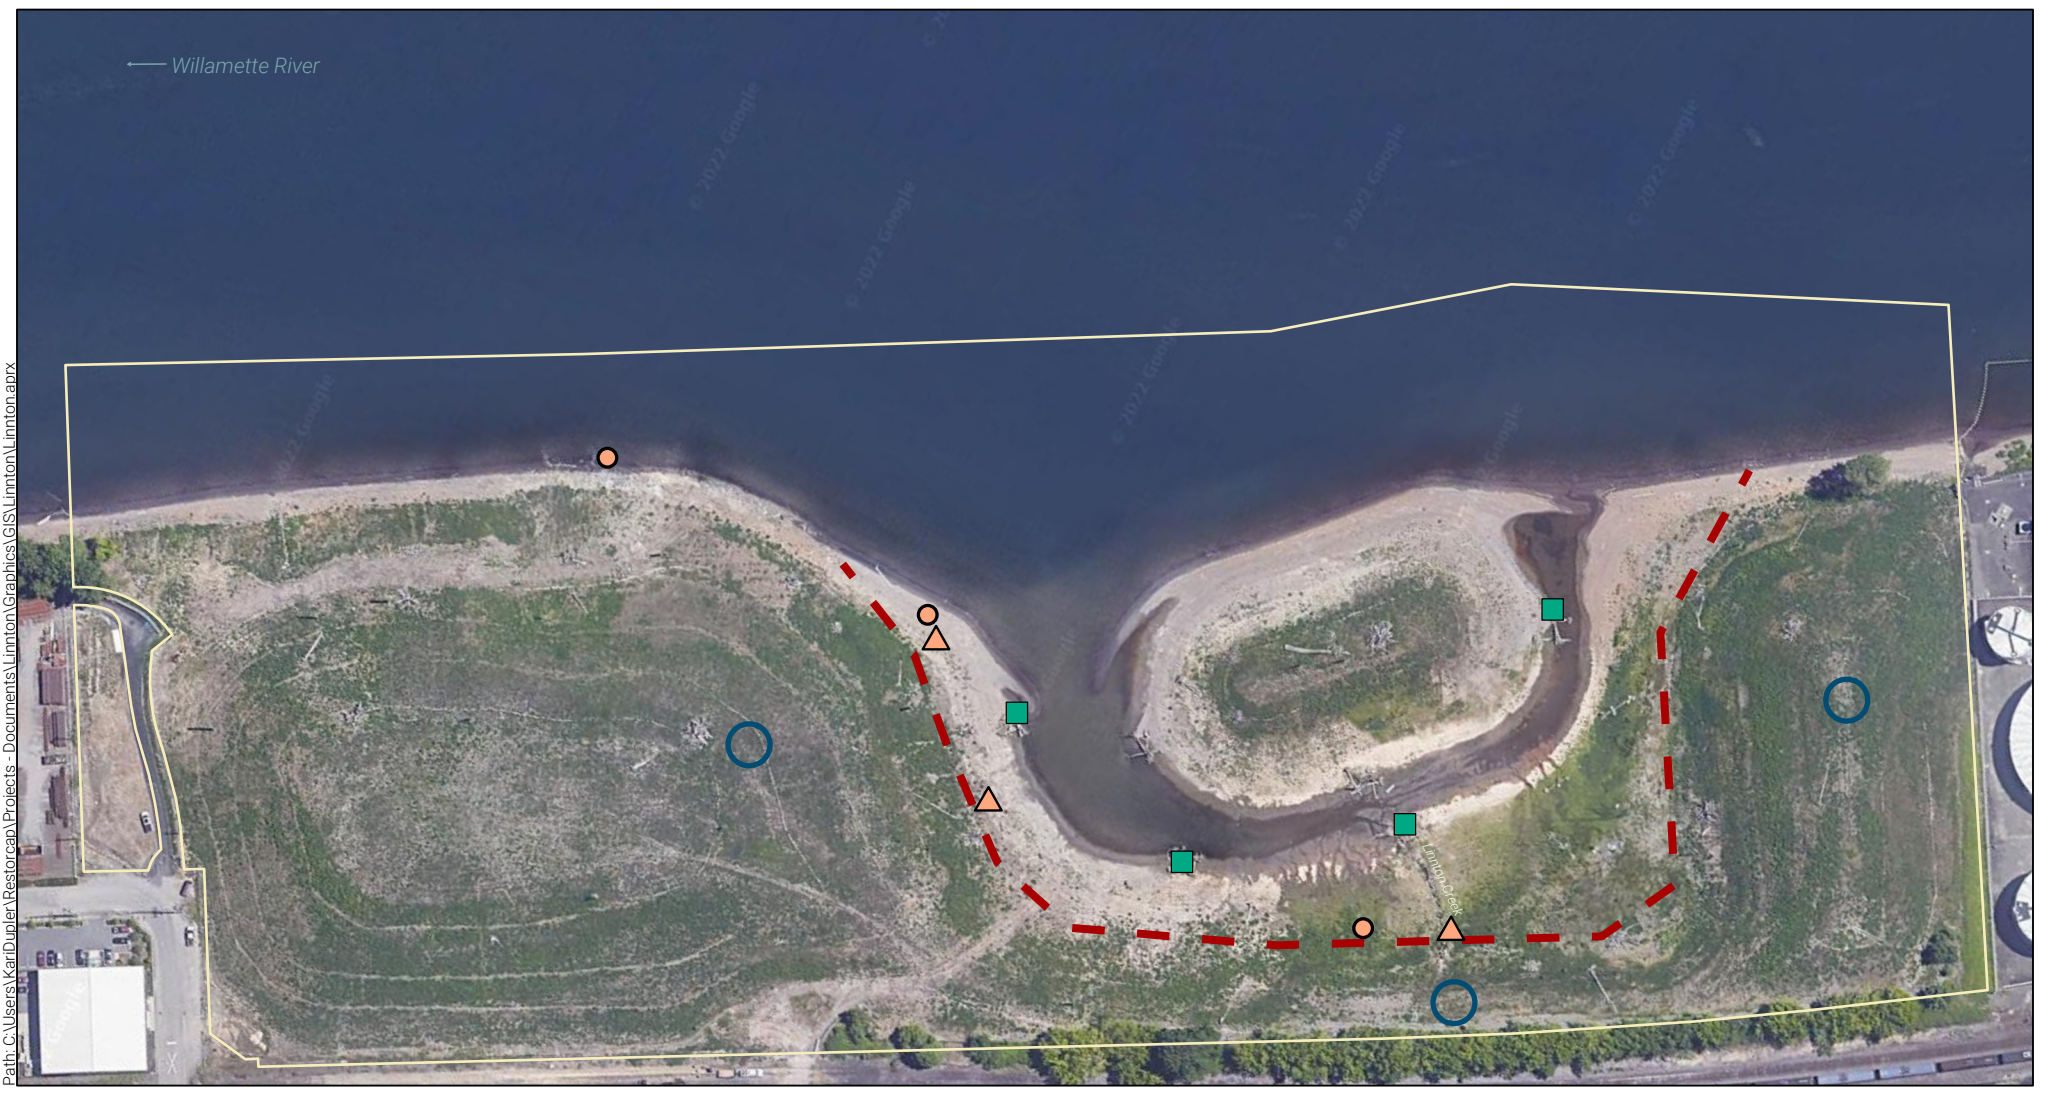
FIGURE 6

Wildlife Monitoring

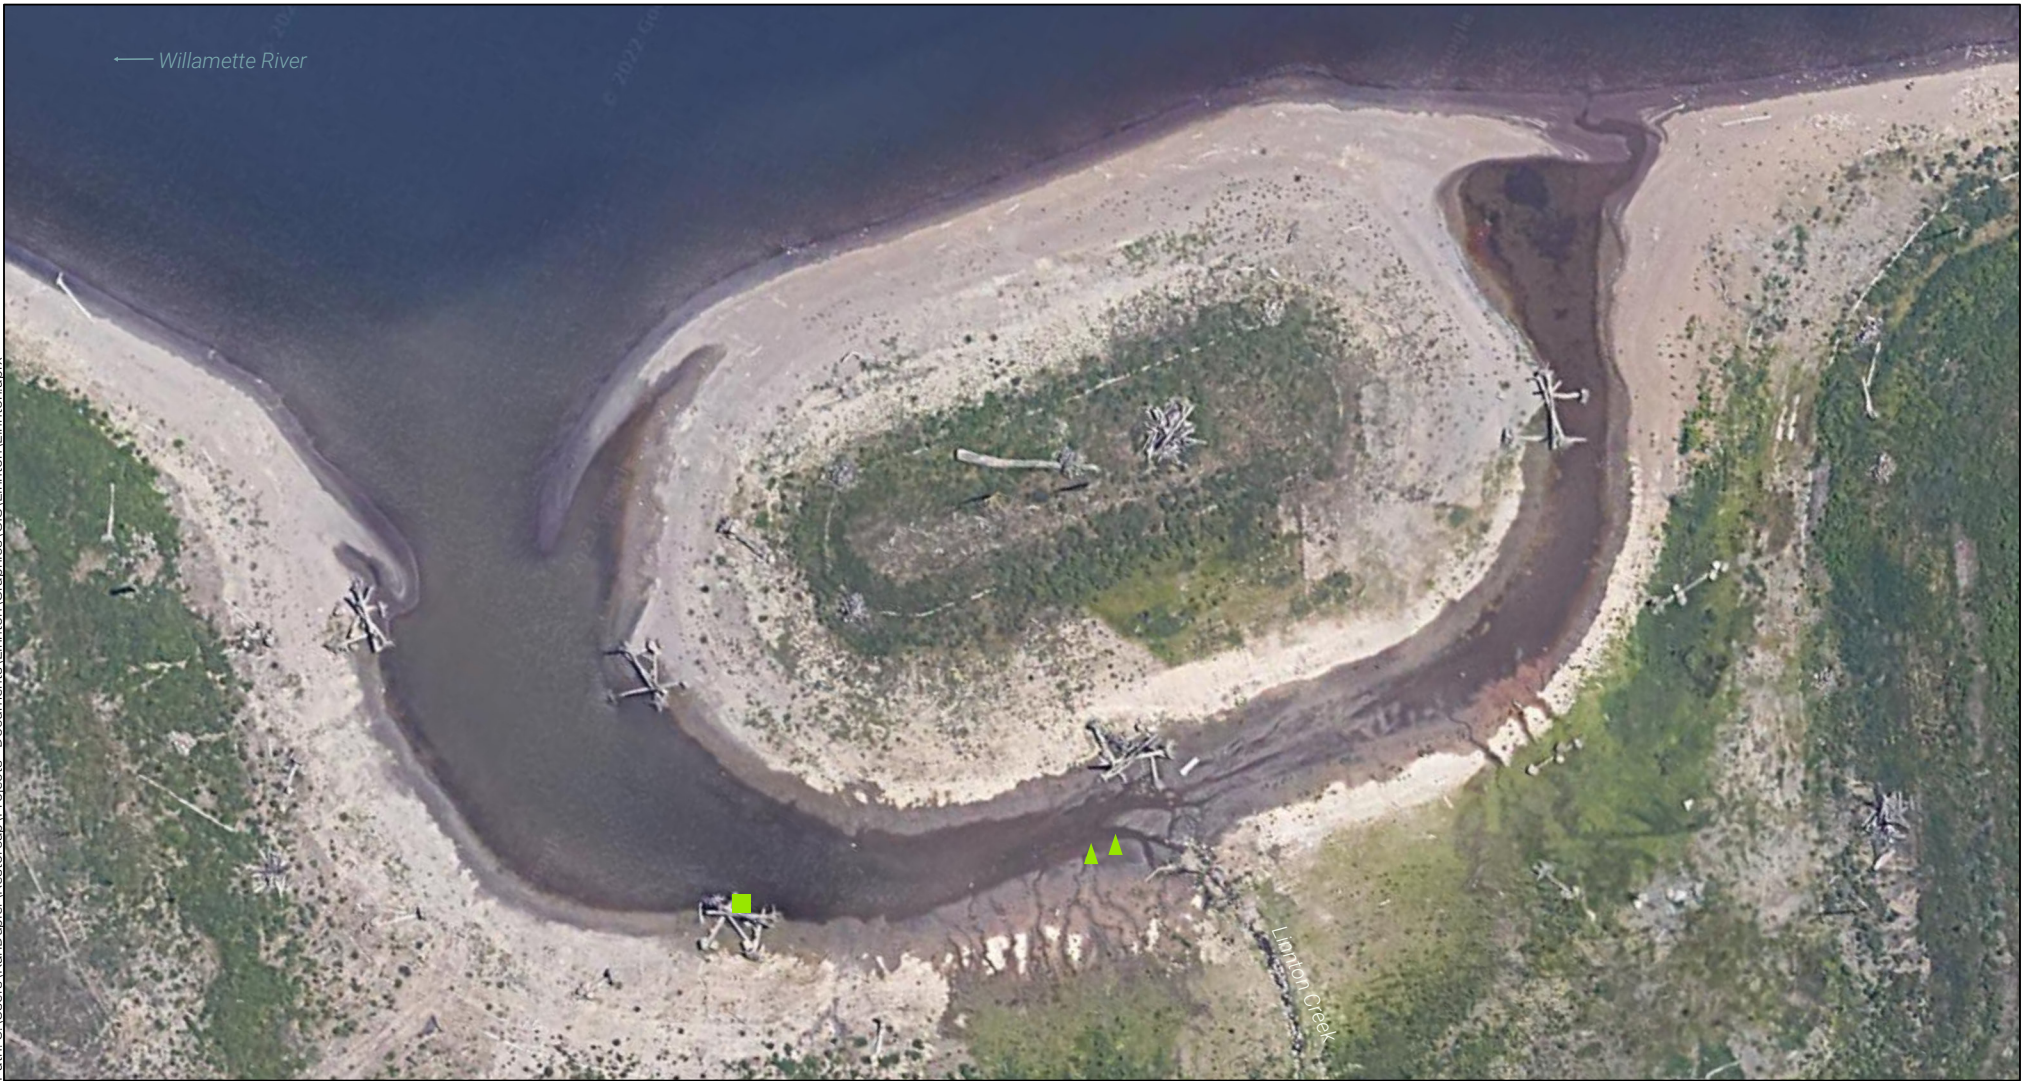
FIGURE 7

Fish Monitoring

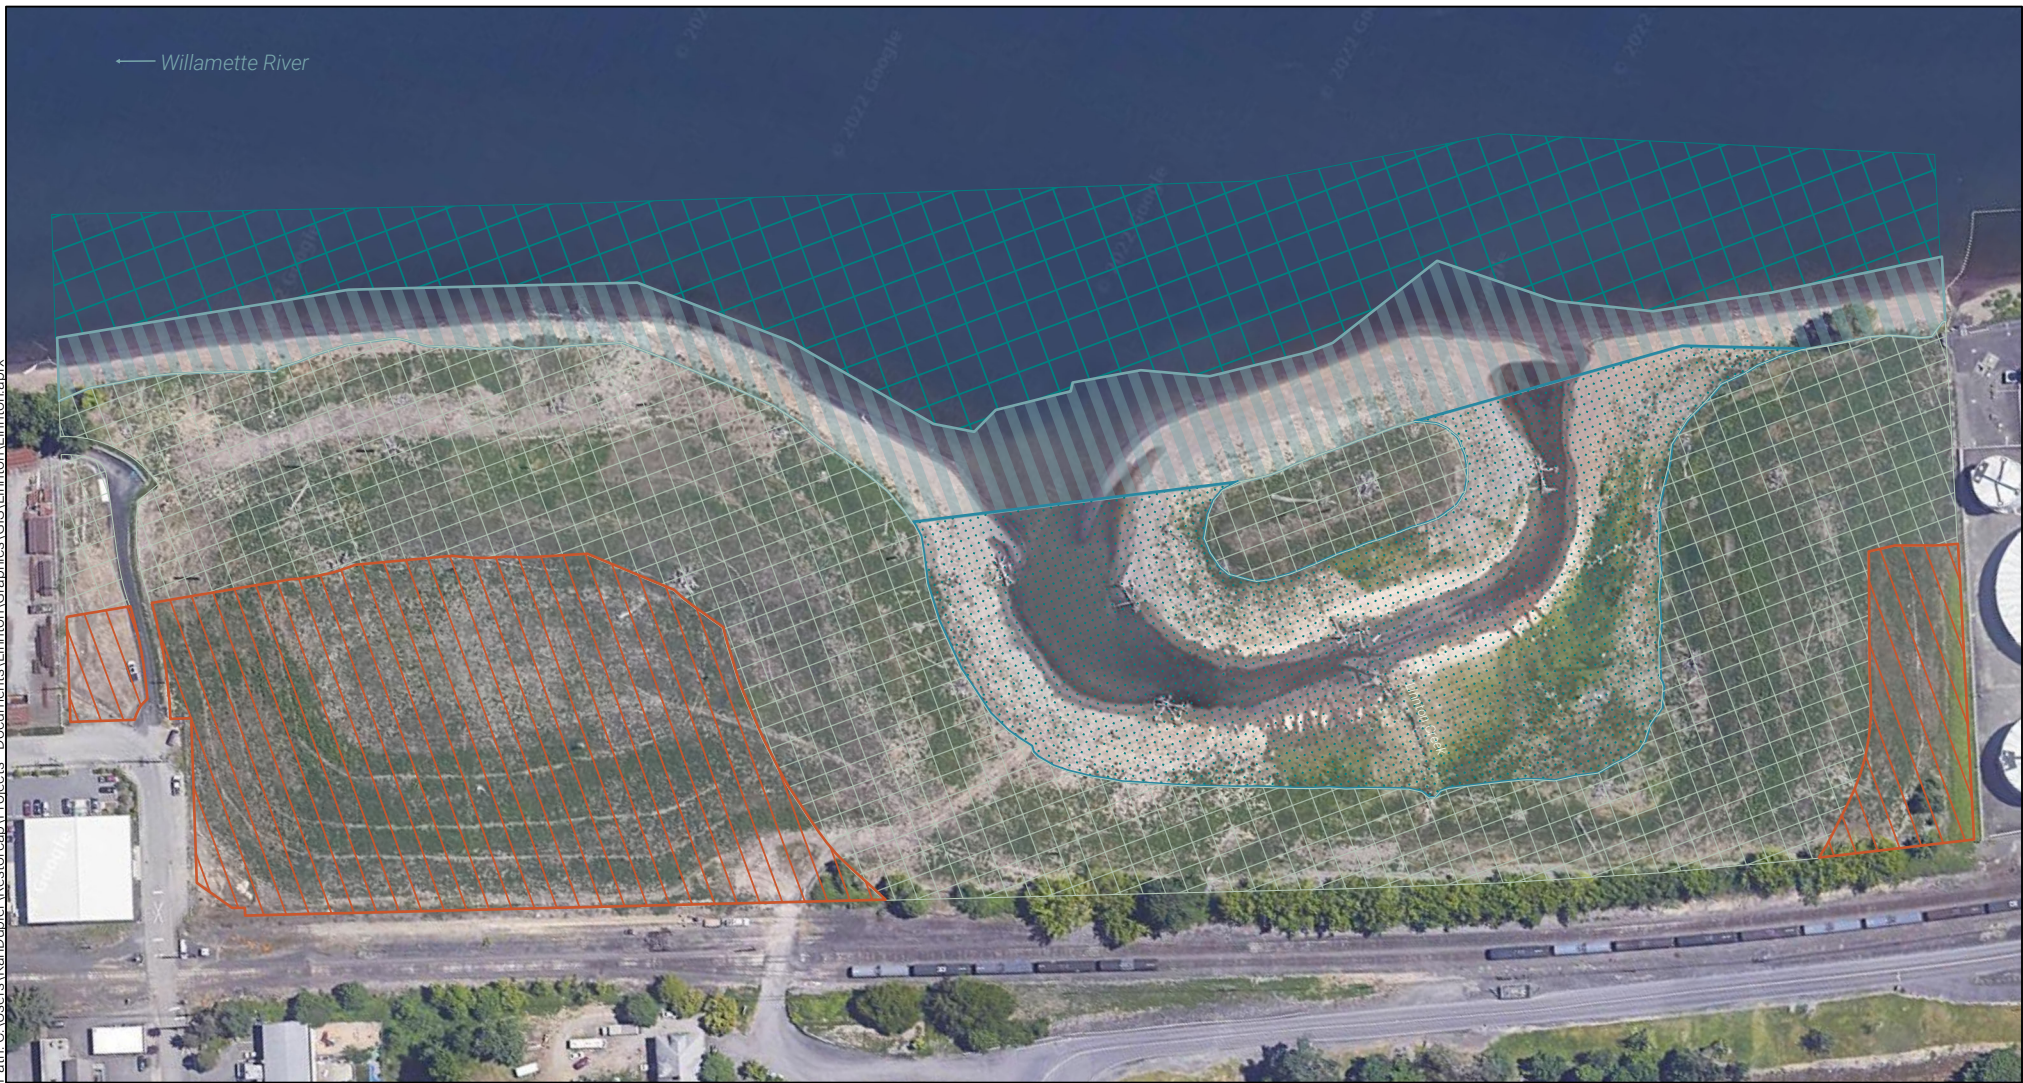
FIGURE 8

As described in Section 3, vegetation monitoring in 2022 was conducted in two surveys timed to the growth period of each specific habitat. High water in June and July caused grass die-off in the elevation zone from approximately 13 to 16 ft, which reduced herbaceous cover in a few of the shrub and forested plots in this area. The area is approximately 1,500 sq ft located southwest of plot 9S.

Adaptive Management Planting

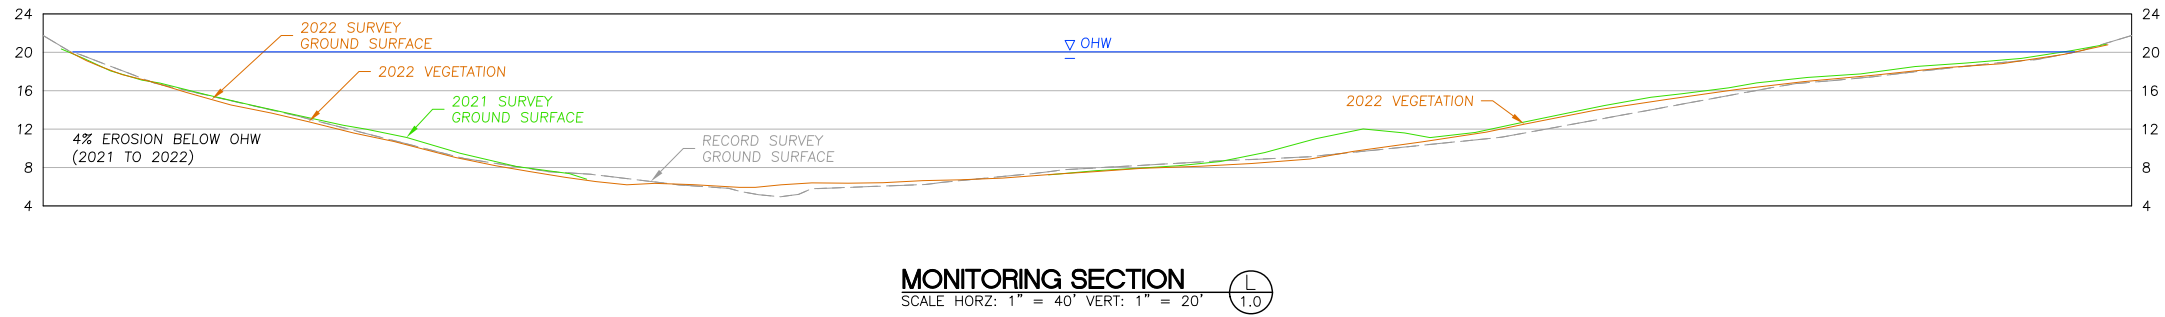
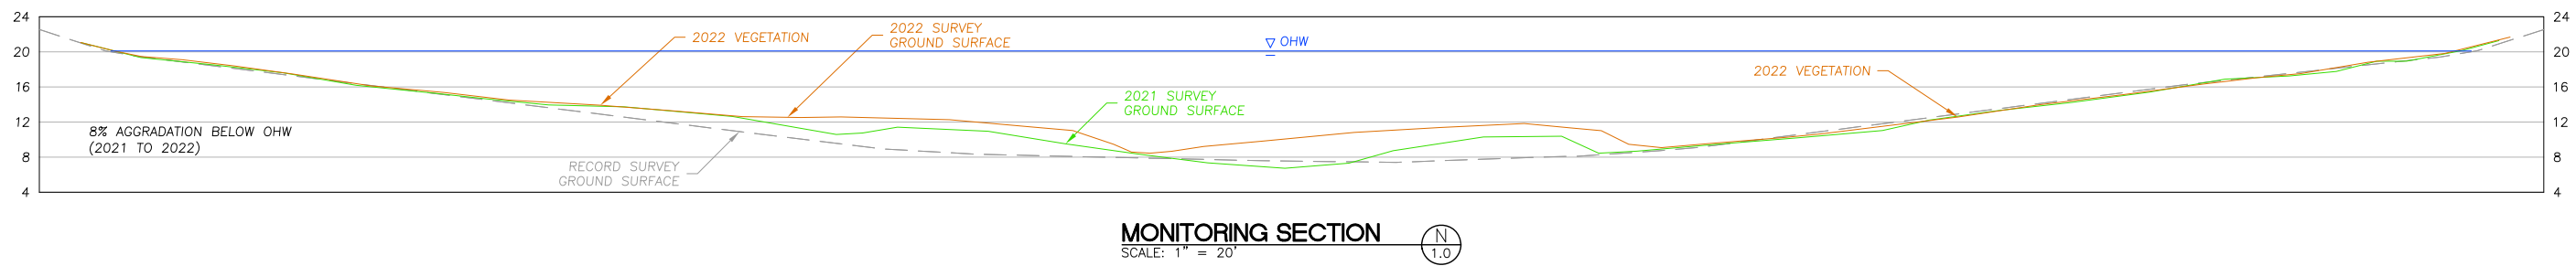
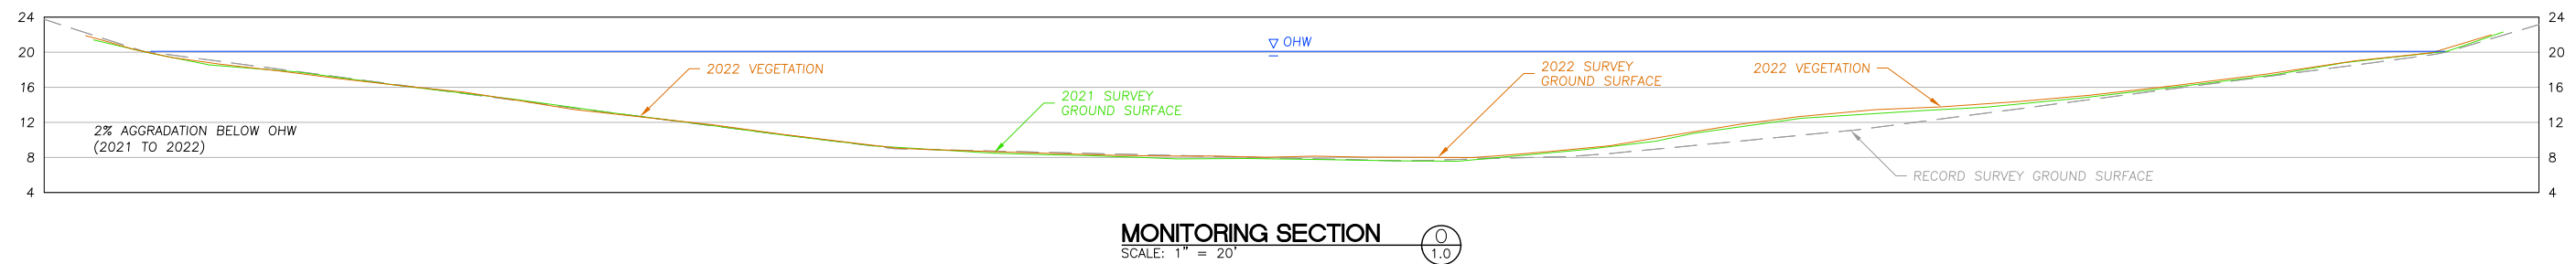
ATTACHMENT 2. ELEVATION CROSS SECTION COMPARISONS

at the upstream end of the OCH in 2020, which can be seen in transect AH (Attachment 2). Based on the photographic monitoring and topographic surveys, the berm has remained stable since monitoring in 2020 and is overtopped when water surface elevations exceed the 12.1 ft height of the berm (Attachment 3, page 26). This sand berm represents an obstruction for fish to directly access the OCH from the upstream end in low-water conditions. Based on water surface elevation data, fish had access to the side channel habitat, *over the berm*, approximately 47.8% of the time during the peak migration months (March – June). Water surface elevations indicate this section of the channel was connected via the downstream inlet approximately 79% of the time, which is within the 75-85% inundation connectivity design. Additionally, fish were able to access the downstream portion of the OCH through the downstream inlet that remains connected to the Willamette via Linnton Creek at all times. The flow-through channel is currently functioning as designed and was not intended to remain connected to the Willamette River at both ends for the entirety of the year (Grette 2018b, Waterways 2016).

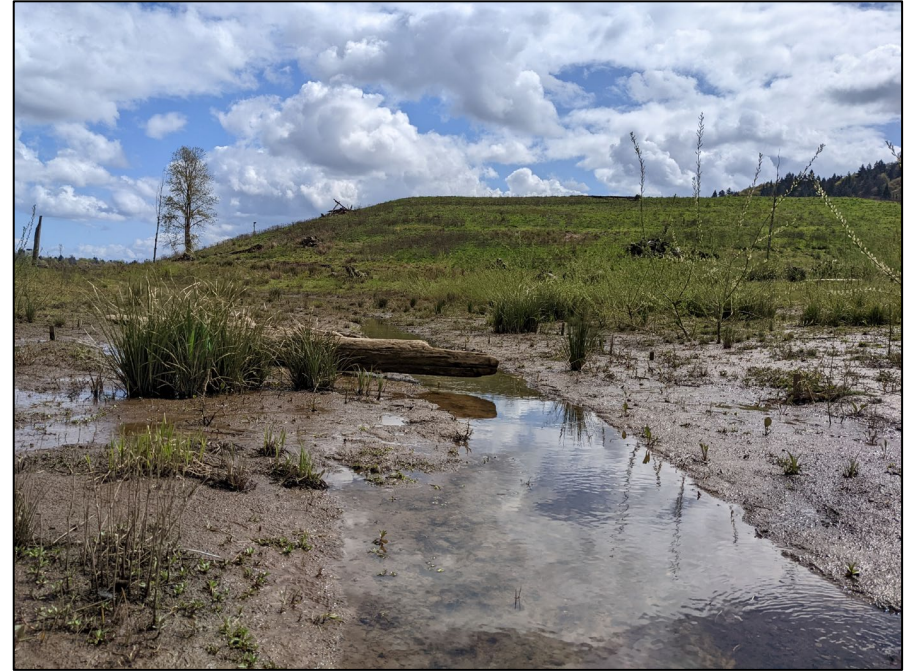
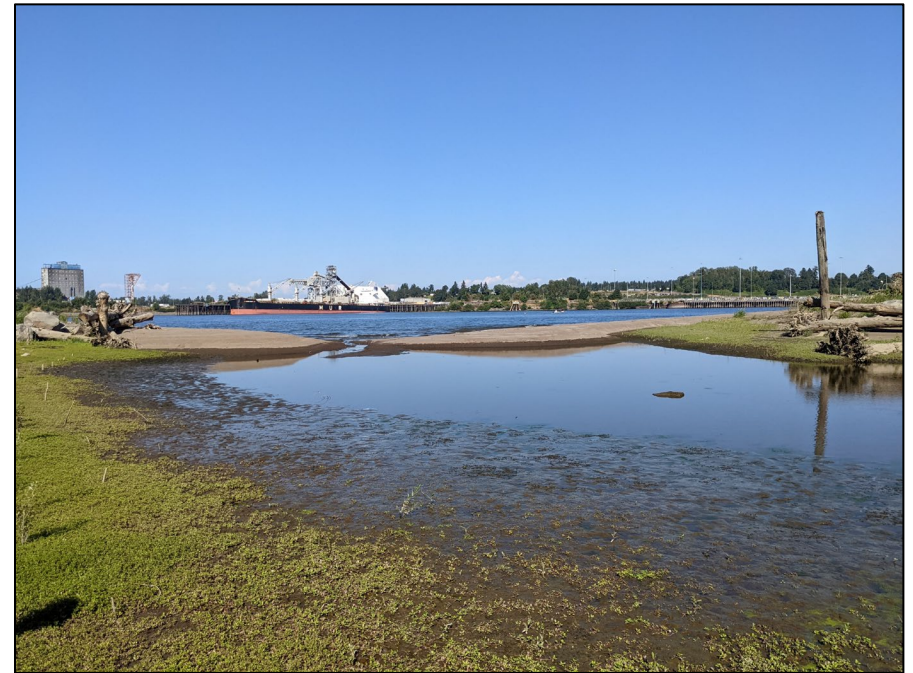
The depression adjacent to the berm has not deepened from the previous survey and still retains water after water levels recede. This depression may pose a stranding risk to smaller fish using the OCH and prevents direct access to the upstream portion in low-water conditions. There was no evidence of fish being stranded (e.g., dead fish) in this portion of the OCH. Water elevations are discussed below in Section 4.4.

Photo taken March 8, 2022

Photo taken April 5, 2022

Photo taken June 22, 2022

Photo taken August 25, 2022

Off-Channel Upstream Photo Monitoring – Water surface elevation from on-site side channel probe (NAVD88)

RestorCap will implement adaptive management actions to fill the ponded area with sand from on-site during the work window and dry conditions within this portion of the OCH.

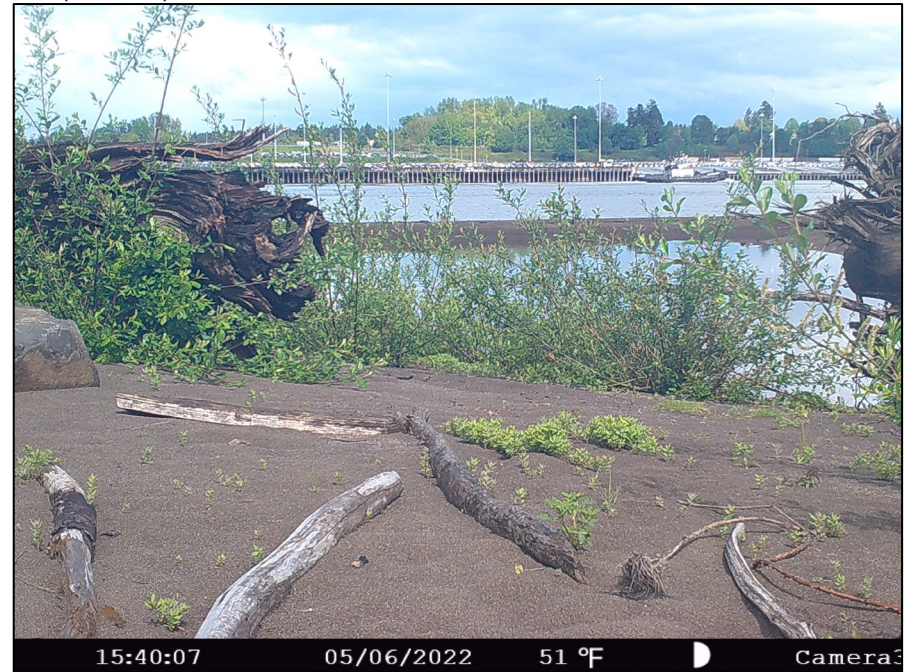
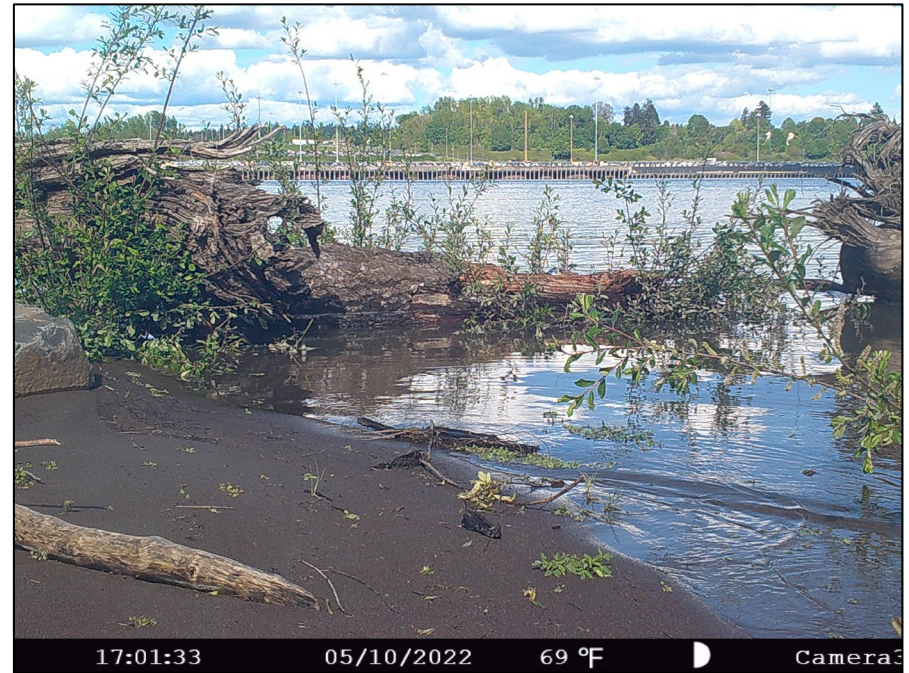
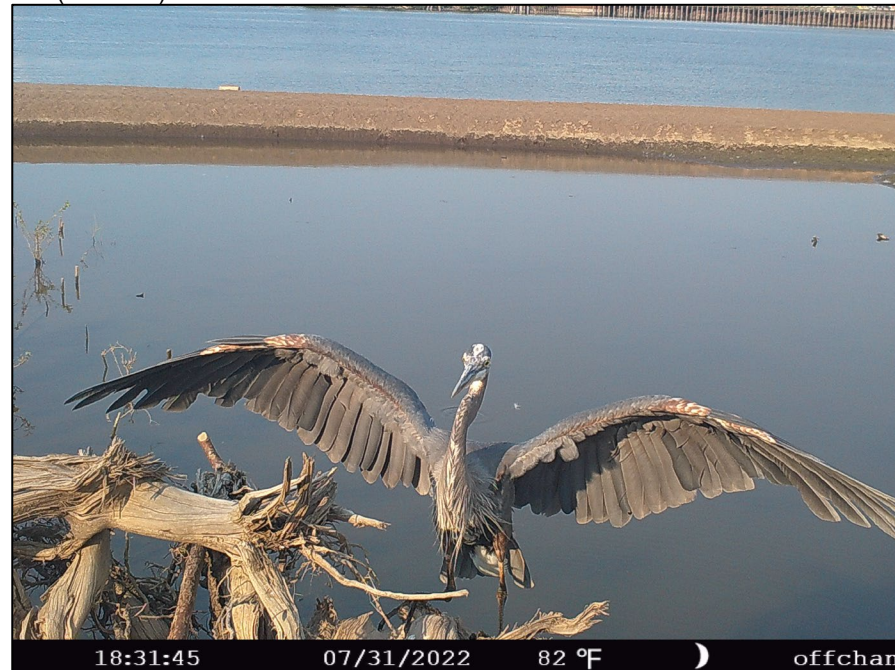
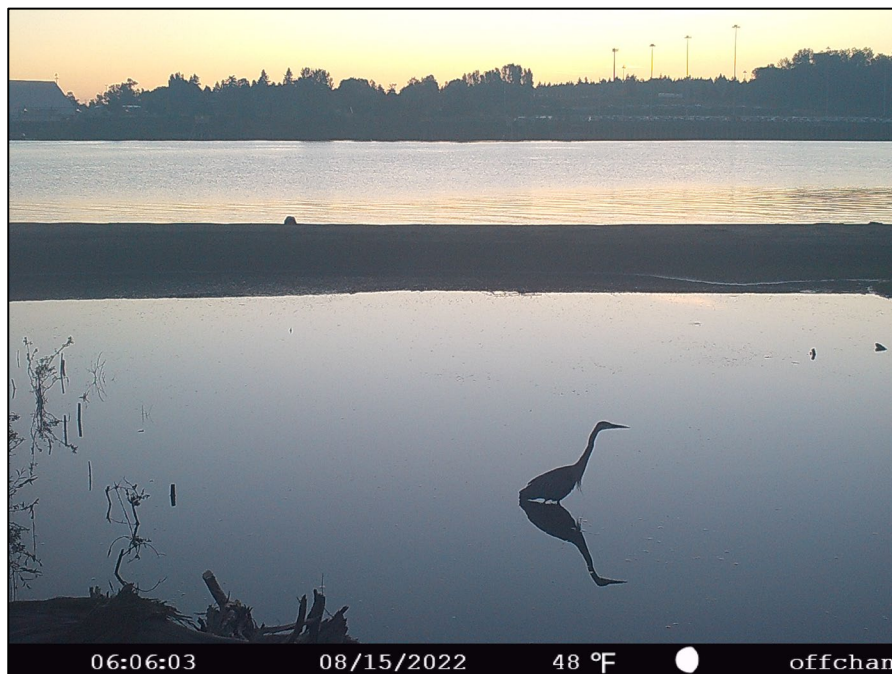
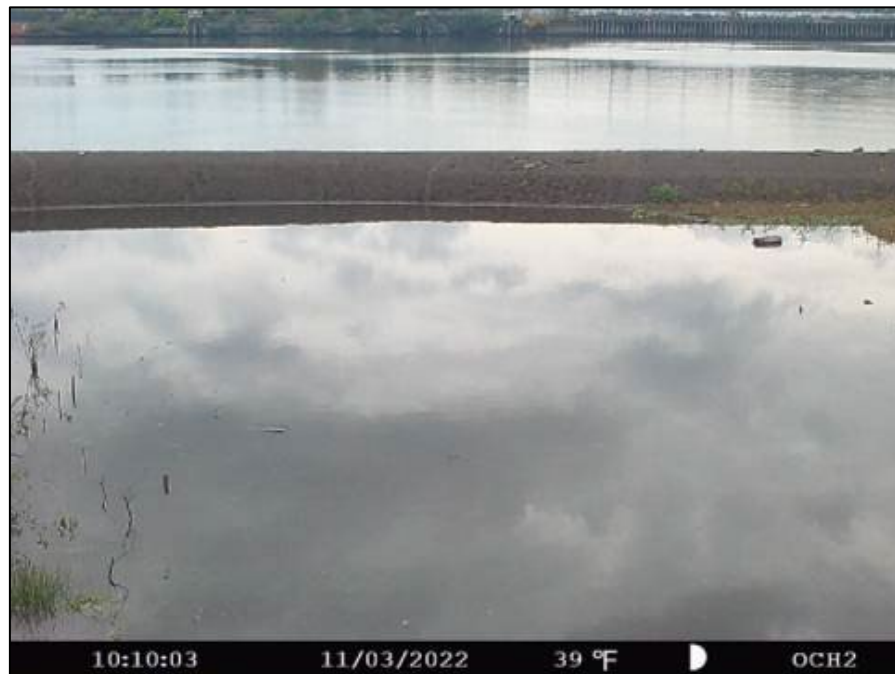
Water surface elevation 10.18 ft

Water surface elevation 10.87 ft

Water surface elevation 12.74 ft

Water surface elevation 14.14 ft; previous 48-hour rainfall total 1.31 inches

Water surface elevation 14.56 ft; previous 48-hour rainfall total 2.45 inches

Water surface elevation 10.15 ft

Water surface elevation 10.09 ft

Water surface elevation 10.22 ft

Off-Channel Photo Monitoring – Water surface elevation from on-site side channel probe (NAVD88)

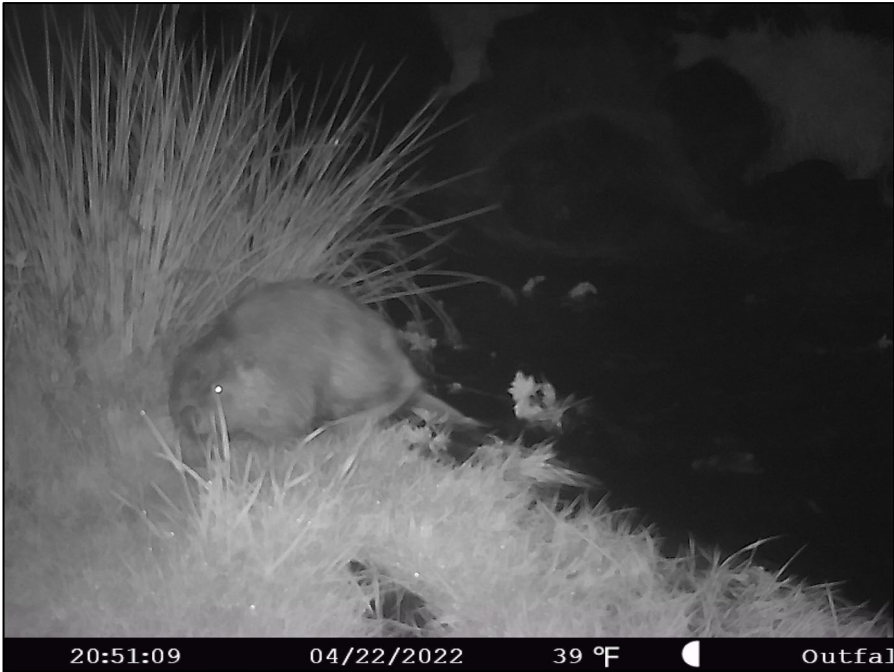
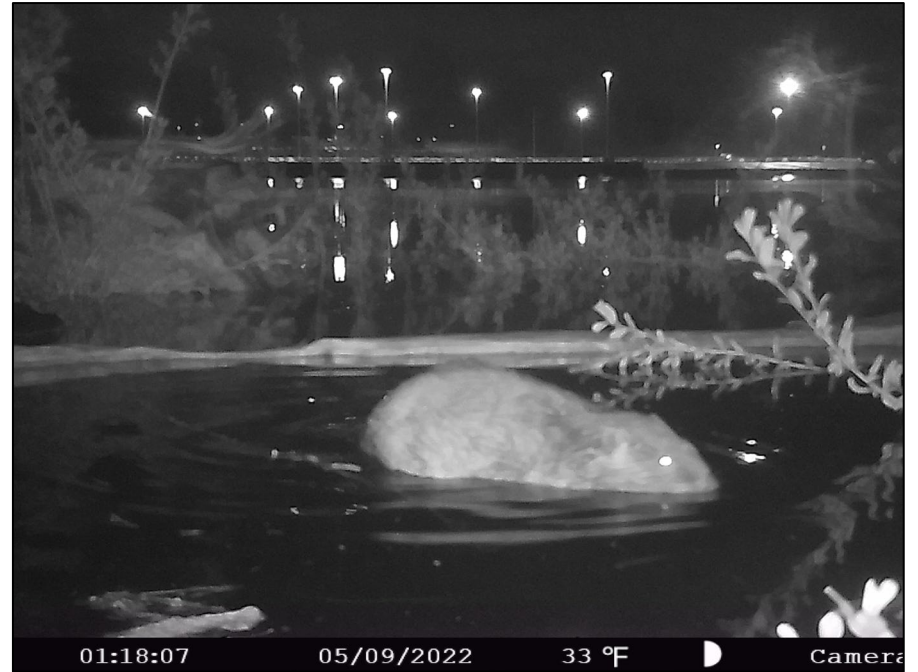
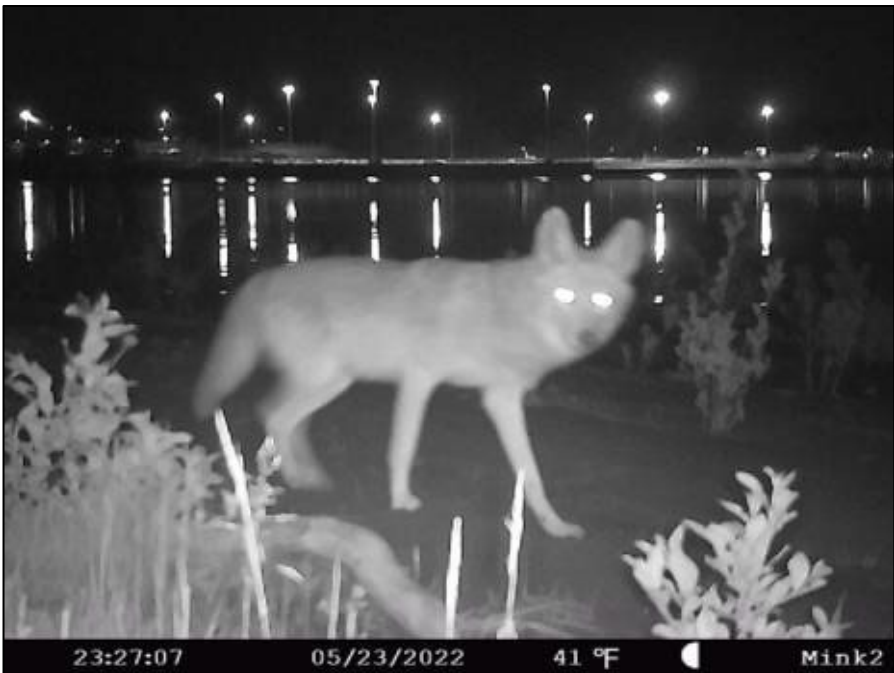
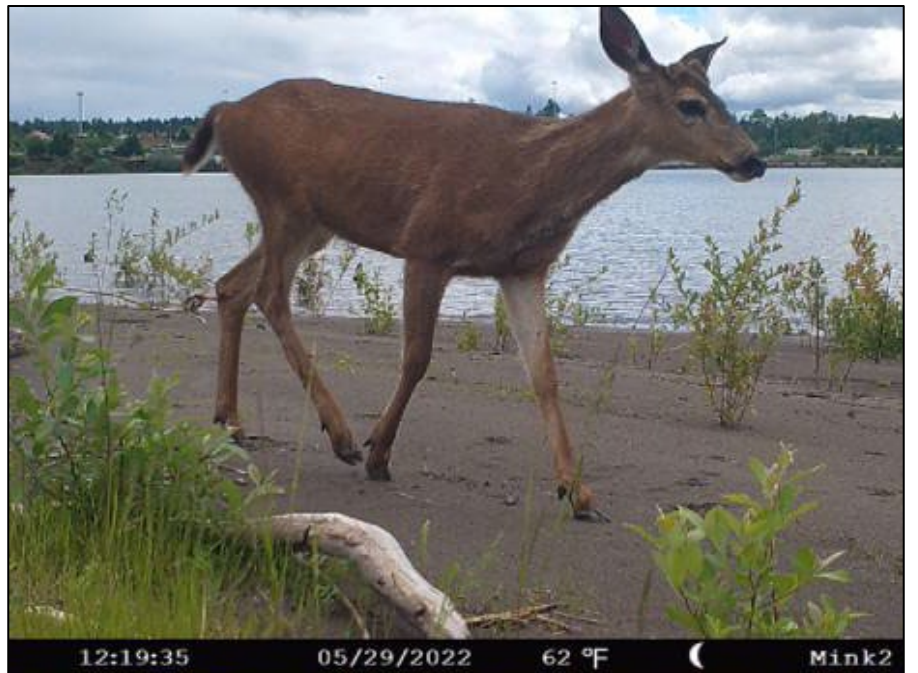
Photographs 109-112. Wildlife captured on mink and beaver monitoring cameras in 2022.

No mink were observed either on camera or in visual surveys of tracks and scat on the beach and mud. One long-tailed weasel (*Mustela frenata*) was observed on multiple occasions using the large wood piles in the scrub-shrub zone and on the island and moving between the north hill and the pedestrian pathway area on the north side of the site.

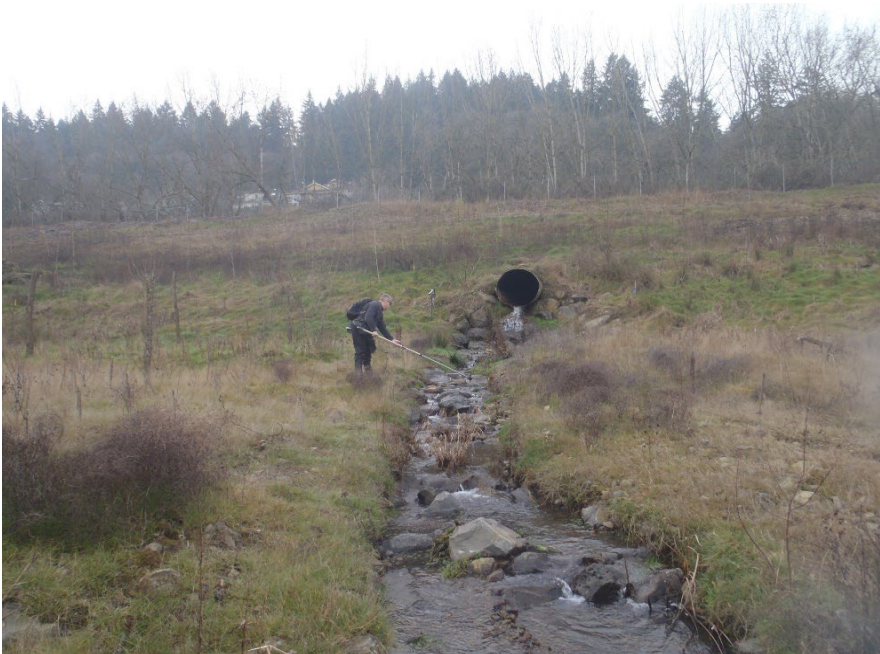
Photo 1. Underwater video survey provided a clear view under most large wood structures when they were wetted. Unfortunately, the angle of the camera proved to be critical when viewing footage. The camera changed angle often when it hit an obstruction underwater.

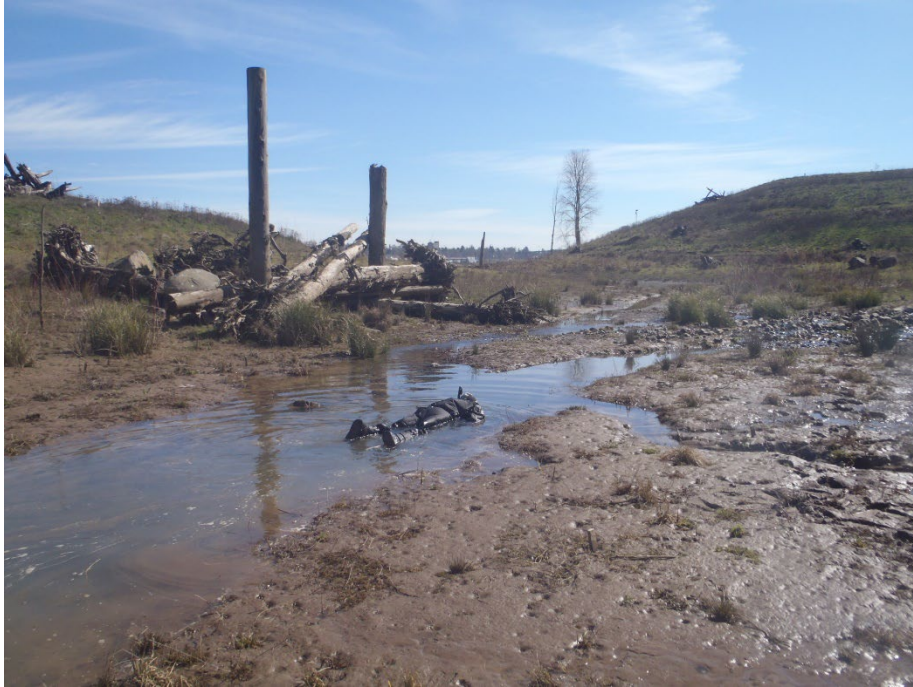
Photo 2. View upstream of Linnton Creek. Linnton Creek provides a continual source of cool, clean water to the side channel and provided habitat conditions that appeared the most suited to fish using the side channel.

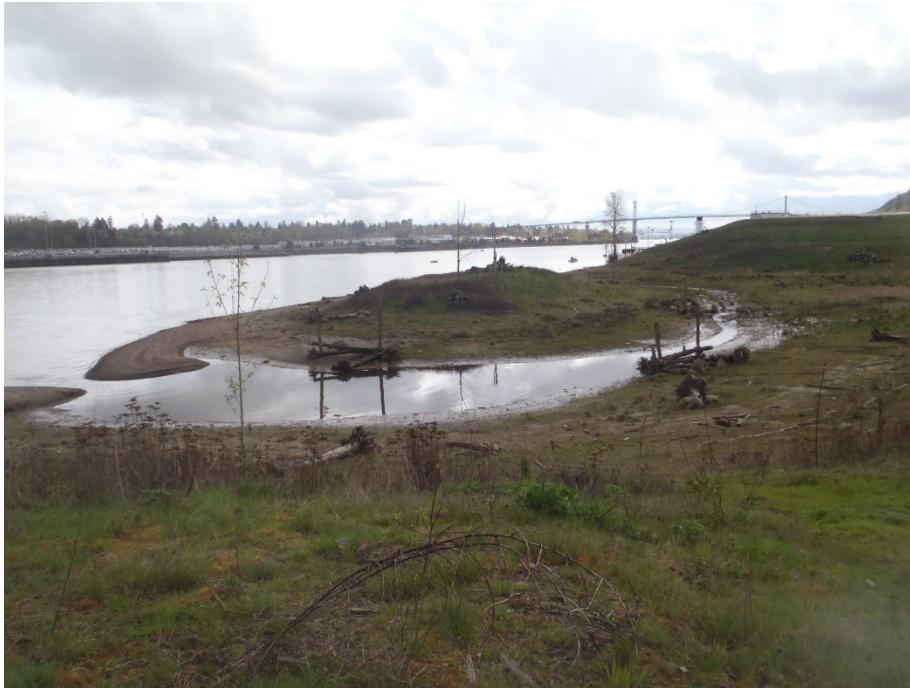
Photo 3. Snorkeling was limited to a water depth that allowed free movement of the snorkeler.

*Photo at mouth of Linnton Creek.
