**YEAR 3 (2022)
MONITORING REPORT
Linnton Mill Restoration Site**

DECEMBER 2022 *UPDATED MARCH 2023*

RestorCap LLC
337 17th Street, Suite 200
Oakland, CA 94607

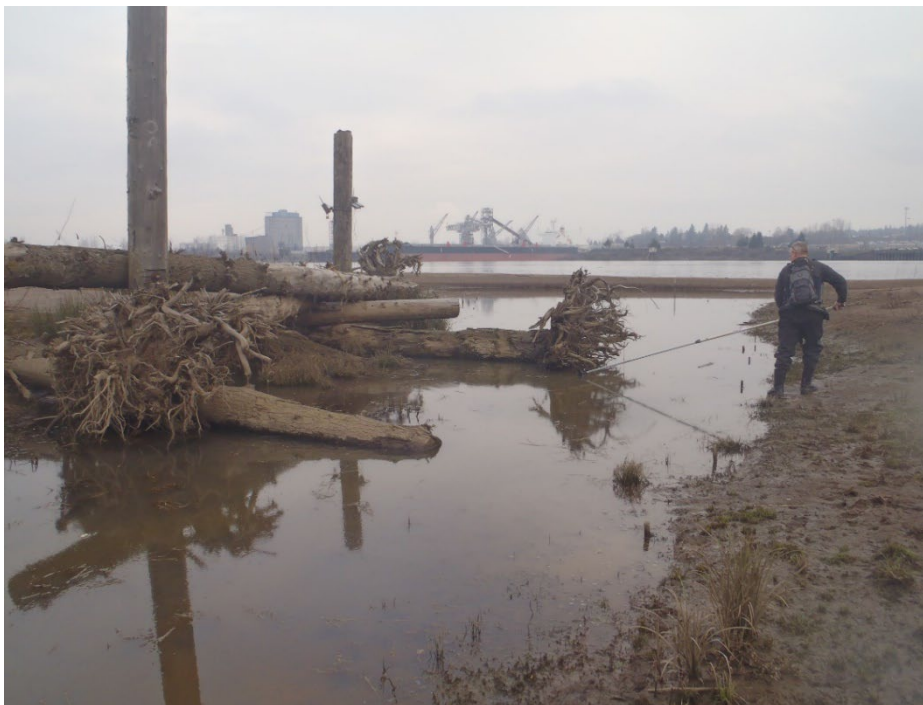
Photo 4. Low flow conditions created challenges finding the right time of the tidal sequence to perform the underwater (snorkel and camera) surveys.

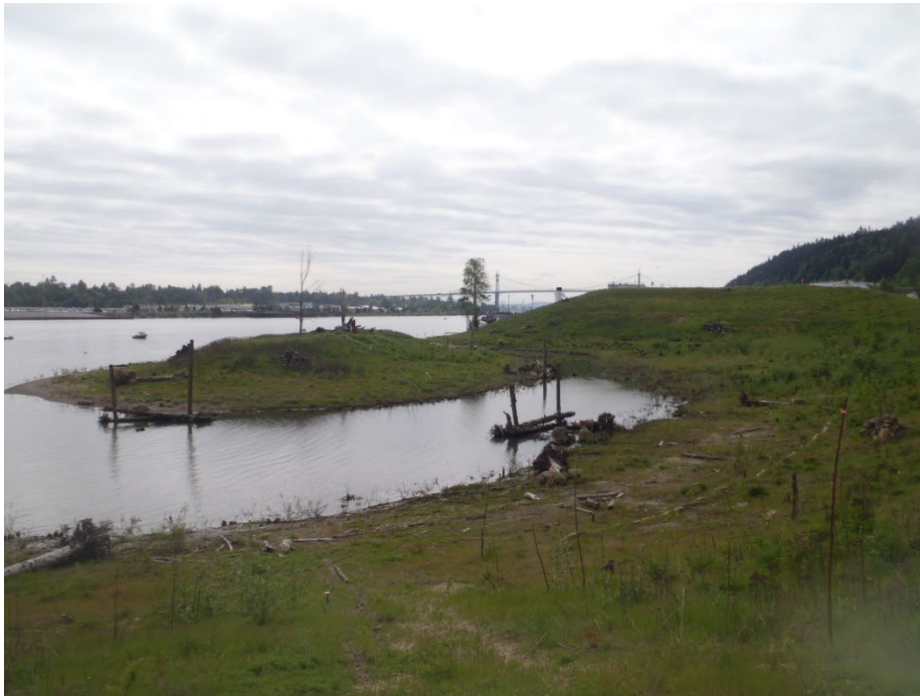
Photo 5. Very high turbidity in the upper end of the channel limited monitoring opportunities. There is no connection to the Willamette River at the upper end of the channel at very low flows

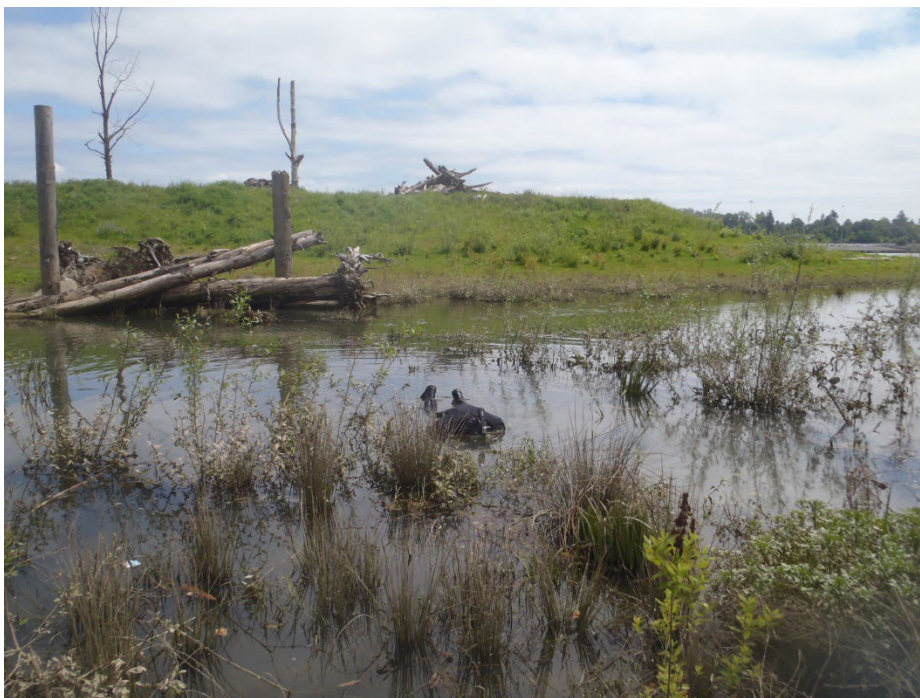
Photo 6. Conditions in late spring provided the best opportunity to conduct underwater surveys but turbidity still limited effectiveness of snorkeling and underwater camera.

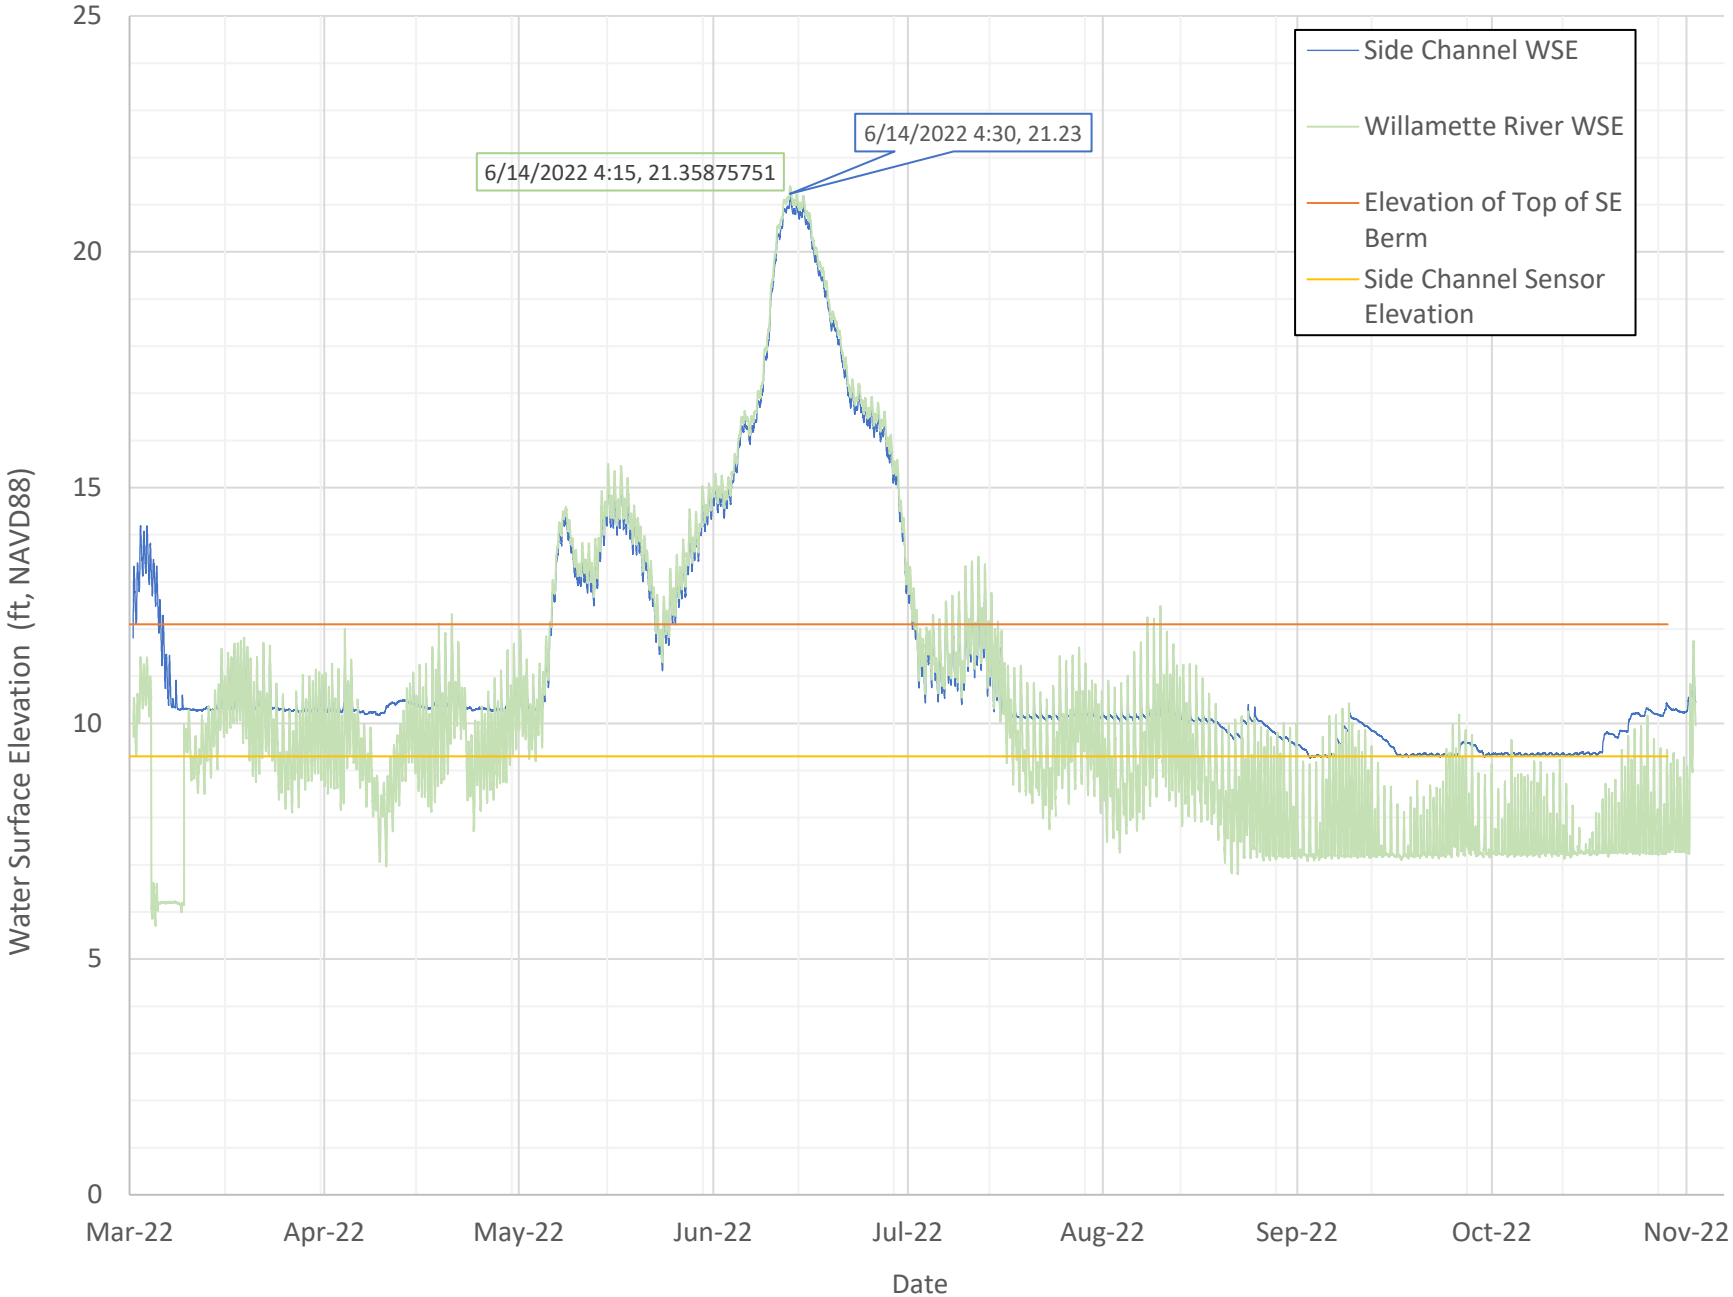
ATTACHMENT 9. WATER SURFACE ELEVATIONS

Attachment 9. Water surface elevations for two probes at the Linnton Mill Restoration Site.
