Portland General Electric Harborton Restoration: Final Year 2 Monitoring Report

Portland General Electric

December 2022
Revised October 2023

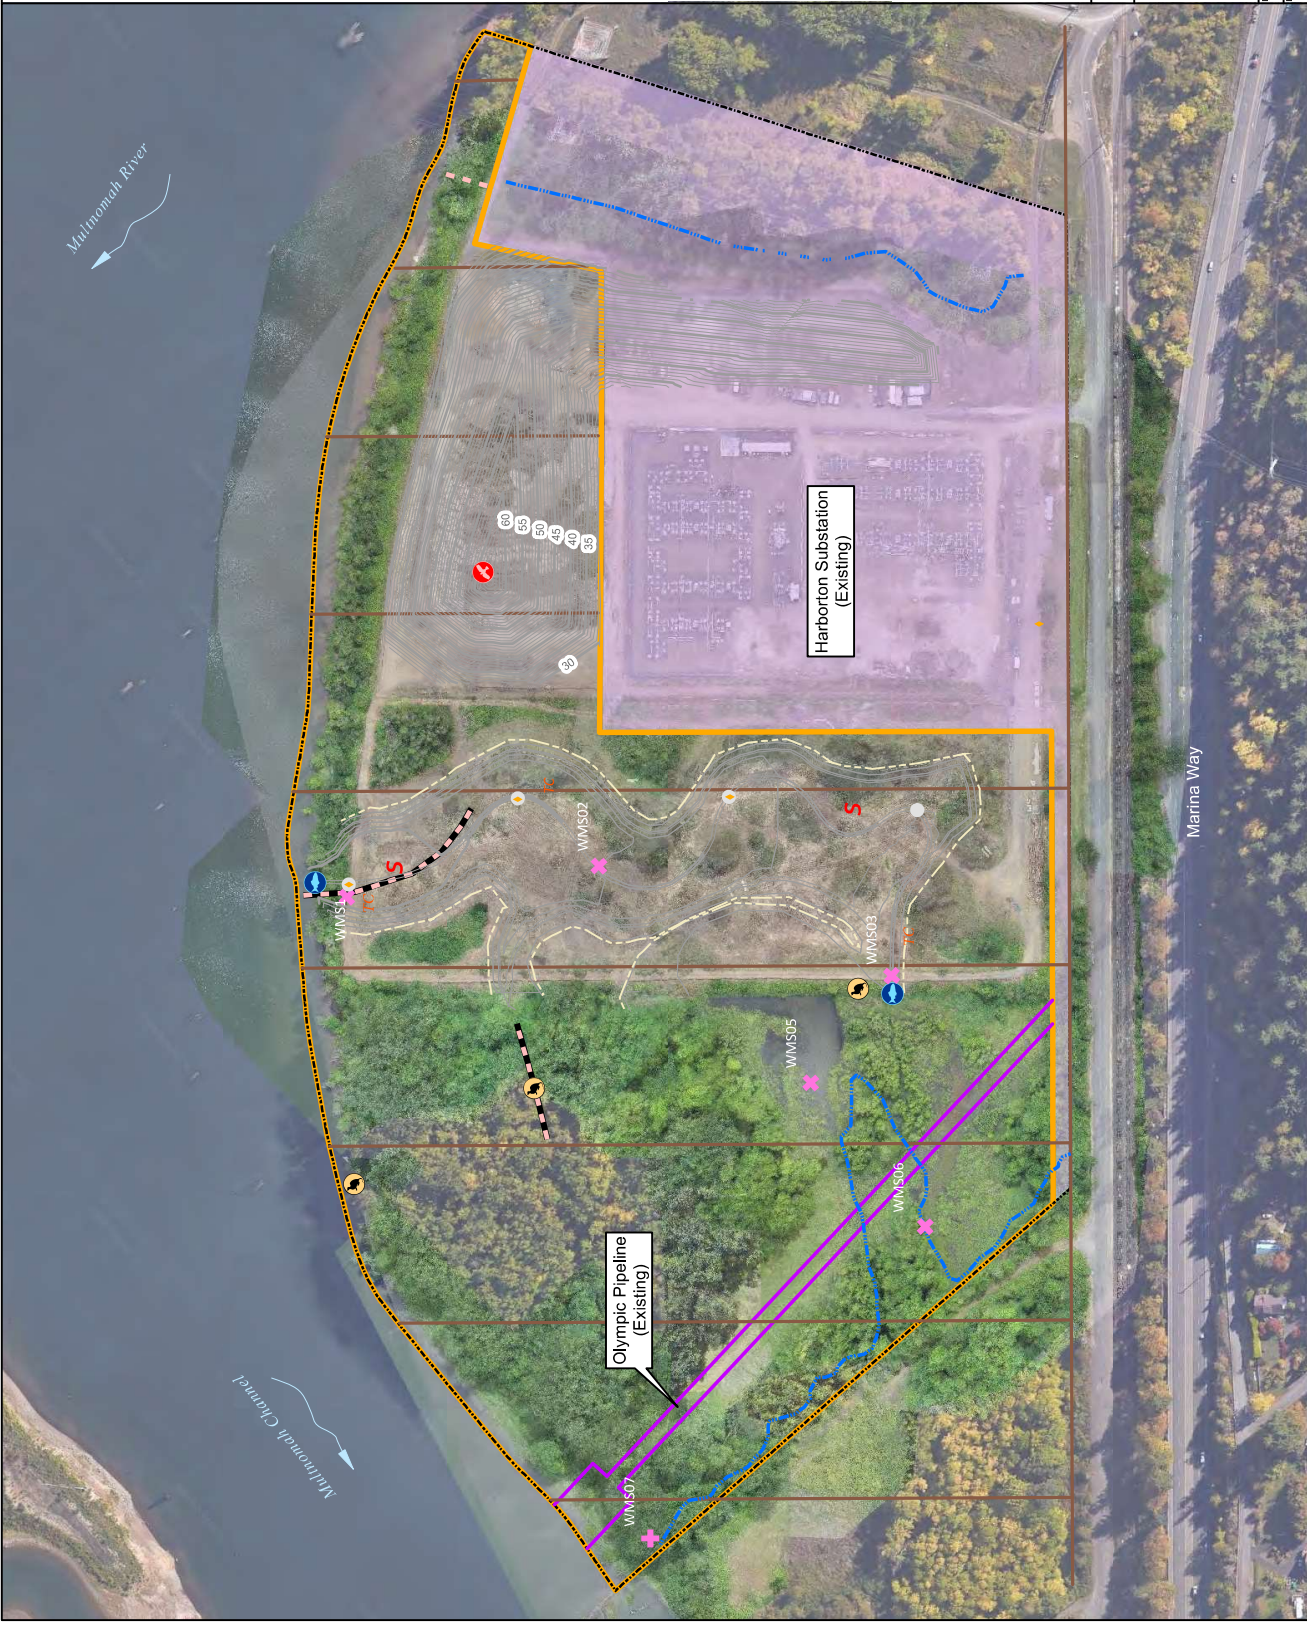
Figure 2
Fixed Monitoring Stations

Two long-term temperature monitoring sensors are installed in fixed locations in the North Channel. Temperature sensors gathered temperature data in one-hour intervals. One sensor is installed near the channel outlet near the Willamette River (Station 1; see Figure 2); the other is installed at the upstream entry to the channel adjacent to Sub Area 4 (Station 3).

DO was measured using a hand-held meter (Milwaukee MW600). Prior to use, the device was calibrated per manufacturer specifications. Readings were collected at three locations within North Channel (Figure 2) except during periods of flooding when readings were done along the shoreline as close to the monitoring station as possible.

surface water duration and extent in Sub Area 4 and a portion of Sub Area 3 wetlands from January to July, the key period for amphibian breeding and rearing. At the request of the Trustee Council following the review of the 2021 Year 1 Monitoring Report, PGE tracked North Channel connectivity to Sub Area 4, length of the dry channel, and made occasional measurements of water depth in the channel at Water Monitoring Stations (see Figure 2).

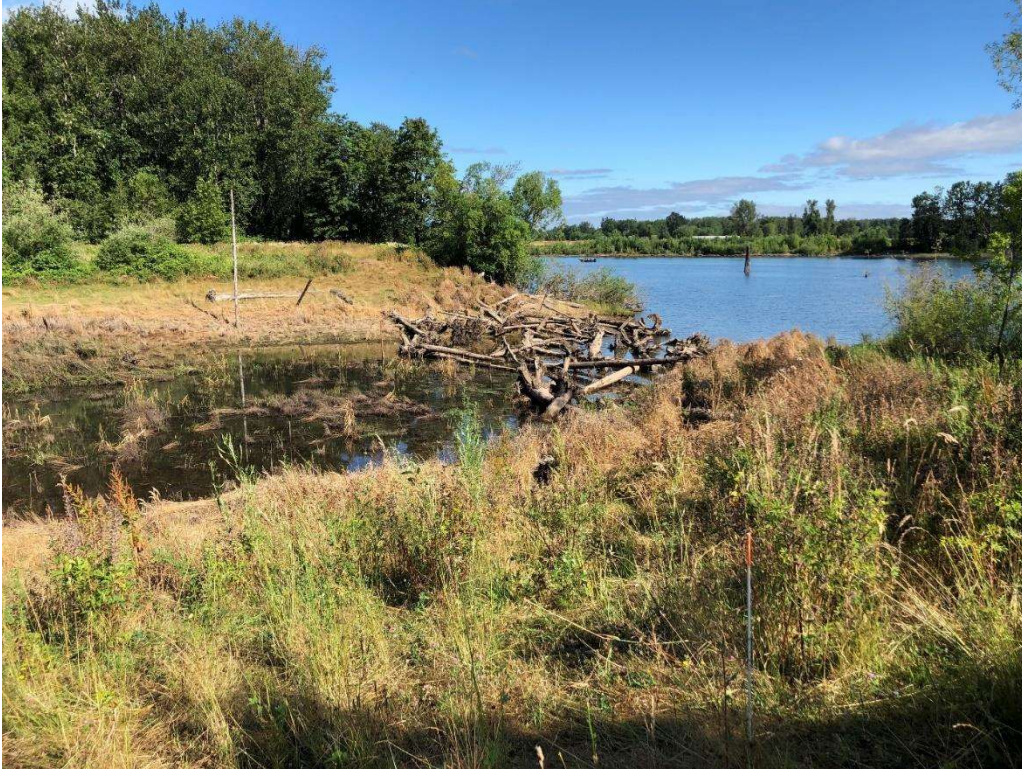
Channel Photo 1. North Channel outlet July 2022 during receding June flooding

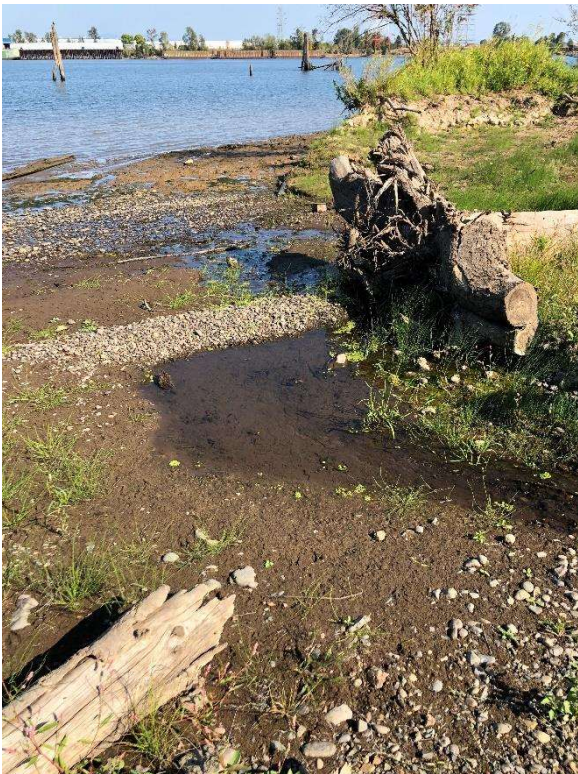
The performance standard for fish passage was met except for a brief period in mid-August to September 28. During this time a mixed sand/gravel bar formed by the Willamette River caused deformation of the exposed Willamette riverbank, just outside the project area, from a single-thread channel to a shallow braided channel. However, speckled dace (*Rhinichthys osculus*) was observed in the North Channel during all 12 field observations made in August-October, indicating suitable conditions for fish to persist through a period when the channel was expected to be dry.

Formation of the gravel bar at the North Channel/Willamette River confluence is consistent with conditions observed at other Willamette River tributaries like the North Channel. Dynamic, constantly changing conditions will inevitably lead to temporary fish passage barriers in such streams that will, in time, be eroded and erased as the tributary regains competence (i.e. ability to move sediments) when discharges increase. Efforts to prevent such bar formations are inevitably likely to fail and would be counter to natural processes.

Channel Photo 2. North Channel outlet (facing upstream) on August 5, 2022. Note gravel bar formed at outlet.

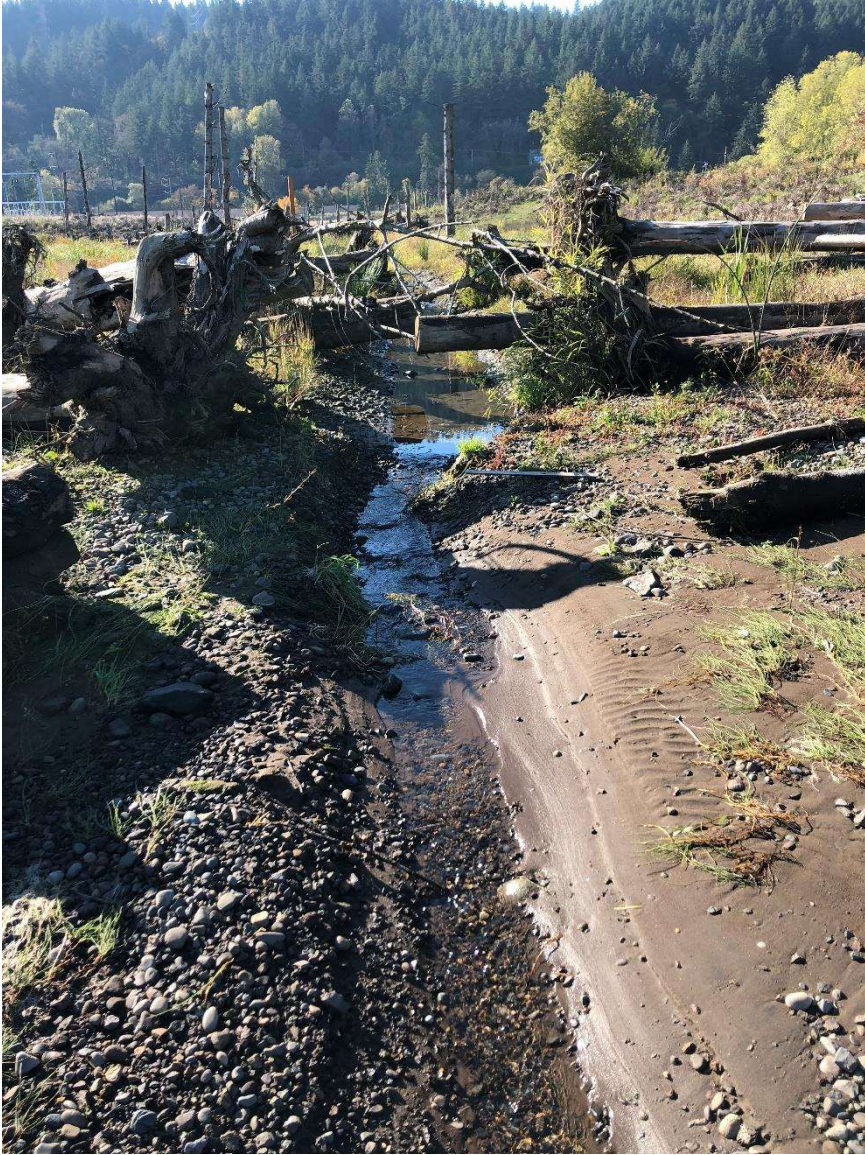
The shallow braided channel that formed at the outlet limited water outflow to the Willamette River extending the duration of wetted channel during the hottest period of the year. This may have contributed to the warmer water temperature potentially providing refugia for organisms able to tolerate high water temperatures. These higher temperatures could cause stress or be lethal to species that prefer cooler water temperatures, if present.

Channel Photo 3. Outlet of North Channel (facing upstream) following September rain event. Note channel morphology – loss of channel sinuosity and erosion/transport of the gravel bar formed in July/August (see Photo 2.)

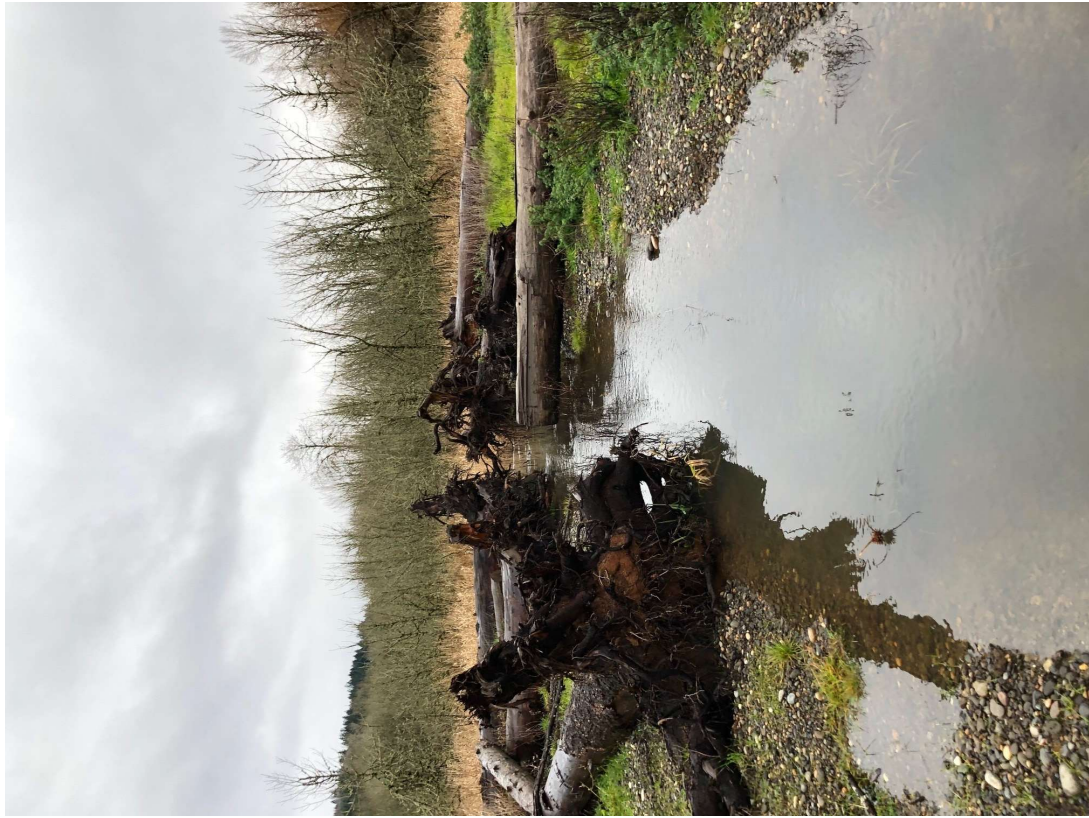
NORTH CHANNEL - PHOTO FACING UPSTREAM (JAN. 12, 2022)

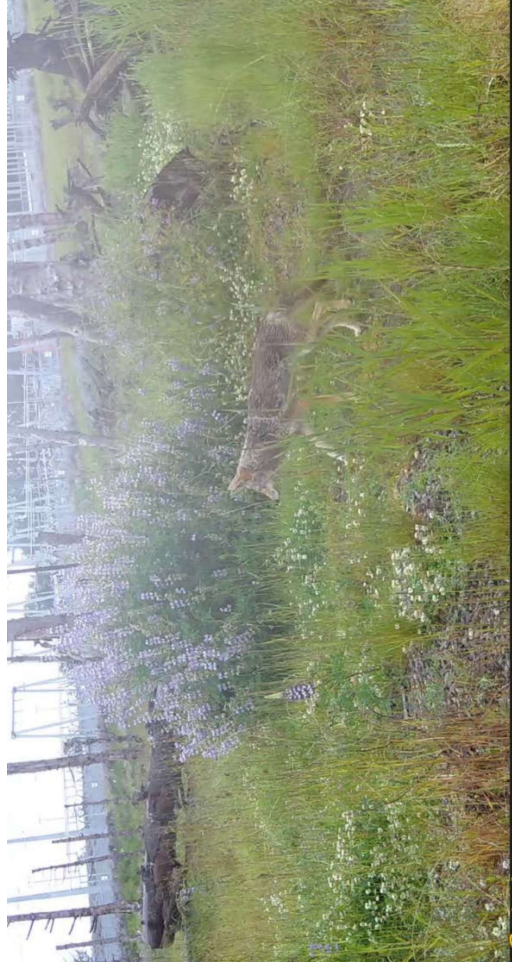
NORTH CHANNEL - PHOTO FACING DOWNSTREAM (JUNE 5, 2022)

Observations of North Channel depth and extent noted that surface water connectivity to Sub Area 4 was lost between July 22 and July 24. Surface water connectivity had not re-established as of the writing of this report. Dry channel length was 18 feet on July 24 and increased to 270 feet by August 16 where it remained for the rest of the monitoring period.

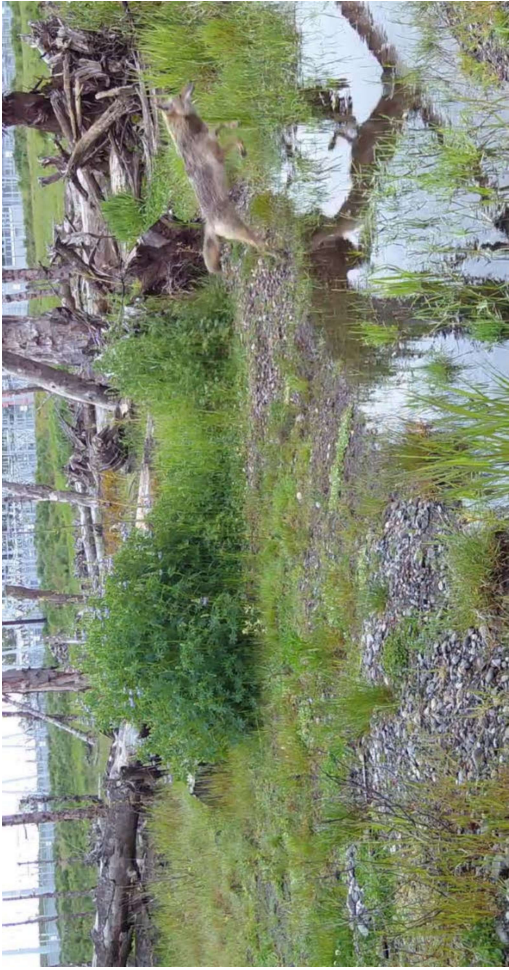
Persistent surface water over the lower 1,550 linear feet of North Channel continues to be a fortunate, unexpected site feature. Surface water in the channel was expected to be seasonal, with conditions driven by precipitation, high water levels in Sub Area 4, and by Willamette River backwater flooding. The upper 250-300 feet of channel lost surface water connection to Sub Area 4 in early July and remained so through the drafting of this report (mid-December).

NORTH CHANNEL - PHOTO FACING DOWNSTREAM (JULY 14, 2022)
