CONSENT DECREE APPENDIX E

LINNTON MILL RESTORATION SITE

RESTORATION PLAN

DECEMBER 4, 2018

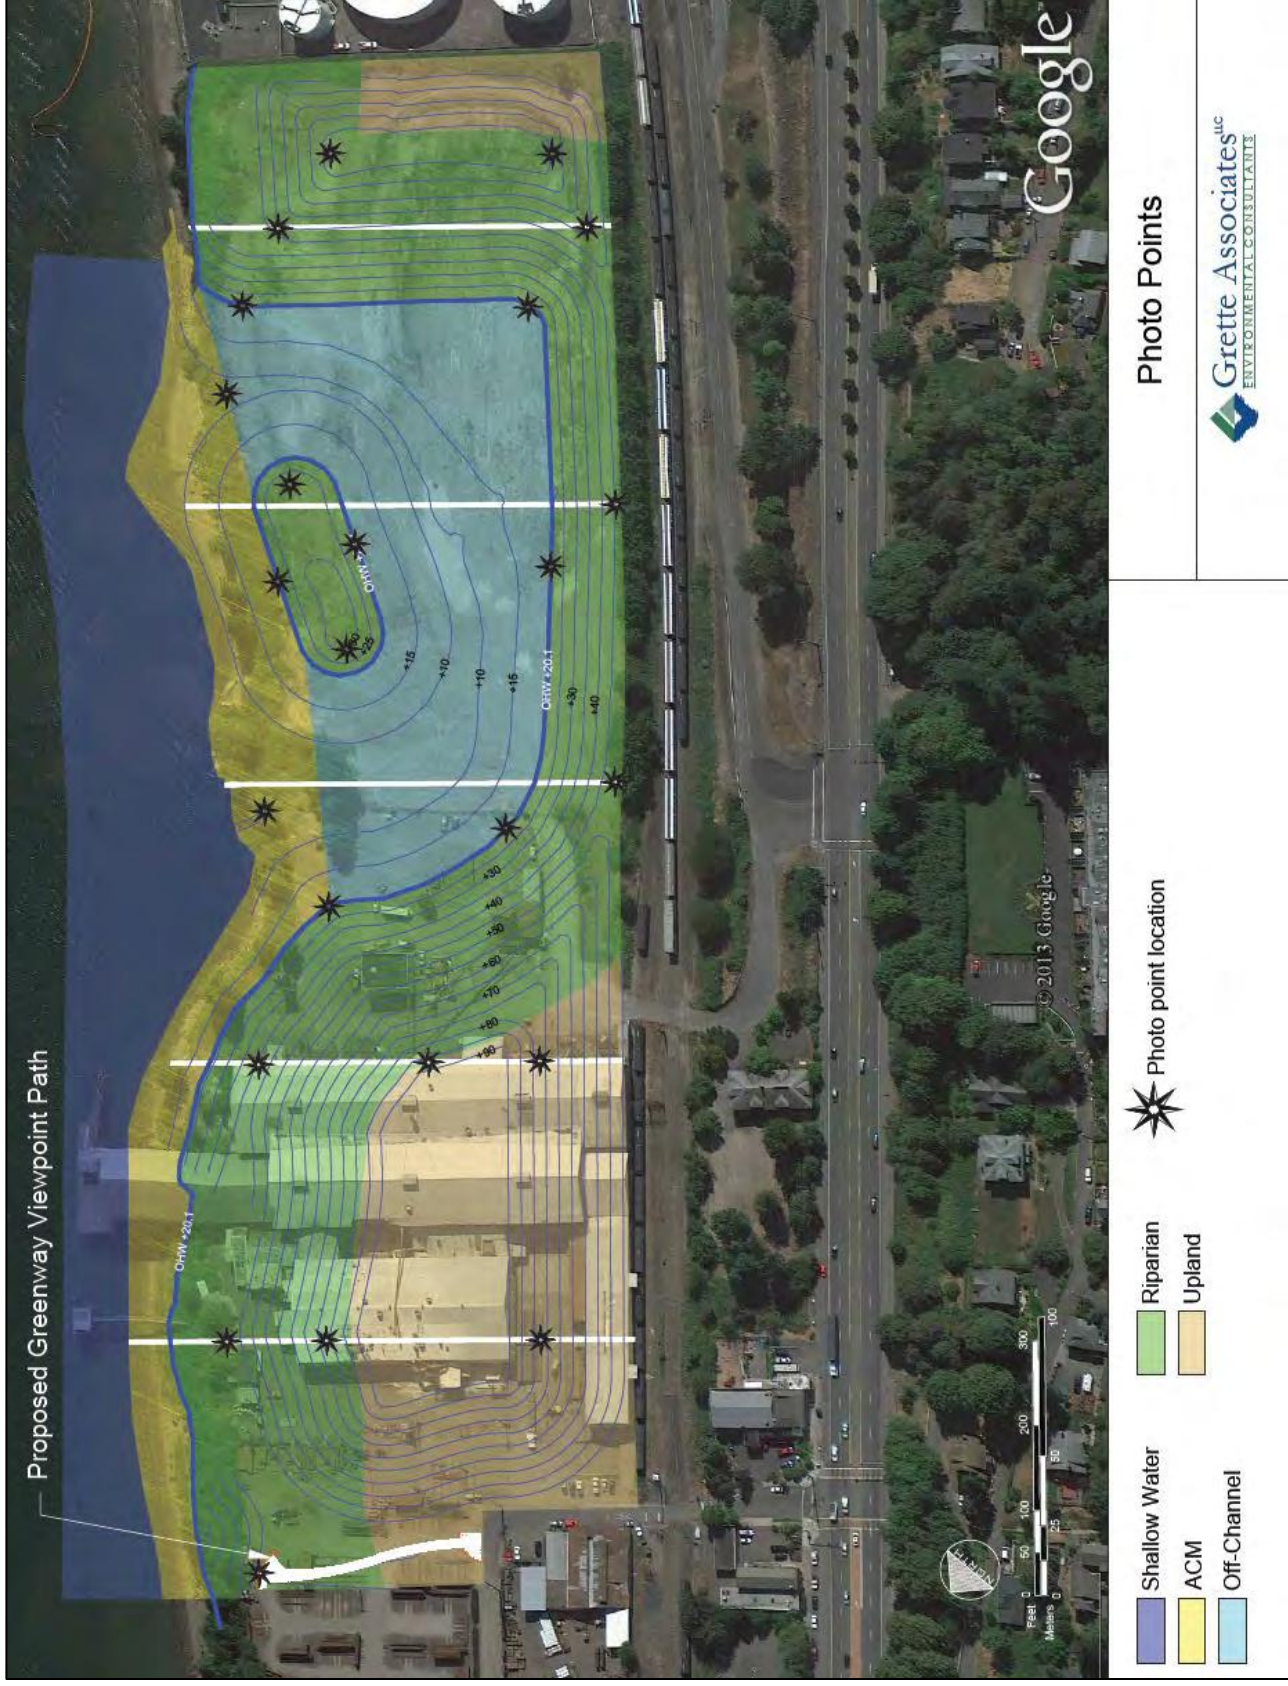
Figure 8. Photo Point Locations.

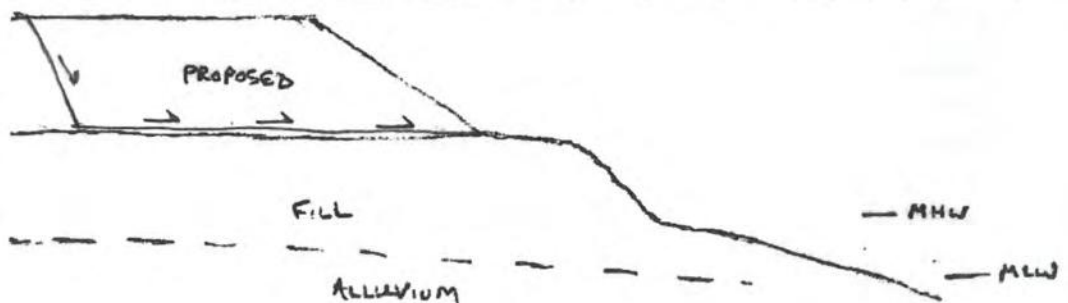
- Again evaluate new embankment only, with block failure on smooth, sloping concrete surface. Compare results to file LINN6.
- Model strength as frictional coeff of 0.35 multiplied by overburden ($c = fN$). Set program to "Vertical Stress Ratio" rather than "Mohr-Coulomb".
- Schematic:
