RINEARSON NATURAL AREA RESTORATION YEAR 5 (2023) MONITORING REPORT

June, 2024

Rinearson Natural Area Restoration Monitoring – Cover Sheet

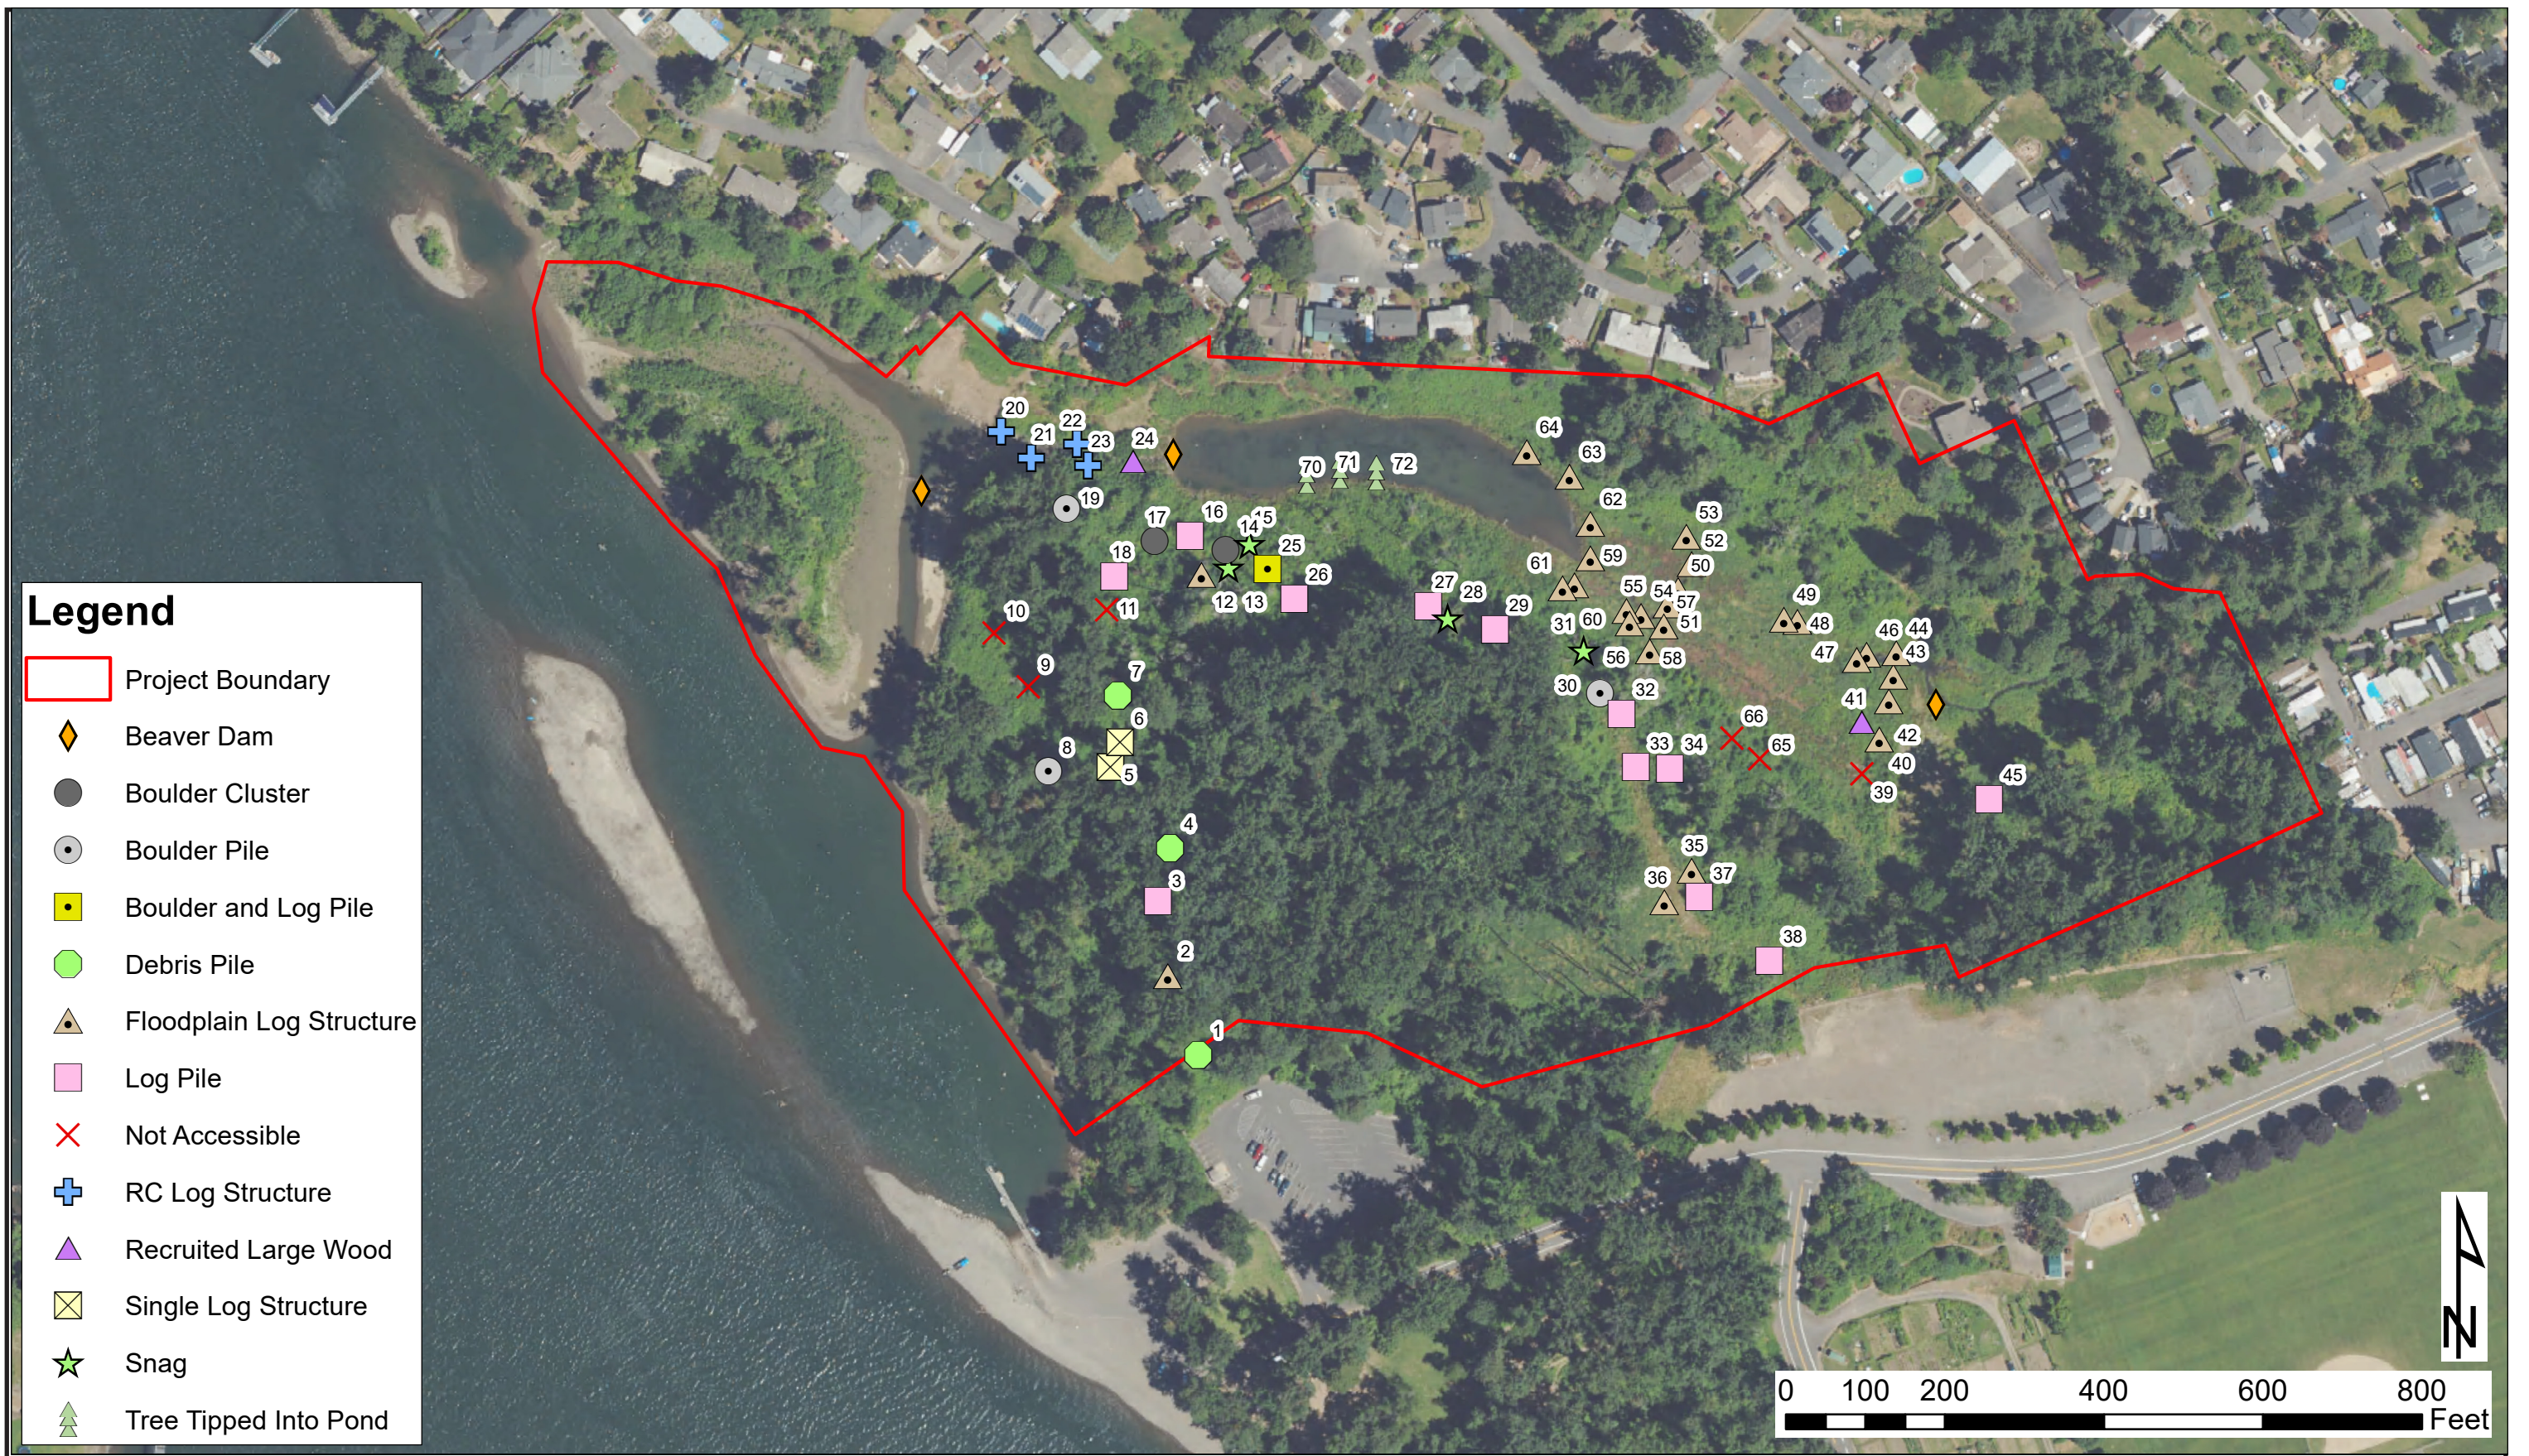
The HDP performance standard for structures within the ACM is that 80% of the total pieces placed in aquatic and terrestrial areas upstream of the remnant pond be intact, and 100% of the installed in-stream large wood pieces downstream of the remnant pond be retained and present or naturally recruited. A total of 28 structures are shown in the as-built drawings: 13 floodplain structures, 12 meander channel structures as well as 3 trees tipped into the remnant pond. All structures except one floodplain log structure were identified in the August 2023 assessment, which indicates that more than 80% of the structures were intact and therefore the HDP standard was met.

Two instances of recruited logs were recorded (noted on Figure 2-1) and appeared to be associated with logs that had fallen from dead trees. These two logs are examples of on-site recruited wood that will continue to enhance the function and ecological integrity of the site.

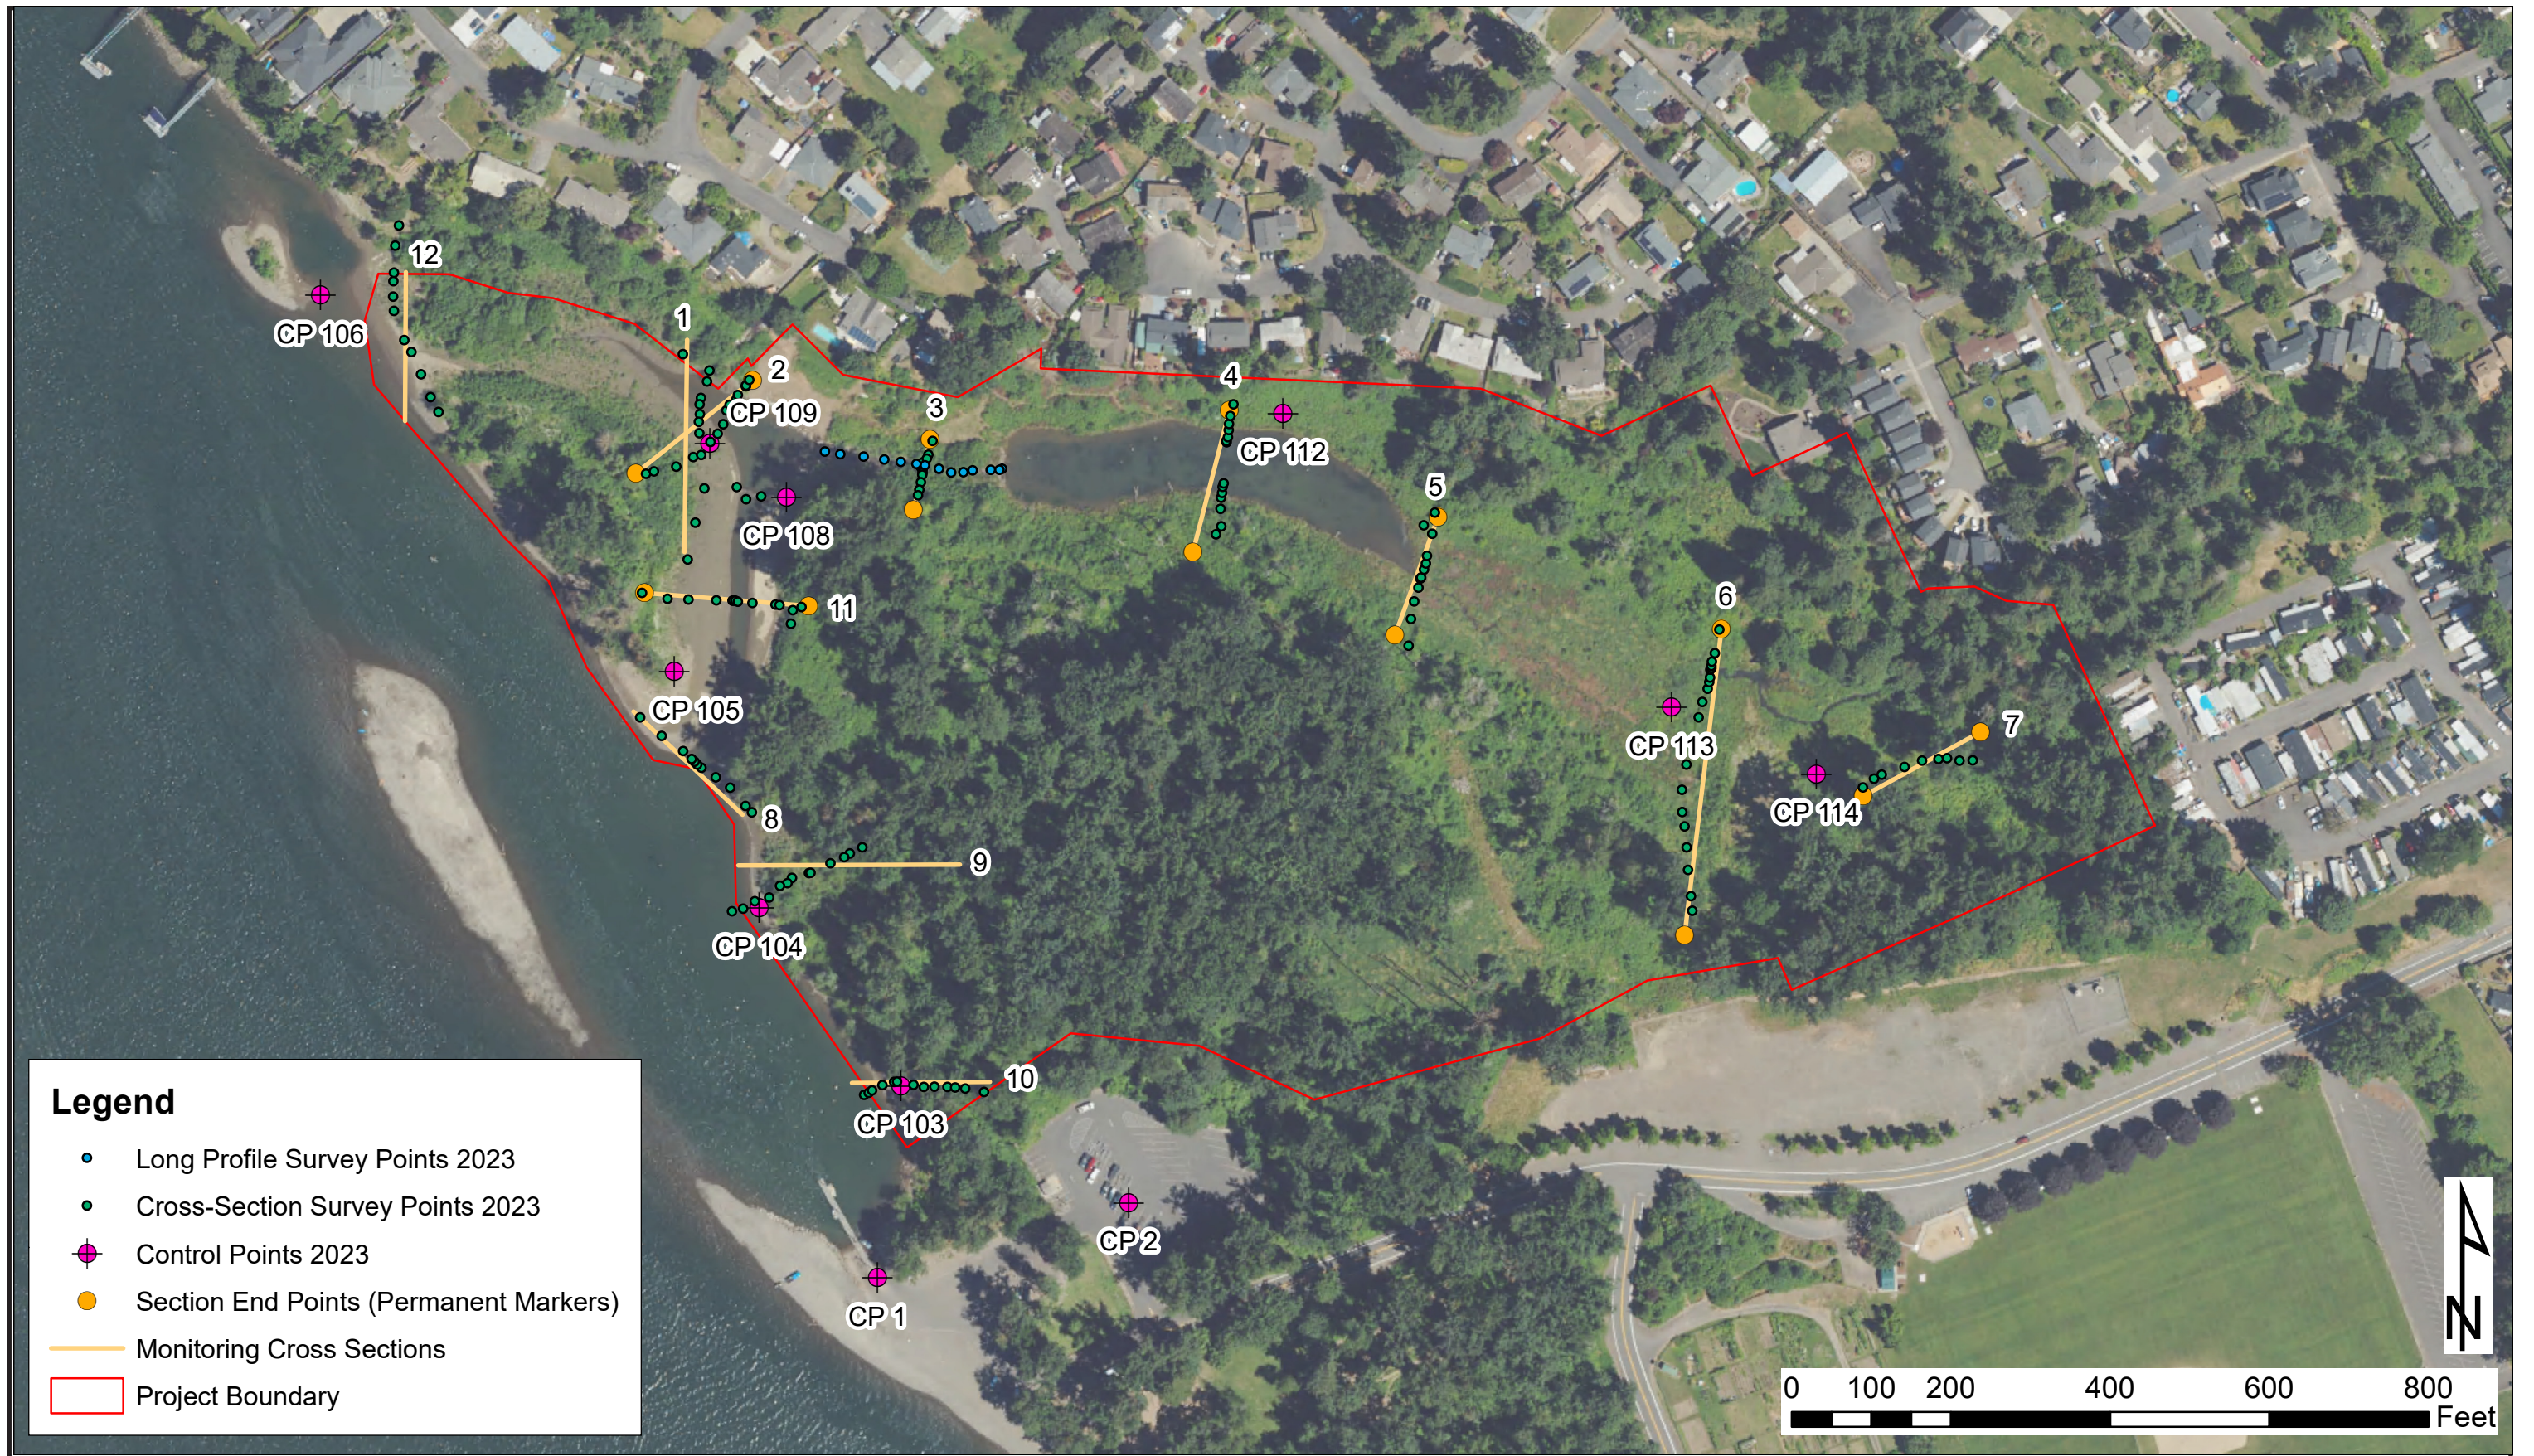
Cross-Section Monitoring Map

On August 21 and 22, 2023, Waterways surveyed 12 cross-sections in approximately the same locations established in 2019, which were also used in the Year 3 monitoring efforts by ESA. Two additional cross-sections (cross-sections 11 and 12 on **Figure 2-2**) were monitored in Year 5 based on the cross-section locations established by the HDP (shown in Figure 8 of the HDP). **Figure 2-2** shows the locations of the monitoring cross-sections and displays all survey points taken for this Year 5 effort. Due to dense vegetation (such as blackberry and willow), several of the established cross-section end point stakes were not found. Therefore, Waterways used known GPS locations to approximate the ends of those cross-sections. Furthermore, some of the sections were not marked in the field with permanent stakes during the as-built survey, and so no end points were present (**Figure 2-2**). Vegetation growth, along with deep water or silt depth, made gathering survey points exactly along the cross-sections difficult.

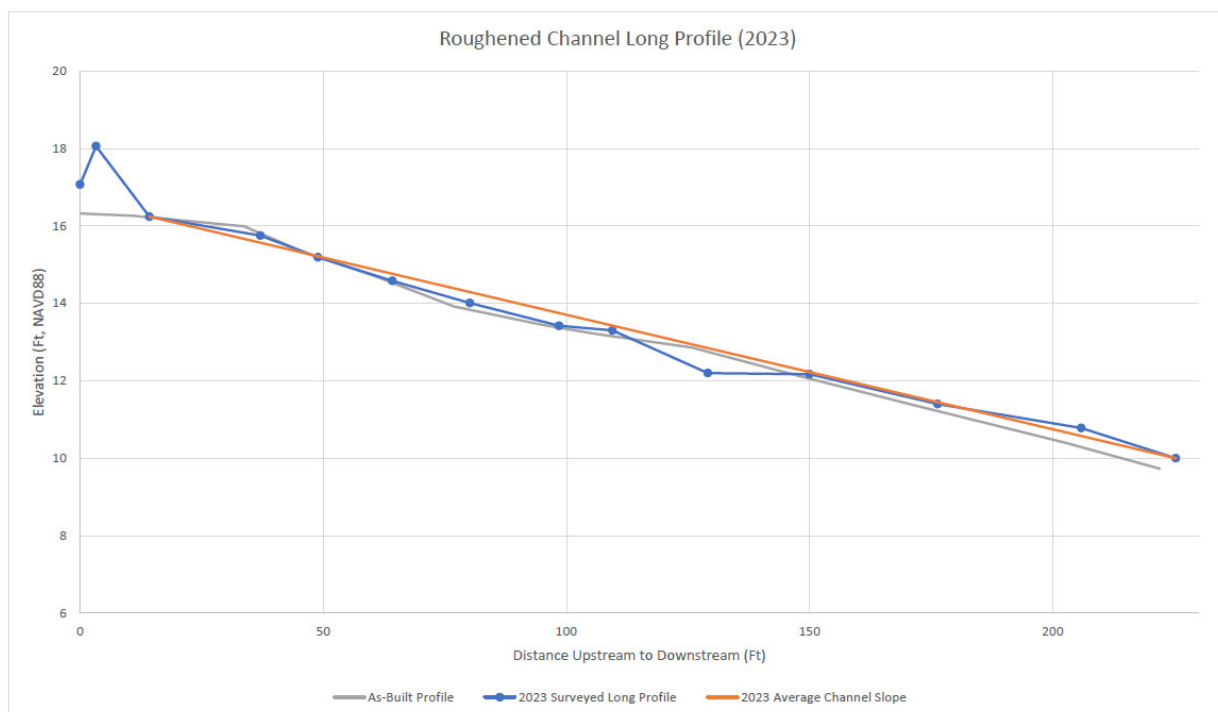
Figure 2-3: Roughened Channel Long Profile for Year 5 (2023)

Figure 2-3 shows the long profile of the roughened channel that was surveyed by Waterways on August 22, 2023. The surveyed grades, as well as field observations, reveal that there have not been any significant changes, migration, or erosion of the roughened channel. The upstream-most point at the top of the roughened channel (below the beaver dam) was 16.24 feet (NAVD88) and the downstream-most point was measured to be 10.00 feet (NAVD88). The total length of the roughened channel was surveyed to be 222 feet, and therefore the slope of the channel was calculated to be 0.028 or 2.8%. The performance standards identifies that the gradient of the roughened channel must remain less than 4%.

Per the as-built records, the top of the engineered channel was constructed at an elevation of 16.85 feet. Based on the Year 5 (2023) surveyed long profile (**Figure 2-3**) for the roughened channel, and field observations, the roughened channel grade has remained stable. The water surface elevation upstream of the roughened channel is controlled by the roughened channel crest and the beaver dam at the pond outlet, which was surveyed in 2023 to have a crest elevation of 18.06 feet (NAVD88). However, once the Willamette River stage exceeds the elevation of the roughened channel crest, the water surface elevations above the pond outlet are responsive to changes in the Willamette River. This response can be observed in the water surface elevation measurements collected by the loggers and shown in **Figure 2-5**.

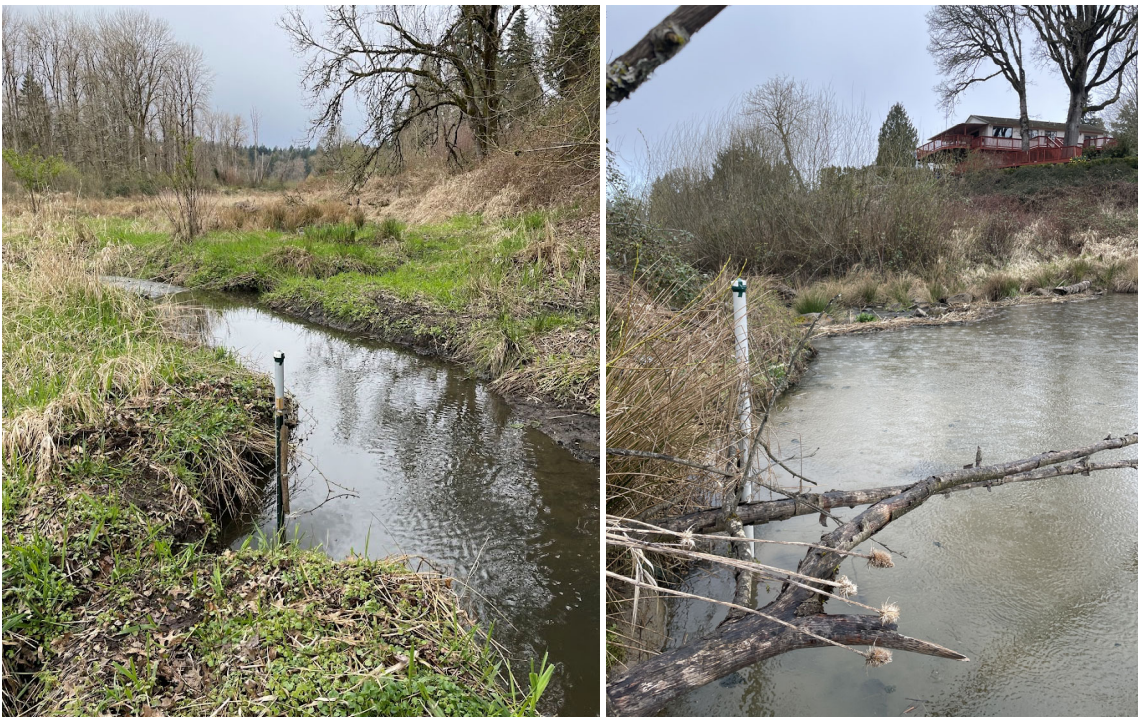
Figure 2-4: Waterways water level loggers installed on site.

To monitor the water surface elevations at the project site, Waterways deployed two water level loggers on April 4, 2023. These loggers remained on site through the peak snowmelt season and were removed on July 12, 2023. The loggers were located at the remnant pond outlet and at the entrance of Rinearson Creek into the project site (see **Figure 1-1** for the mapped logger positions and **Figure 2-4** for images of the installed loggers).

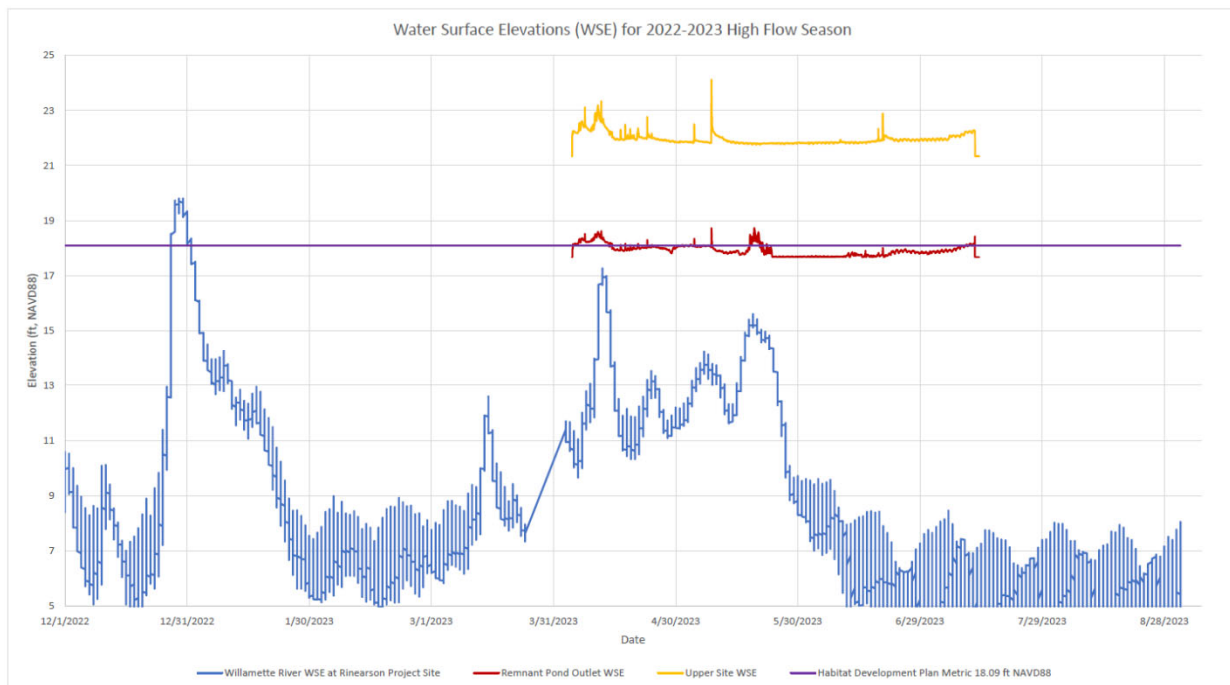
Figure 2-5: Water Surface Elevations for 2022-2023 (Year 5) High Flow Season

The Waterways logger in the upper reach of the project site on Rinearson Creek is also shown in **Figure 2-5**. This logger reported higher water surface elevations than the pond outlet logger, with an average water surface elevation of approximately 21.8 feet (NAVD88). This difference is partially due to the slight slope of the channel, but primarily because of the beaver dam that has formed at the upper portion of the meander channel (see **Figure 2-1**).

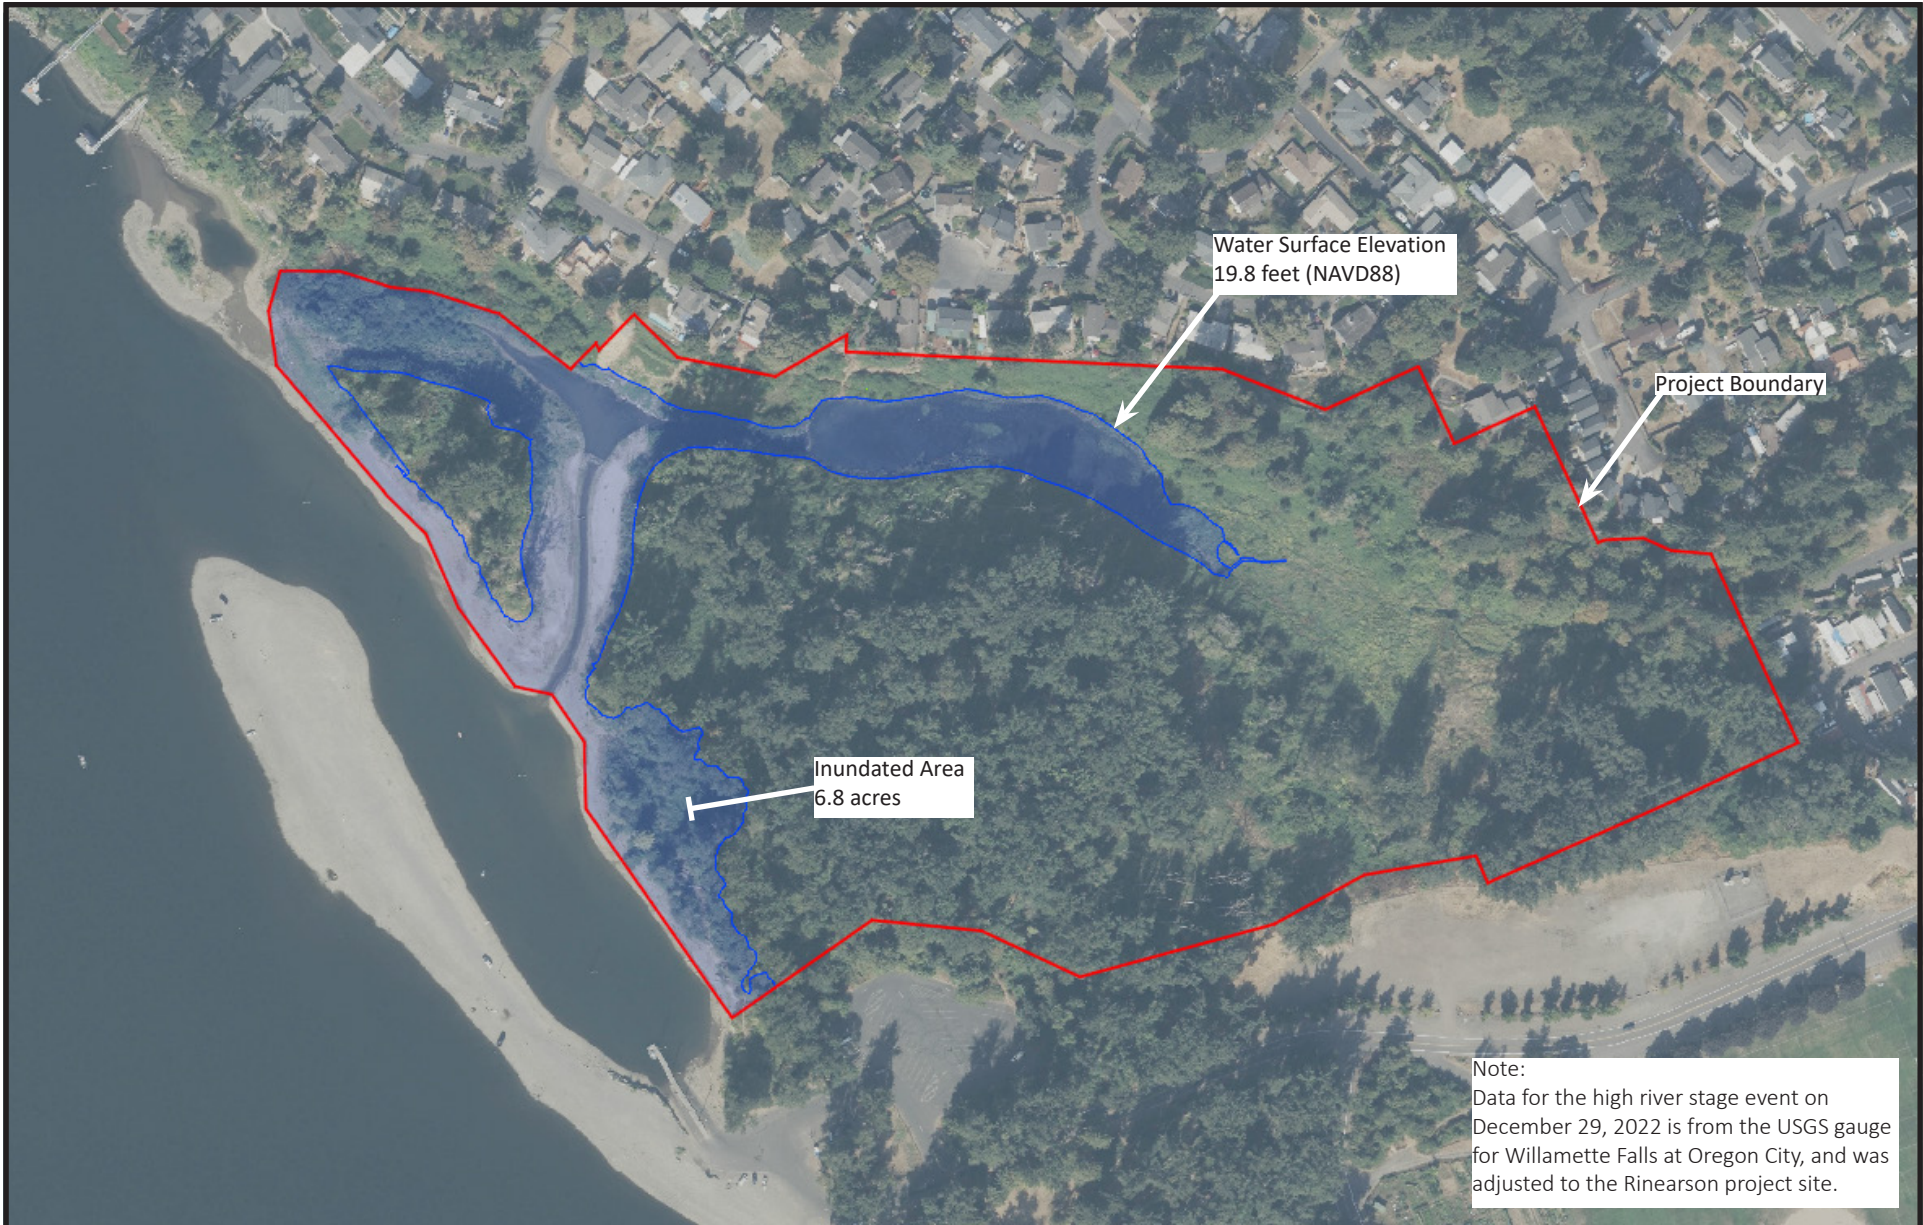
FIGURE
2-6

A high Willamette River stage on December 29, 2022 (based on the USGS gauge 14207770 for the Willamette River Below Falls at Oregon City) resulted in a maximum water surface elevation of 19.8 feet (NAVD88) in the Willamette River at the Rinearson Site. The elevation of the roughened channel crest is 16.85 feet (NAVD88), and therefore the remnant pond sill was overtopped by 2.95 feet, which inundated approximately 6.8 acres of the site (**Figure 2-6**). Per the performance standards set in the HDP, a minimum of 8.6 acres should be inundated when the Willamette River exceeds 22.0 feet (NAVD88) at the project site. Even though no storm event in the 2022-2023 season resulted in the Willamette River reaching 22 feet (NAVD88), we assume that a larger storm event producing a river stage near 22 feet would inundate approximately 9.8-acres of the site (which is well above the 8.6-acre minimum) based on the as-built contours that are consistent with the 2023 surveyed cross-section elevations. Given the

fact that the cross-sections surveyed in 2023 closely matched the as-built condition, and the fact that a complete, updated topographic survey of the site will not be conducted until Year 10, the as-built survey represents the best available data for use in calculating acreages at different reference elevations. Therefore, to calculate the acreage at 19.8 feet NAVD88 (highest Year 5 Willamette stage) and 22 feet NAVD88, planar surfaces representing those elevations were used to intersect the area above the roughened channel, using AutoCAD, and the resulting acreage was computed, producing 6.8 acres and 9.8 acres, respectively.

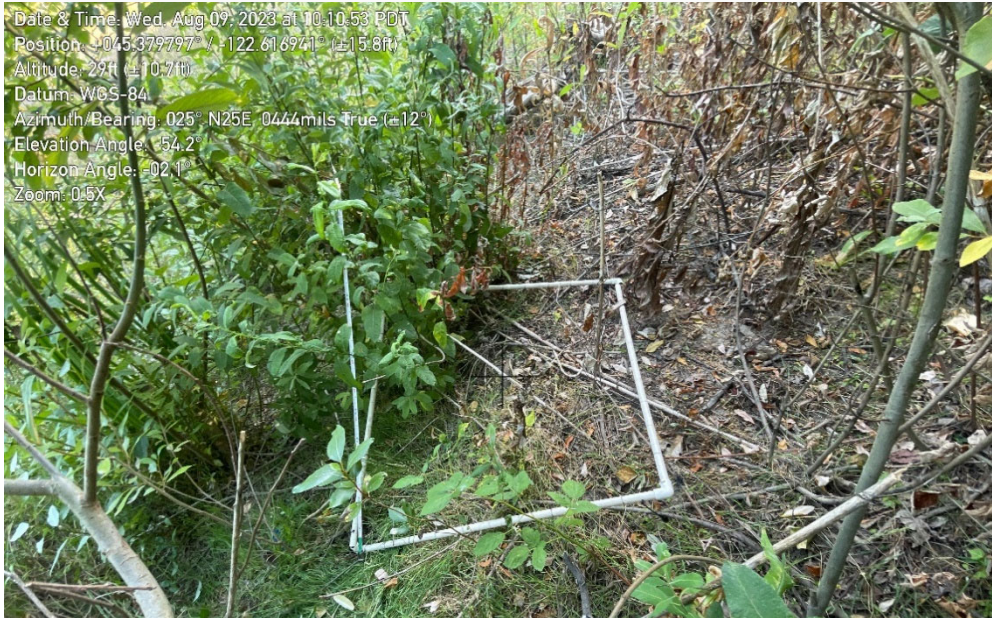
Figure 3-2: Example of plot placement in an RFR plot

A total of 65 1-m² quadrat plots were sampled across four different habitat categories: emergent marsh, riparian forest restoration, riparian forest enhancement, and upland/riparian forest invasive. **Table 3-1** shows a detailed count of the plots within each habitat, and **Figure 3-1** shows the locations of all these plots. The criteria for these categories are outlined in the HDP, along with detailed protocol and statistical analysis background. Aside from riparian forest restoration (RFR) sample plots, Quadrat placement was not outlined in detail in previous monitoring reports, nor in the HDP. To attempt to standardize plot placement for subsequent sampling efforts, the following protocol was used for quadrat placement: facing north (or at a bearing of approximately 0°) from the sample point, the “lower left” corner of the quadrat is placed on the plot center. This ensures that the area being monitored will generally remain the same over time. See **Figure 3-2** for an example of this alignment. Following placement, the absolute percent cover of all herbaceous/woody plant and bare ground within the sample plot was estimated and recorded. Bare ground includes bare mineral soil, thatch, and unvegetated water surfaces. RFR plots also include an expanded 2 x 10-m² plot, in which all living woody plants were identified and counted to determine woody plant density. For these specific plots, quadrats will be centered along the sampling sub-transects; quadrat length will be measured with a measuring tape; quadrat length will be measured with a measuring tape facing by facing north (0°) and measuring 10 meters in this direction; quadrat width will be measured by holding a 1-meter dowel along the

transect tape. All living woody native and non-native stems occurring within the quadrat will be identified to species level and counted.

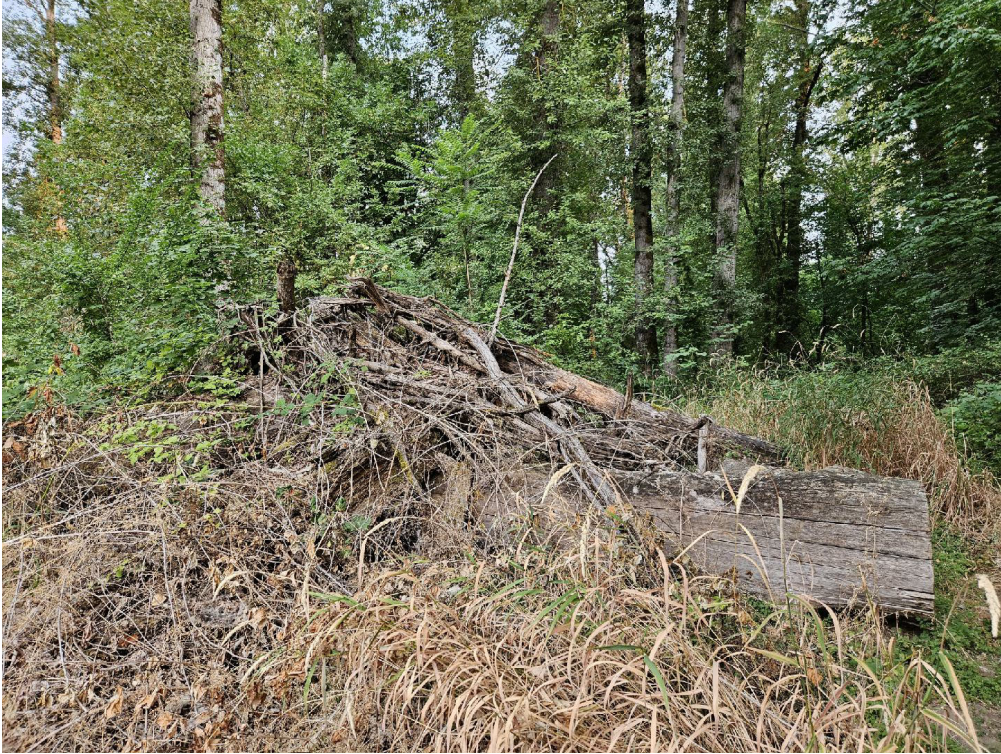
Habitat Structure 2: Floodplain Log Structure (Intact)

Notes: Consists of a log and a few boulders.

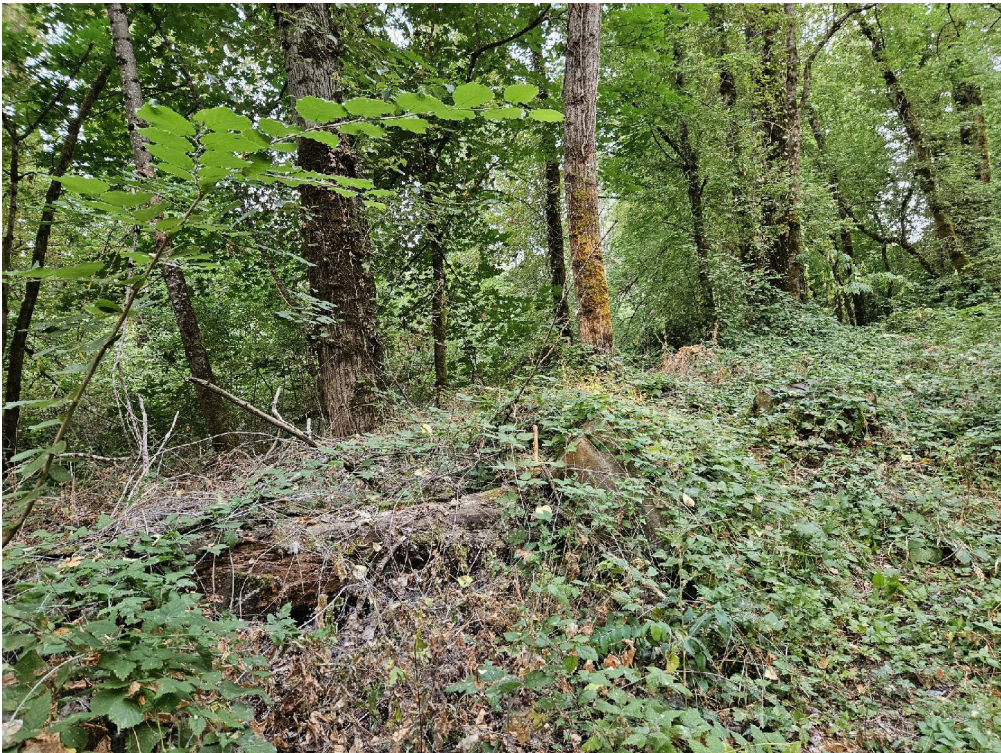
Habitat Structure 3: Log Pile (Intact)

Notes: Consists of multiple large cottonwood logs and is covered in native trailing blackberry.

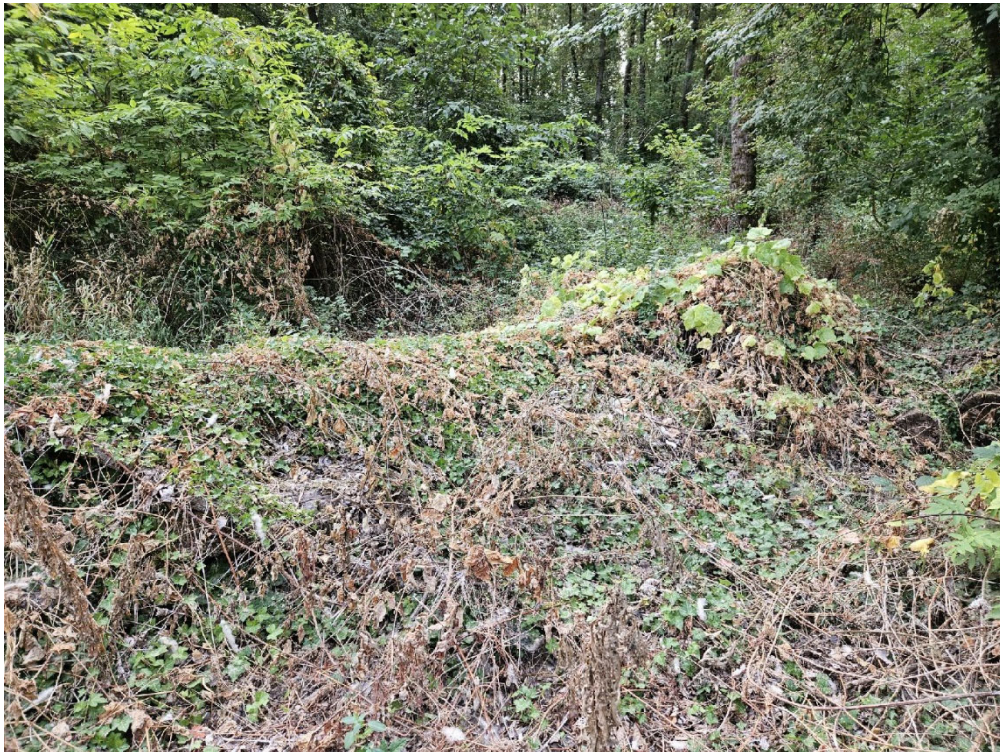
Habitat Structure 7: Debris Pile (Intact)

Notes: Wood debris pile covered in a mix of native and non-native vines.

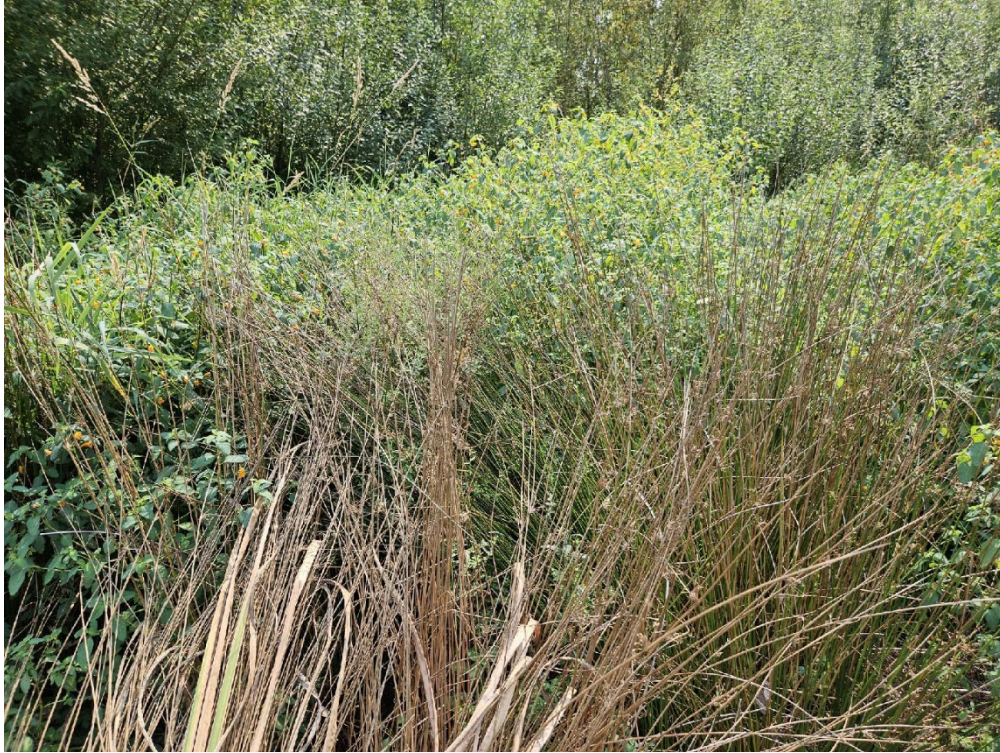
Habitat Structure 39: Not Accessible (Unknown)

Notes: Site found but hidden under vegetation

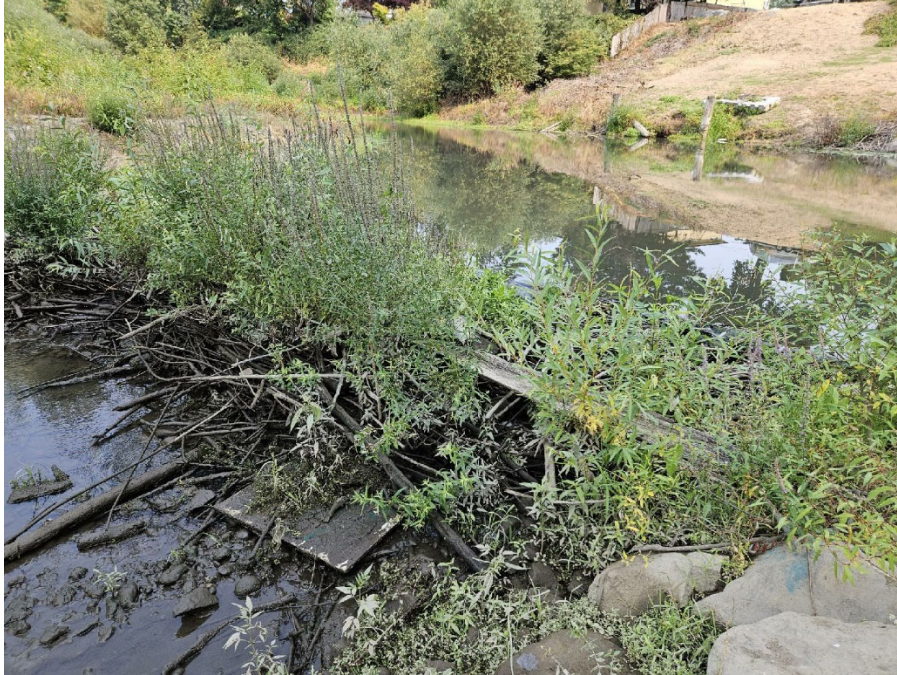
Meldrum Channel Beaver Dam: Holds approximately 2.5 feet of grade, maintains flooded lagoon upstream, is mostly inundated at summer high tide, and is not considered a fish barrier.

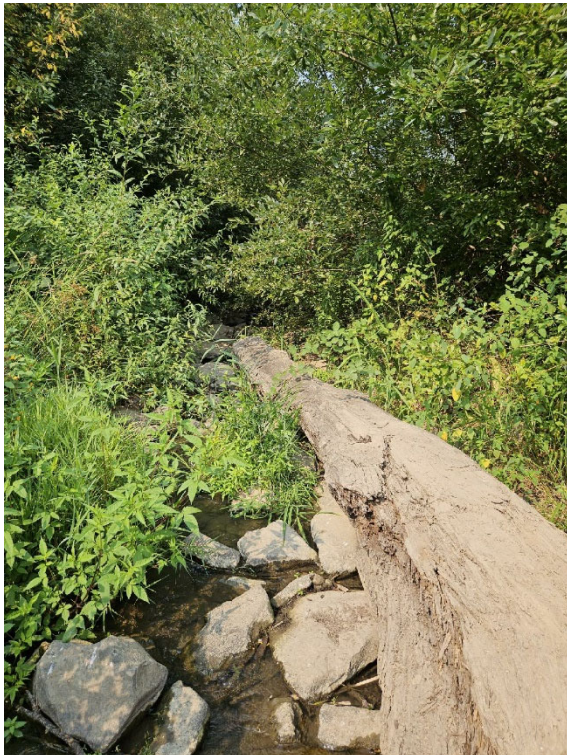
Roughened Channel (RC): RC is stable with depths at low flow adequate to facilitate fish movement. There are no stability issues observed. The reach is vegetating well with a canopy of primarily willow with some cottonwood growth. There are very little to no nonnatives.

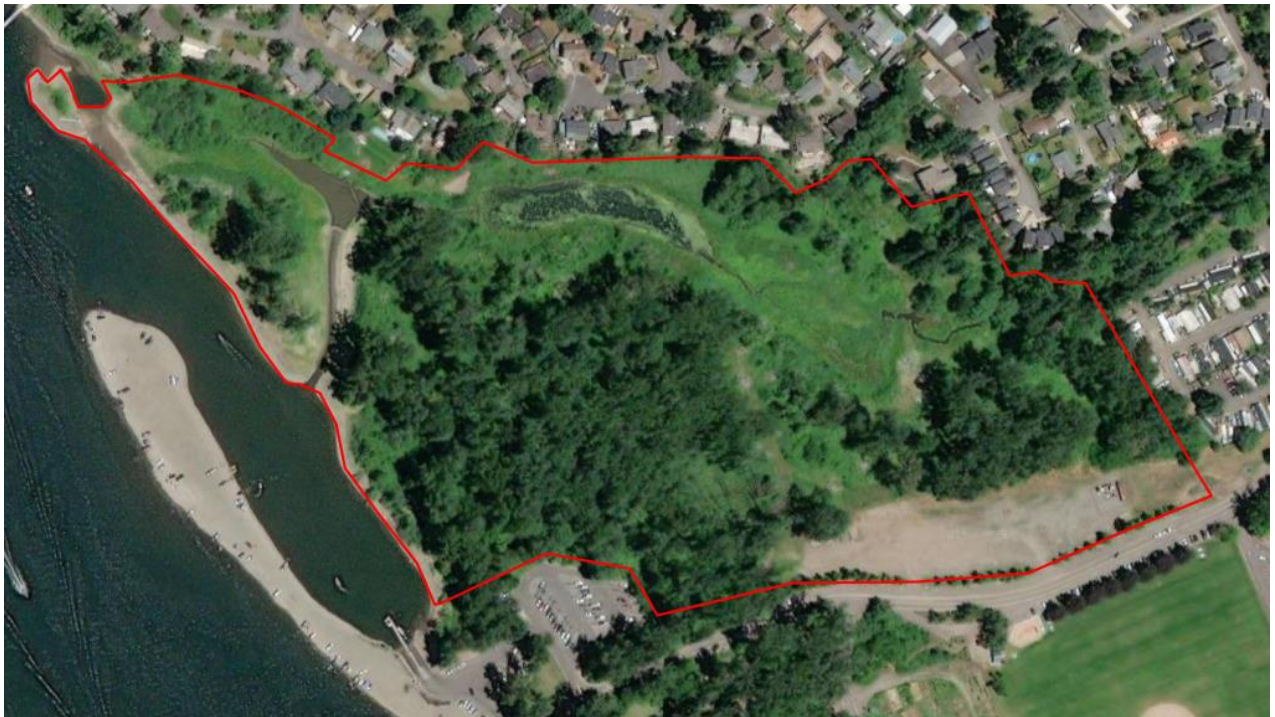
Rinearson Natural Area Invasive Weed Treatments 2023

- *Site Treatment* – Winter spot/ broadcast spray of full 36 acres on site.
- *Invasive Targets* – Himalayan blackberry, English ivy, Thistles.
- *Herbicide prescriptions* – 2% Garlon3a (Triclopyr), 2% AquaNeat (Glyphosate), 1% Competitor (Surfactant); 2% Garlon3a (Triclopyr), 4% AquaNeat (Glyphosate), 2% Competitor (Surfactant)
- *Habitat Management* – broadcast sprayed, brush cut, and removed debris from turtle nesting habitat areas.
