*Deepwater Horizon*  
NRDA Early Restoration Project Comprehensive Final Monitoring  
Report:

## Louisiana Oyster Cultch Project

Prepared by: Louisiana Natural Resource Trustees

May 2016

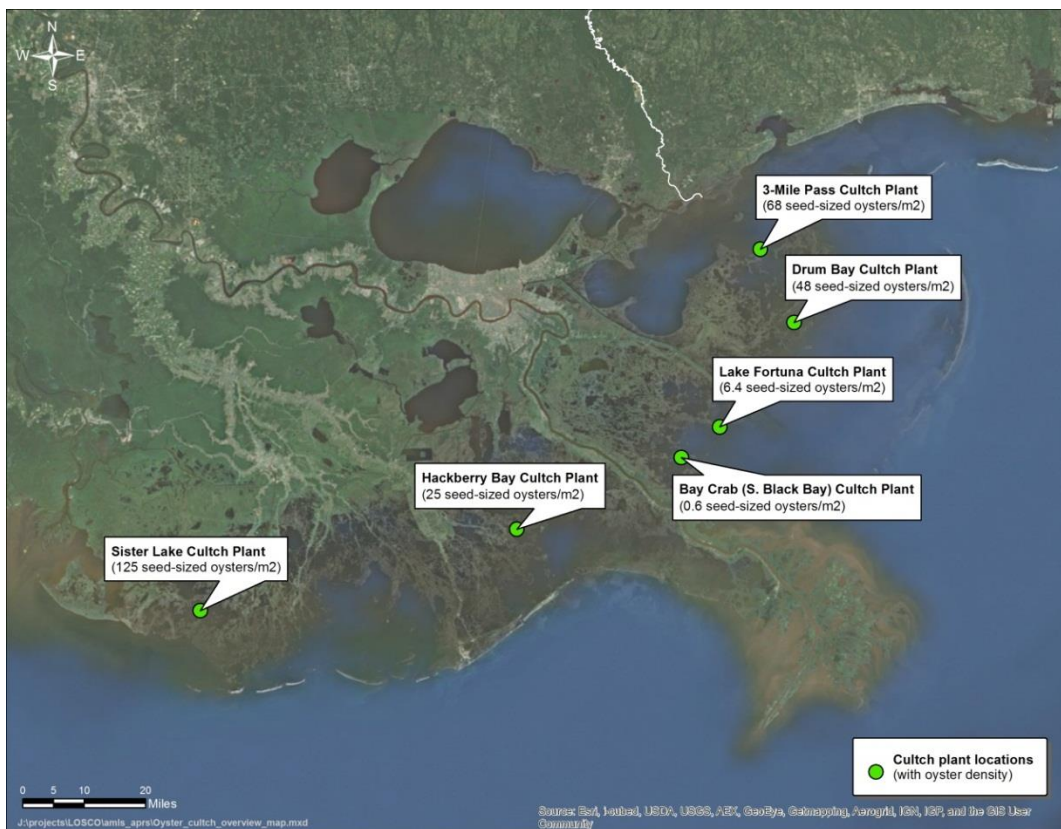
**Figure 1. Location of cultch plants and mean density of seed-sized oysters from summer 2014 project-specific sampling.**

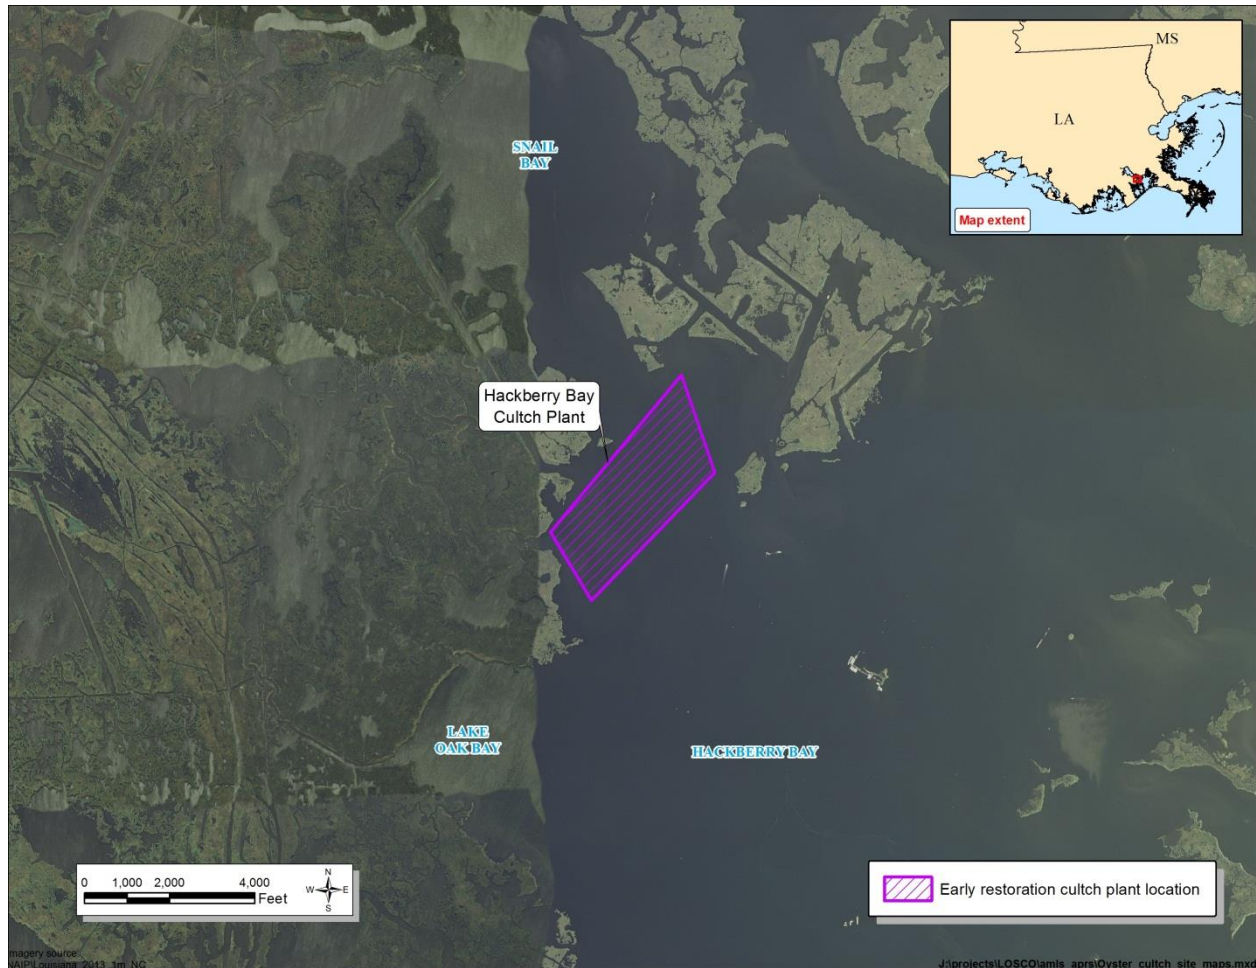
The Hackberry Bay cultch plant site is located in Barataria Bay within Louisiana's Coastal Study Area 3 (CSA 3; Figure 2). This CSA includes three public oyster areas. The oldest, Hackberry Bay, became a POSR in 1944 (LDWF, 2012b). LDWF has conducted cultch plantings in this area since 1943 to bolster oyster production. Little natural reef exists in the Hackberry Bay POSR; production depends on when and where cultch plants were placed in the bay. The addition of the Hackberry Bay cultch plant restoration project in May 2012 effectively tripled the available oyster reef acreage of the Hackberry Bay POSR from 99.7 to 299.7 acres (Louisiana Natural Resource Trustees, 2014).

**Figure 2. Hackberry Bay cultch plant placement site.**

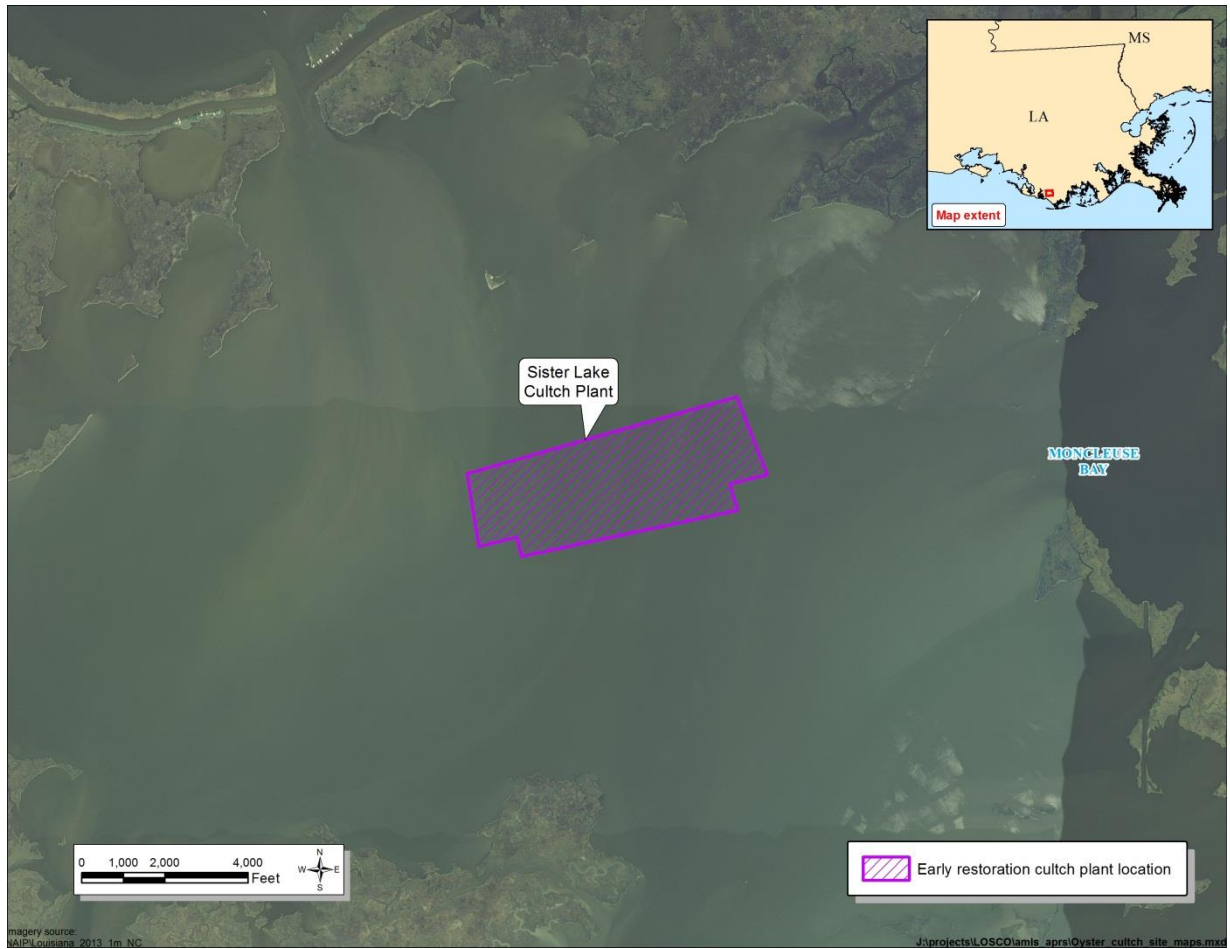
Sister Lake is the largest project cultch plant site, totaling 358 acres. Before cultch placement, side-scan sonar surveys of the Sister Lake POSR area showed that the reef covered approximately 2,280 acres in 2012 (LDWF, 2012b). The estimated total reef covered in the Sister Lake POSR after project cultch placement increased by approximately 100 acres to 2,375 acres, indicating that the majority of project cultch was placed atop existing reef (LDWF, 2013). The project cultch plant site is in the middle of the Sister Lake POSR (Figure 3).

**Figure 3. Sister Lake cultch plant placement site.**

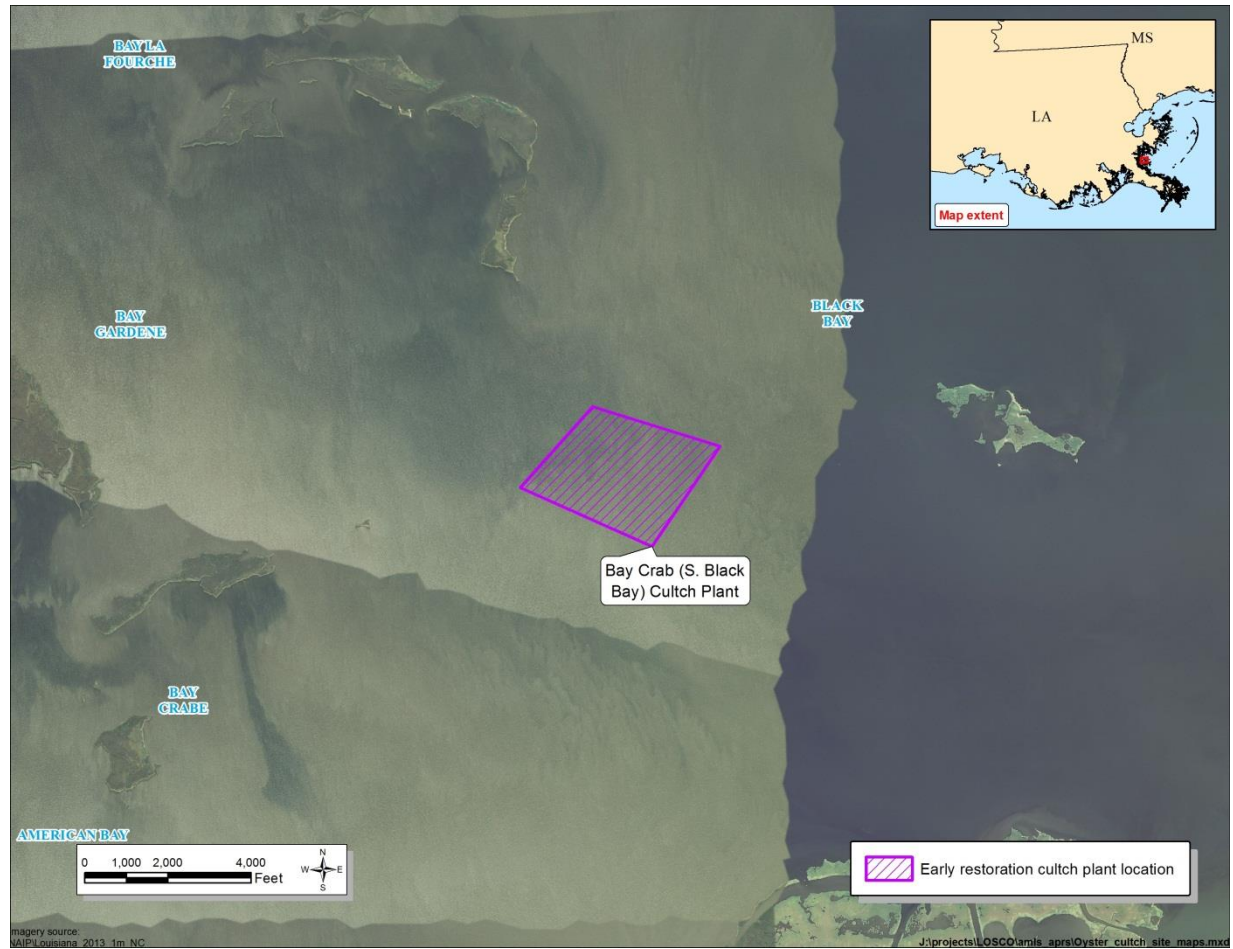
The Bay Crab (or South Black Bay) cultch plant is located in CSA 1 South Pontchartrain Basin POSG (Figure 4). LDWF has operated an active cultch planting program in this area since the early 1900s. In this CSA, oyster recruitment and survival are heavily influenced by Mississippi River discharge via levee gaps, freshwater diversion structures, and main-stem distributaries (LDWF, 2012b). Previous stock assessments in this area, prior to the fall 2012 Bay Crab cultch placement, showed substantial declines of oyster abundance – down 95% to 98% compared to long-term averages. Experts attributed poor oyster performance in 2012 to salt-wedge-induced hypoxia, spring freshets that occurred during peak spawning times, sedimentation, subsidence, disintegration of extant cultch material, and abundant oyster predators and fouling organisms (LDWF, 2013). LDWF reported that oyster stocks in this POSG showed improvement in 2013 surveys compared to the extremely low abundance estimated in 2012 (LDWF, 2013).

**Figure 4. Bay Crab cultch plant placement site.**

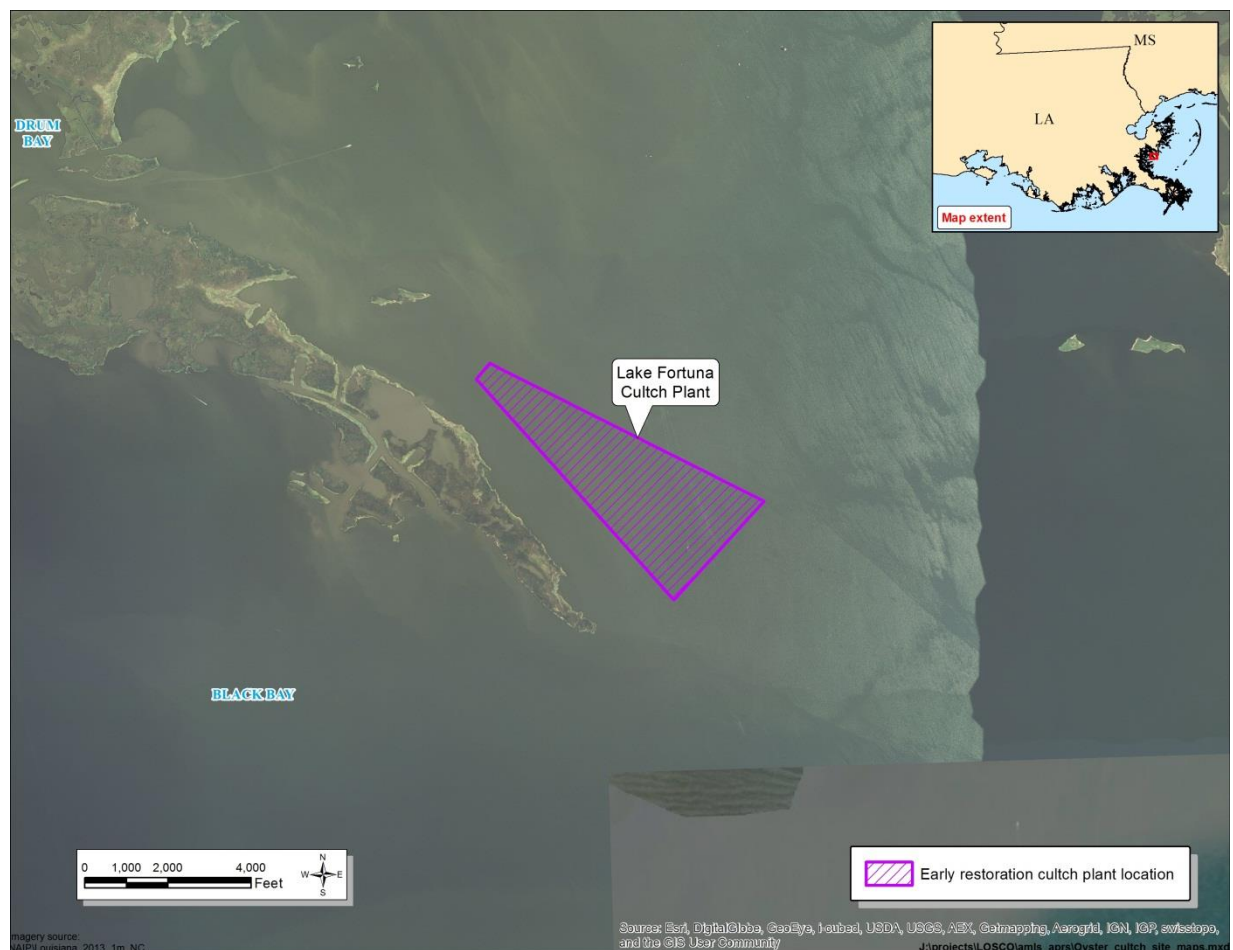
Similar to Bay Crab, the Lake Fortuna cultch plant (Figure 5) is in the Pontchartrain Basin POSG (CSA 1 South), about eight miles northeast of the Bay Crab cultch plant. The same environmental stressors and recent declines in oyster stocks that LDWF has observed near Bay Crab may influence oyster performance in and near the Lake Fortuna cultch plant (LDWF, 2013).

Figure 5. Lake Fortuna cultch plant placement site.

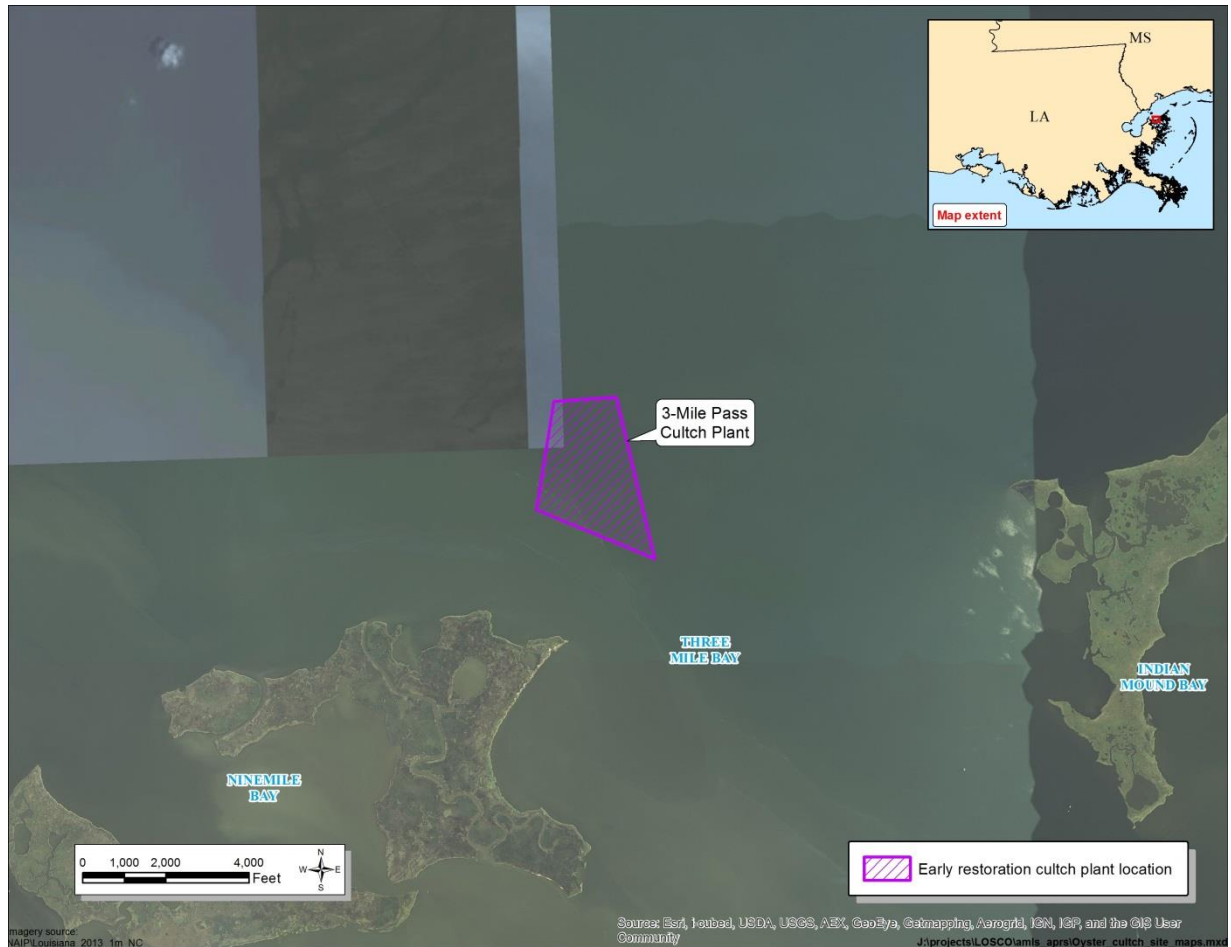
The 3-Mile Pass cultch plant is located in the North Pontchartrain Basin POSG (CSA 1 North; Figure 6). Unlike most other Louisiana CSAs, this area did not become a public oyster area until the late 1980s. The State of Louisiana has continually expanded and enhanced oyster reefs in this area through cultch placement activities. Historically, CSA 1 North has had high oyster production. However, similar to other nearby CSAs, oyster stocks near 3-Mile Pass have declined in recent years. The lowest recorded oyster stock sizes at CSA 1 North occurred in 2011 (LDWF, 2012b). While the 2012 stocks showed an increase in oyster production from 2011, stock sizes were still a fraction of historical averages and densities were highly variable. LDWF (2012b) attributed recently observed declines in seed and sack oysters to several years of heavy harvest, high recent mortalities, strong tropical storms, and impacts from the DWH spill and related response activities.

**Figure 6. 3-Mile Pass cultch plant placement site.**

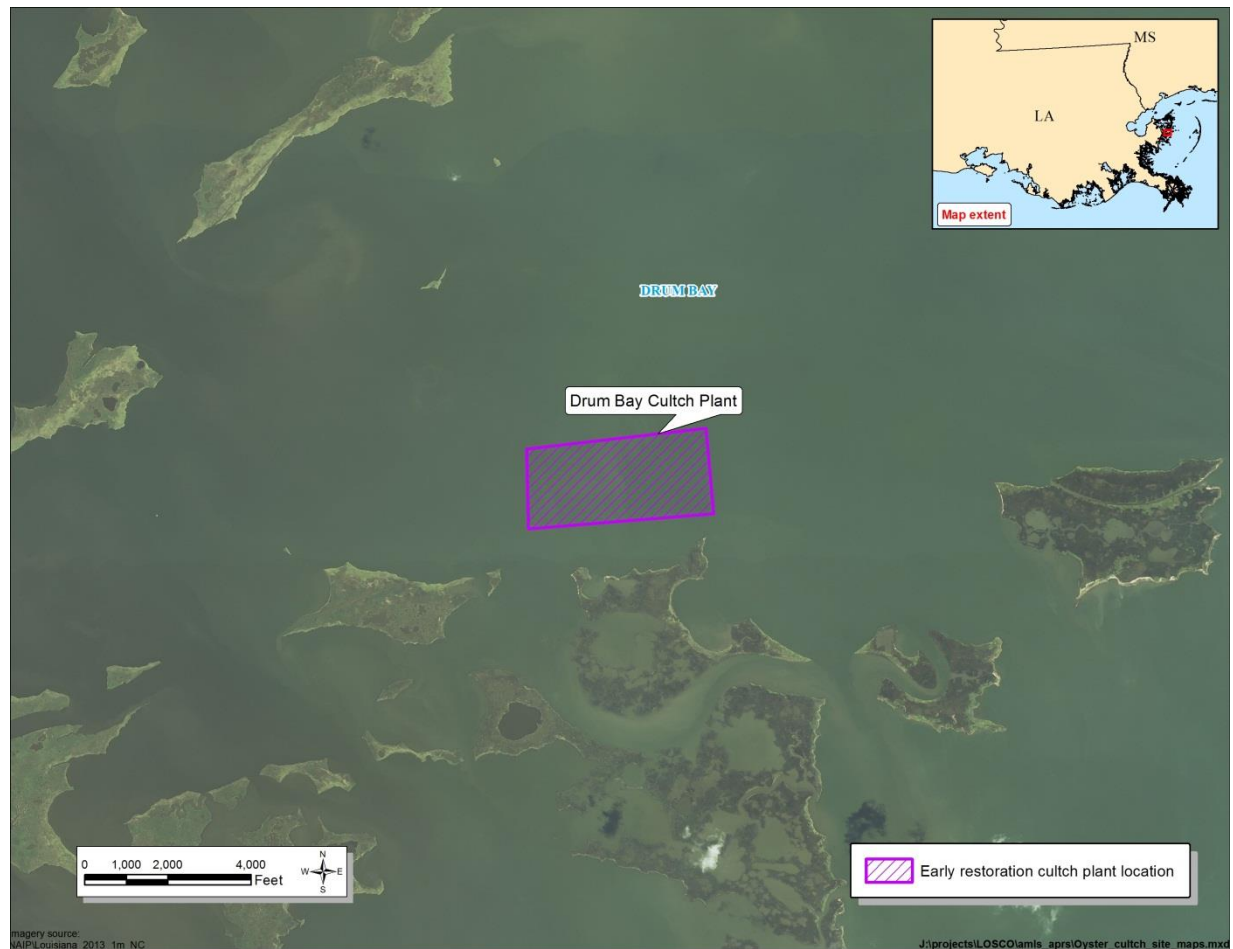
The Drum Bay cultch site (Figure 7) is located in the North Pontchartrain Basin POSG (CSA 1 North), approximately 13 miles south of the 3-Mile Pass project cultch plant. The Drum Bay location experienced similar recent declines in oyster stocks, environmental stressors, and cultch condition as has occurred in other CSA 1 North locations.

**Figure 7. Drum Bay cultch plant placement site.**
