**FINAL
PRIMARY RESTORATION PLAN AND
ENVIRONMENTAL ASSESSMENT
FOR THE 2006 T/V MARGARA GROUNDING
GUAYANILLA, PUERTO RICO**

Prepared by:

The Puerto Rico Department of Natural and Environmental Resources
and
the National Oceanic and Atmospheric Administration

April 2015

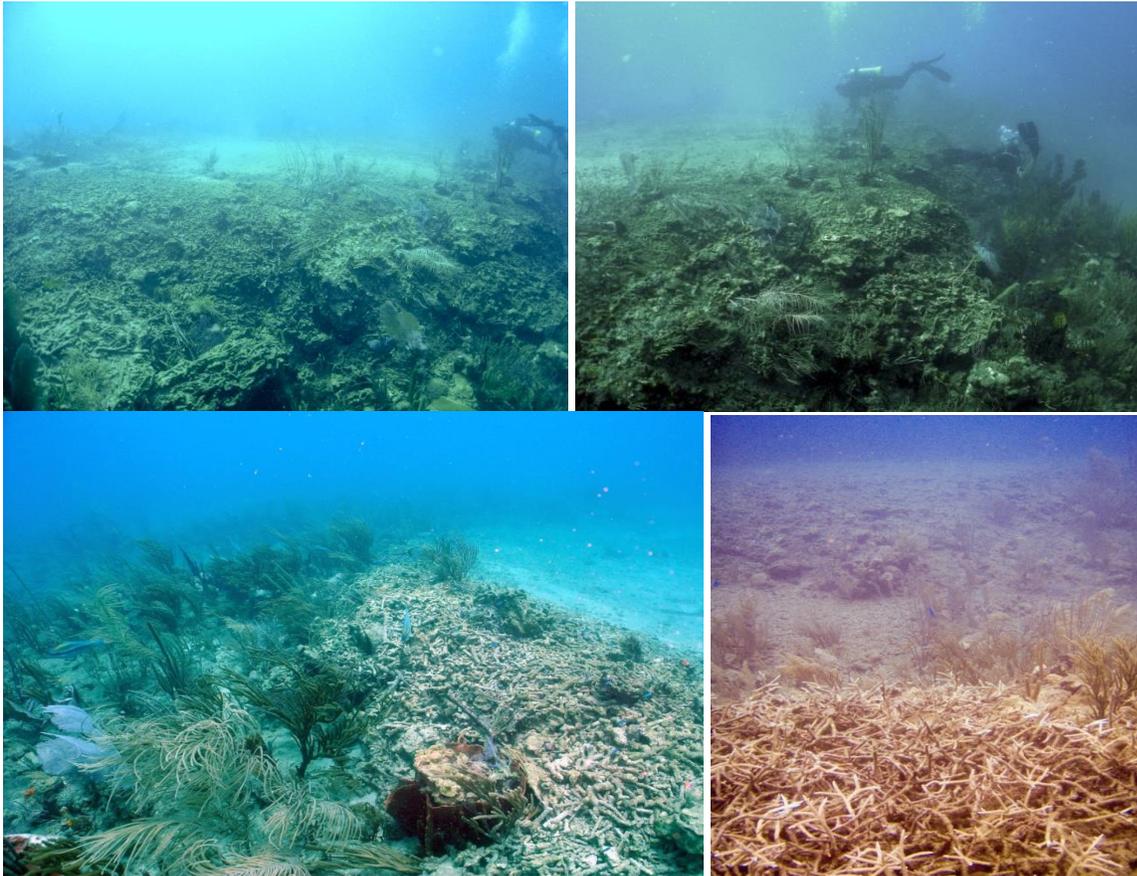
Figure 3: Photos of impacted areas and adjacent reef at the T/V MARGARA site. Photos taken by NOAA Restoration Center in 2006.

The T/V MARGARA Incident caused significant injuries to coral resources, other reef biota, and reef habitat over a large area (Figure 3). The T/V MARGARA impact site can be separated into a southern impact site (~ 1,204 m² of reef impacted), a northern impact site (~ 5,530 m² of reef impacted), and a deeper central area impacted by prop wash (~ 174 m² of reef impacted). The grounding of the vessel, its subsequent movement and actions undertaken to remove the vessel in order to prevent a significant oil spill caused or contributed to 6,908 m² of damage to the sea floor. Within that area, an estimated 6,393 m² of reef suffered a complete loss of biota. The remaining 515 m² suffered partial resource mortalities.

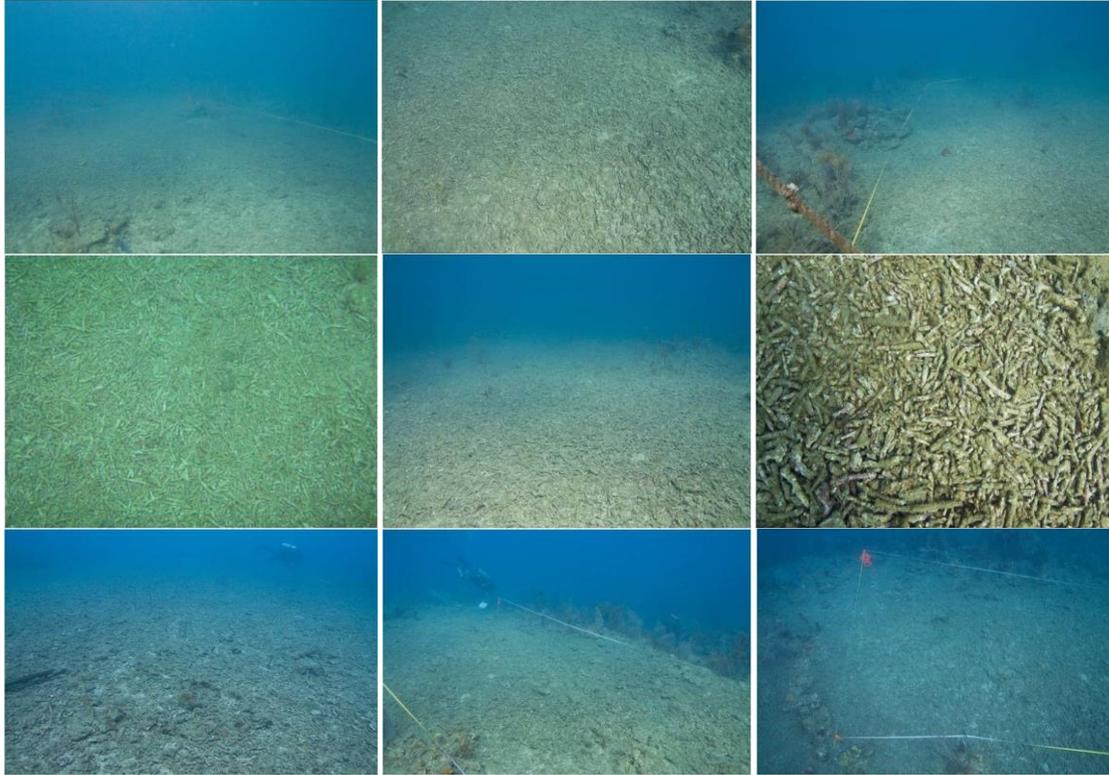
Figure 9: Photos of rubble and some of the areas needing primary restoration at the T/V MARGARA site. Photos by NOAA Restoration Center, December 2008.

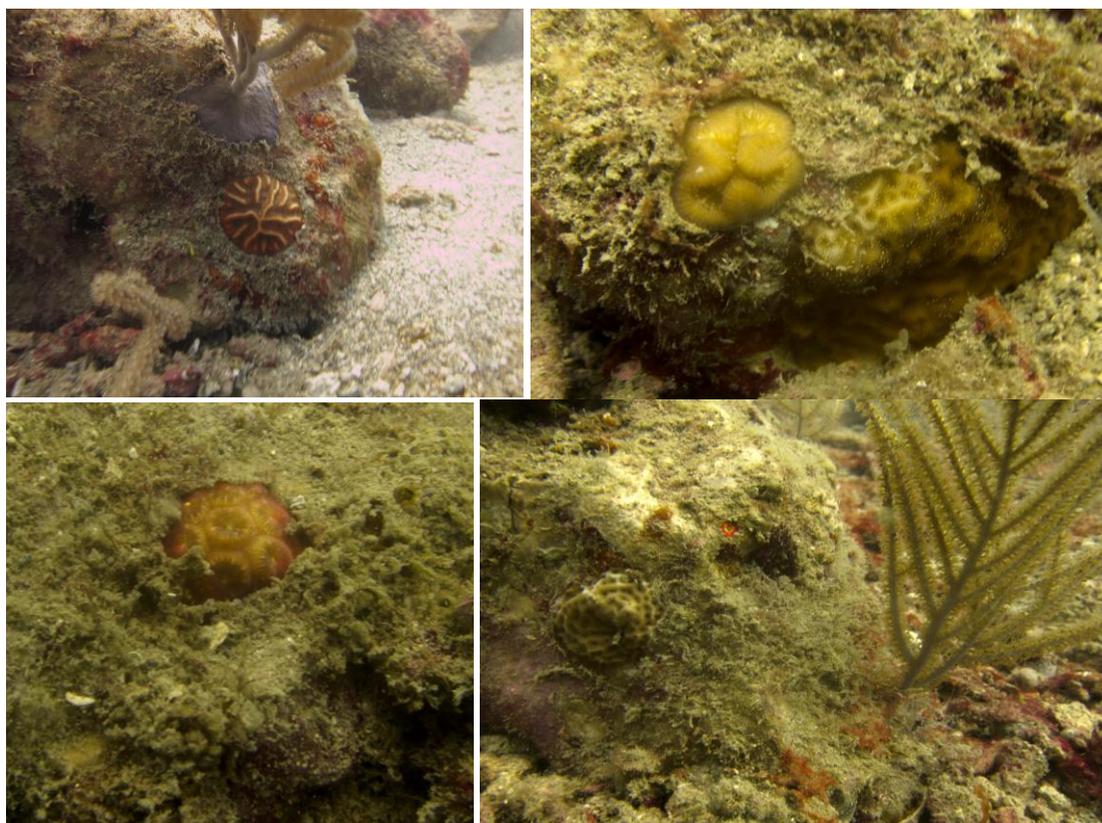
Figure 14: Photos of scleractinian and octocoral recruits on limestone deployed at T/V MARGARA site in 2010. Photos by NOAA’s Restoration Center, 2013.

Phase 2 of the primary restoration plan calls for biological enhancement of the restoration site by transplanting corals from the nearby coral nursery and from other “at-risk” sites. This would return corals to the site immediately. This action would accelerate biological recovery of corals at the site ahead of the time full recovery would occur if recovery relied entirely on natural recruitment as these species take many years, in some instances even decades to recruit and then grow. The restoration plan also calls for the use of karsted-quality limestone. This material is porous and has a lot of holes, crevices and grooves which promote recruitment of marine organisms as new recruits favor irregular surfaces and crevices that provide protection. Coral recruitment is also not as successful on flat surfaces because the corals get smothered by sedimentation (Maida et al., 1994). Ceramic, cement or other materials lack this characteristic. Samples of limestone were placed at the site by the Trustees in 2010 to test how the material would function at the site. After 3 years, there were high rates of coral recruitment and survival on the limestone (Figure 14) including many broadcast spawners like *Orbicella cavernosa*, *Diploria strigosa* and *D. labyrinthiformis* which typically have lower recruitment rates than other coral species that are brooders (Rylaarsdaam, 1983; Smith, 1992; Vermeij, 2006).

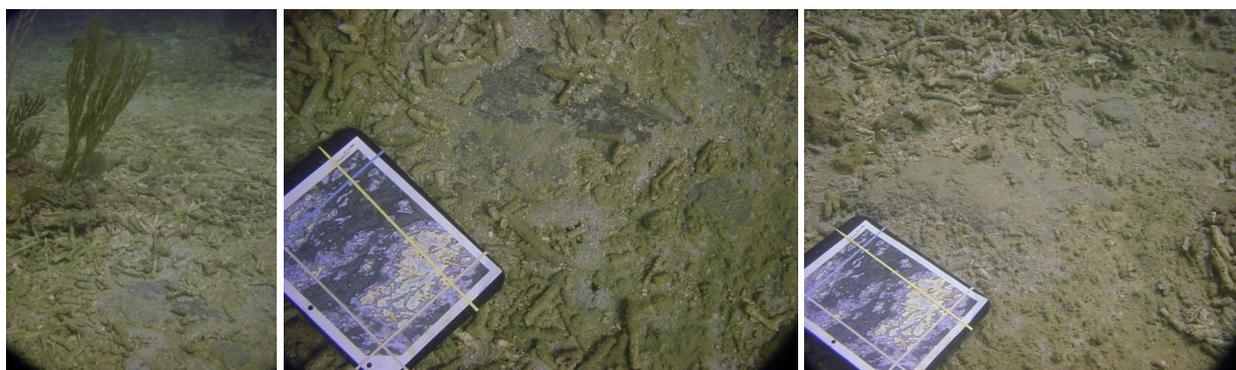
Figure 2: Anti-fouling paint at the MARGARA site exposed by Hurricane Omar, October 2008. Photos taken by NOAA Restoration Center in October, 2008.

The mid-course corrective actions were initiated in November of 2007 and completed in the spring of 2008. Additional hull paint was also subsequently exposed by the passage of Hurricane Omar in October 2008 and later removed as well, to the extent possible (Figure 2).
